Vera C. Rubin Observatory  
Rubin Observatory Operations

## The LSST Camera commissioning

CTN-007

This technote describes what we found during the LSST Camera commissioning.

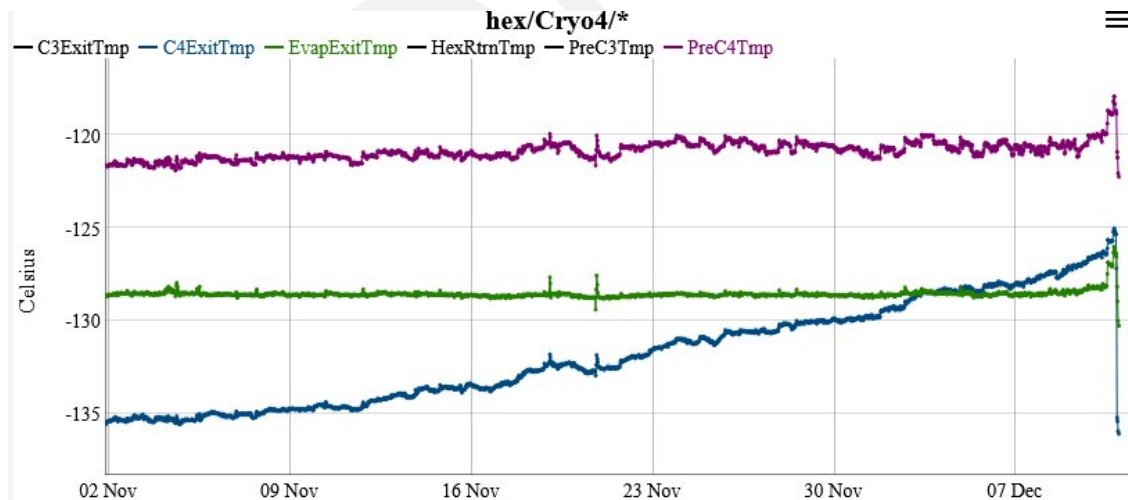
FIGURE 3: **CRYO-04.** The Cryo 4 clog developing through November: the C4 exit temperature (blue) drifts up towards the pre-capillary temperature over five weeks, the signature by which the clog was recognised (2025-12-11, #cam-operator).

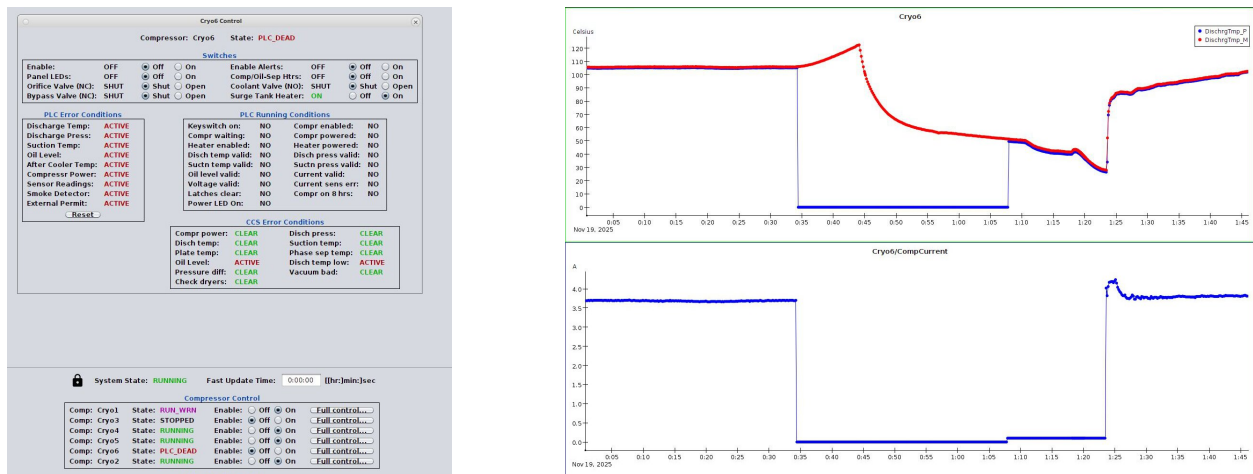
was attributed to a software update elsewhere on the summit mis-setting the glycol set-point in response to bad environmental sensor readings (FRACAS-322, OBS-1394, OBS-1395). The PLC failure itself is suspected to be a problem in the PLC, and its root cause is not known. The CCS logic that closes the coolant valve when a PLC is declared dead was flagged as needing revision (LSSTCCSREFRIG-319 and LSSTCCSREFRIG-332).

FIGURE 4: **CRYO-05**. Left: the CCS Cryo 6 panel during the failure, reporting State: PLC\_DEAD with every PLC error condition ACTIVE. Right: the discharge temperature and compressor current across the event, the temperature rising while the compressor is off (2025-11-19).

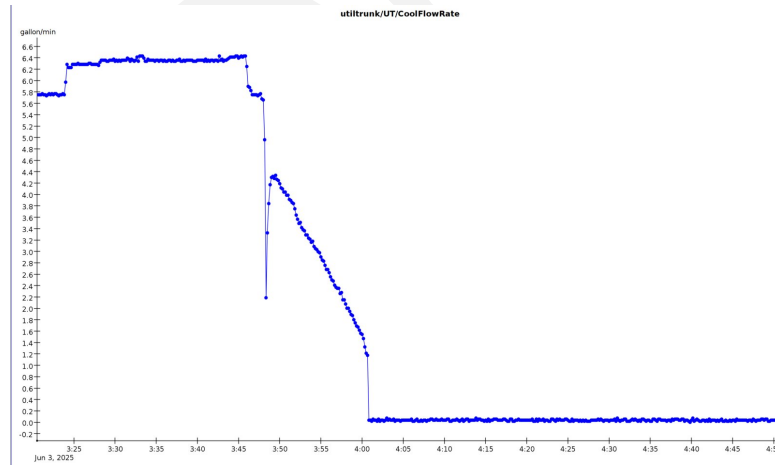
**DYN-01 Recurrent loss of Dynalene flow to the utility trunk.** *First to last mention 2025-01-18 to 2025-12-17; status **Open**.* Dynalene, which cools the utility-trunk electronics, failed repeatedly all year — from control computer (cRIO) reboots and crashes, chiller faults and power events — each time forcing an emergency power-down of CCDs, REBs and often the shutter and filter changer (OBS-1014, FRACAS-321, FRACAS-328). A review of the August 11 event established that the camera tolerates only about 13 minutes without flow before REB power-supply boards approach their 48°C trip limit. The cRIO was replaced on November 4 and a small UPS was added in late November, but outages continued into the second half of December.

FIGURE 5: **DYN-01.** Utility-trunk Dynalene flow collapsing to zero. This is the signature the events have in common: whatever the cause upstream — a cRIO reboot, a chiller fault, a power event — what the camera sees is the flow going away, and from that moment it has about thirteen minutes before the REB power-supply boards approach their 48°C trip limit (2025-06-03, #cam-operator).

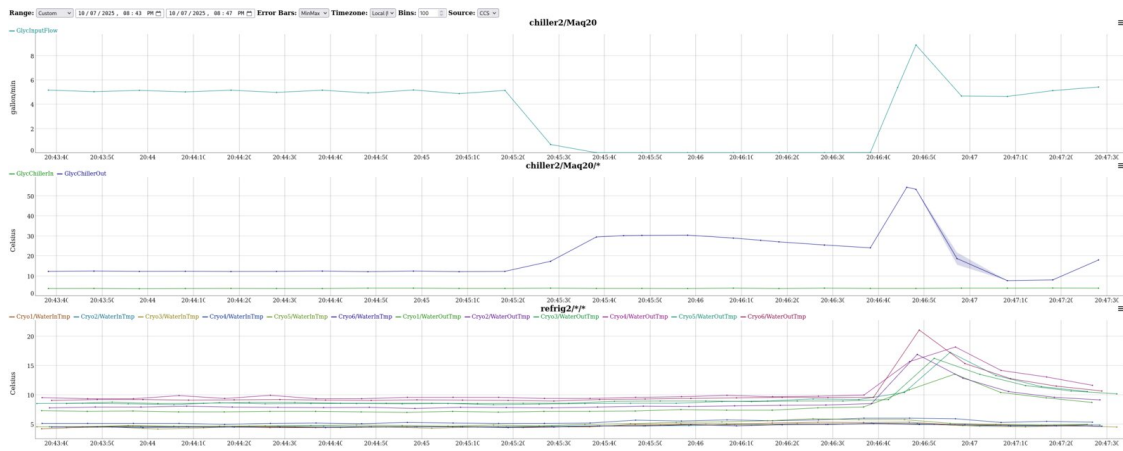
28 to 2025-11-28; status **Resolved**. Every commercial power glitch or generator transfer stops the glycol recirculation pumps for roughly 70–90 seconds, against an observed PCS chiller trip threshold of 90–120 seconds — so each event is a near miss, and several were not (FRACAS-277, FRACAS-278, FRACAS-279). The identified fix, putting the recirculating pumps on UPS, was still pending throughout 2025; in September, observing on generator power had to be restricted in pointing because of it. The issue was closed in early February 2026, after the period covered here.

FIGURE 7: **GLY-01**. One of the near misses, at second resolution. Glycol input flow to the PCS (top) drops from 5.2 gallons per minute to zero at 20:45:30 and is restored about 70 seconds later; the chiller outlet temperature (middle) had already climbed from 12 to 30°C before the interruption and overshoots to 54°C on restart, and the cryo water-out temperatures (bottom) follow it up. The chiller trips if the flow is lost for 90 to 120 seconds (2025-10-07, #cam-operator).

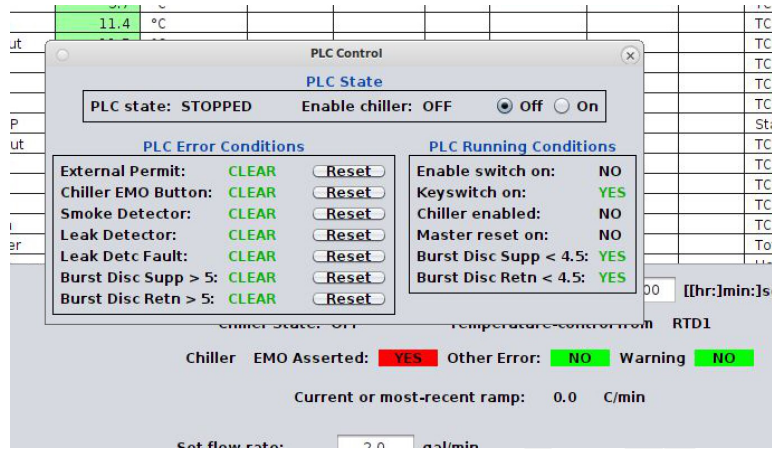
**PCS-02 PCS chiller restart difficulty, and the MRCR unit.** *First to last mention 2025-03-28 to 2025-07-02; status **Open**.* Restarting the chiller is a separate problem from the failures above and was never solved: the unit repeatedly trips on low HFE flow because gas bubbles form in the longer line configuration, which procedure LCA-20281 does not cover. In March it took roughly a dozen attempts over two days, and was recovered only by pressurising the coolant tank; a loud bypass-valve noise during those attempts was later explained as the high-pressure bypass cracking at an 80 psi pump differential. The same behaviour blocked the restart of the unit at the MRCR in July. The MRCR system was found to have failed during the year and is tracked as LSSTCAM-119.

FIGURE 9: **PCS-02.** The chiller PLC panel during a restart attempt: stopped, with every error condition clear. Nothing is reported as wrong, and the unit will still trip on low HFE flow when it is asked to start again — which is why the restarts took about a dozen attempts over two days (2025-03-28, #cam-operator).

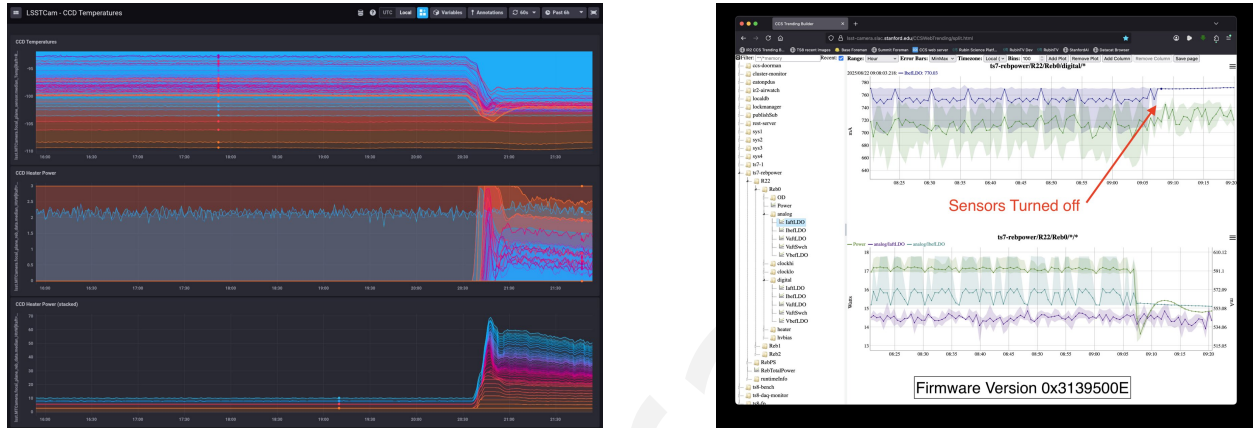
the CCDs run measurably warmer, which was initially misread as lost cryo capacity during the storm. Power-cycling the focal plane and rolling the firmware back confirmed a real power-draw increase of roughly 30 W, and the cause was a register-map conflict in 0x313a5013 that applied maximum heater power — a defect introduced together with the sequencer-override register in 0x31395011 and unnoticed until then. It was fixed by the firmware upgrade to 0x313a5014. See the version history in Table 10.

FIGURE 14: **FW-01.** Left: CCD temperatures and CCD heater power across the firmware roll-back, the step in heater power being the extra draw the faulty build was applying (2025-08-21). Right: the same measurement annotated during the investigation, with the moment the sensors were turned off marked and the firmware version under test named (2025-08-22).

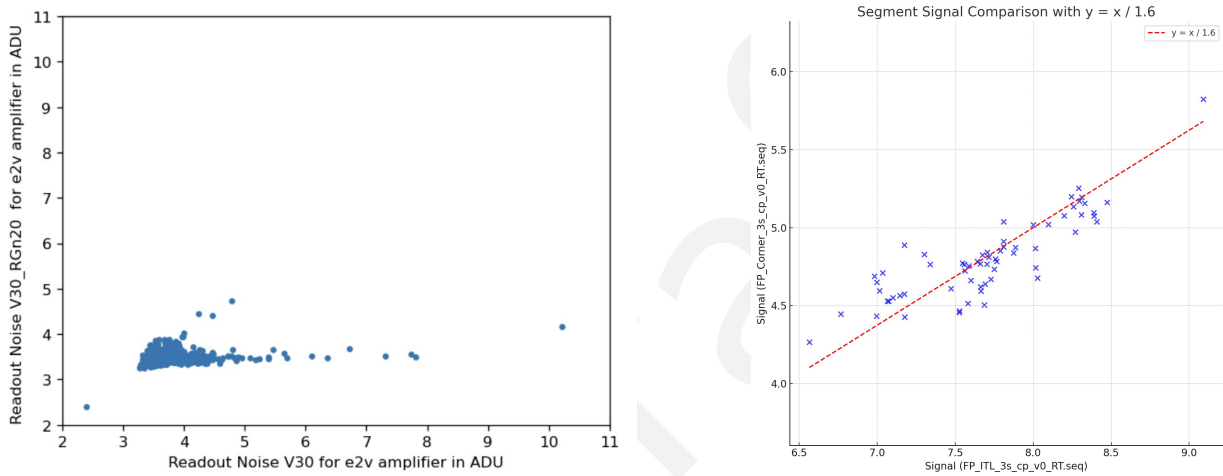
FIGURE 17: **FW-04**. Left: read noise per e2v amplifier with the new sequencer against the old one — most amplifiers unchanged, the worst improved (2025-04-28). Right: segment signal with the 3 s corner-raft sequencer against the ITL one, compared with the expected ratio (2025-06-25).

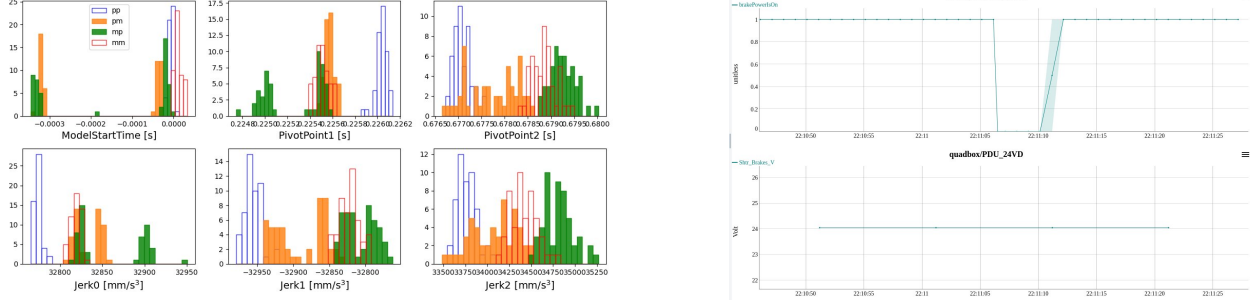
FIGURE 27: **SHT-01**. Left: the shutter motion-profile study of March, fitting model start time, pivot points and jerk for each blade and comparing them with the 2022 reference set (2025-03-24). Right: shutter status and the quadbox 24V supply across one of the stuck-shutter events (2025-04-23).

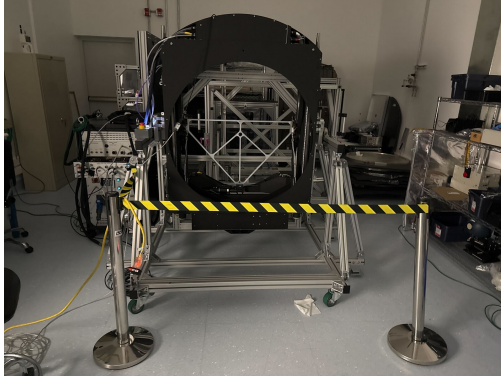
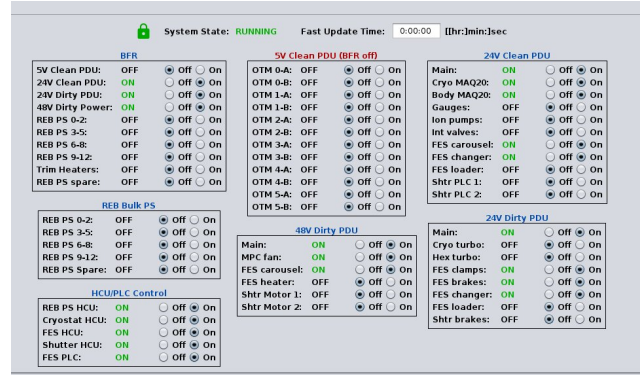
FIGURE 29: **FES-03**. Left: an autochanger on its stand in the clean room, where the homing procedure was qualified (2025-04-07). Right: the quadbox power panel, whose FES carousel, clamp, loader and brake channels are the supplies behind the truck undervoltage faults (2025-02-13).

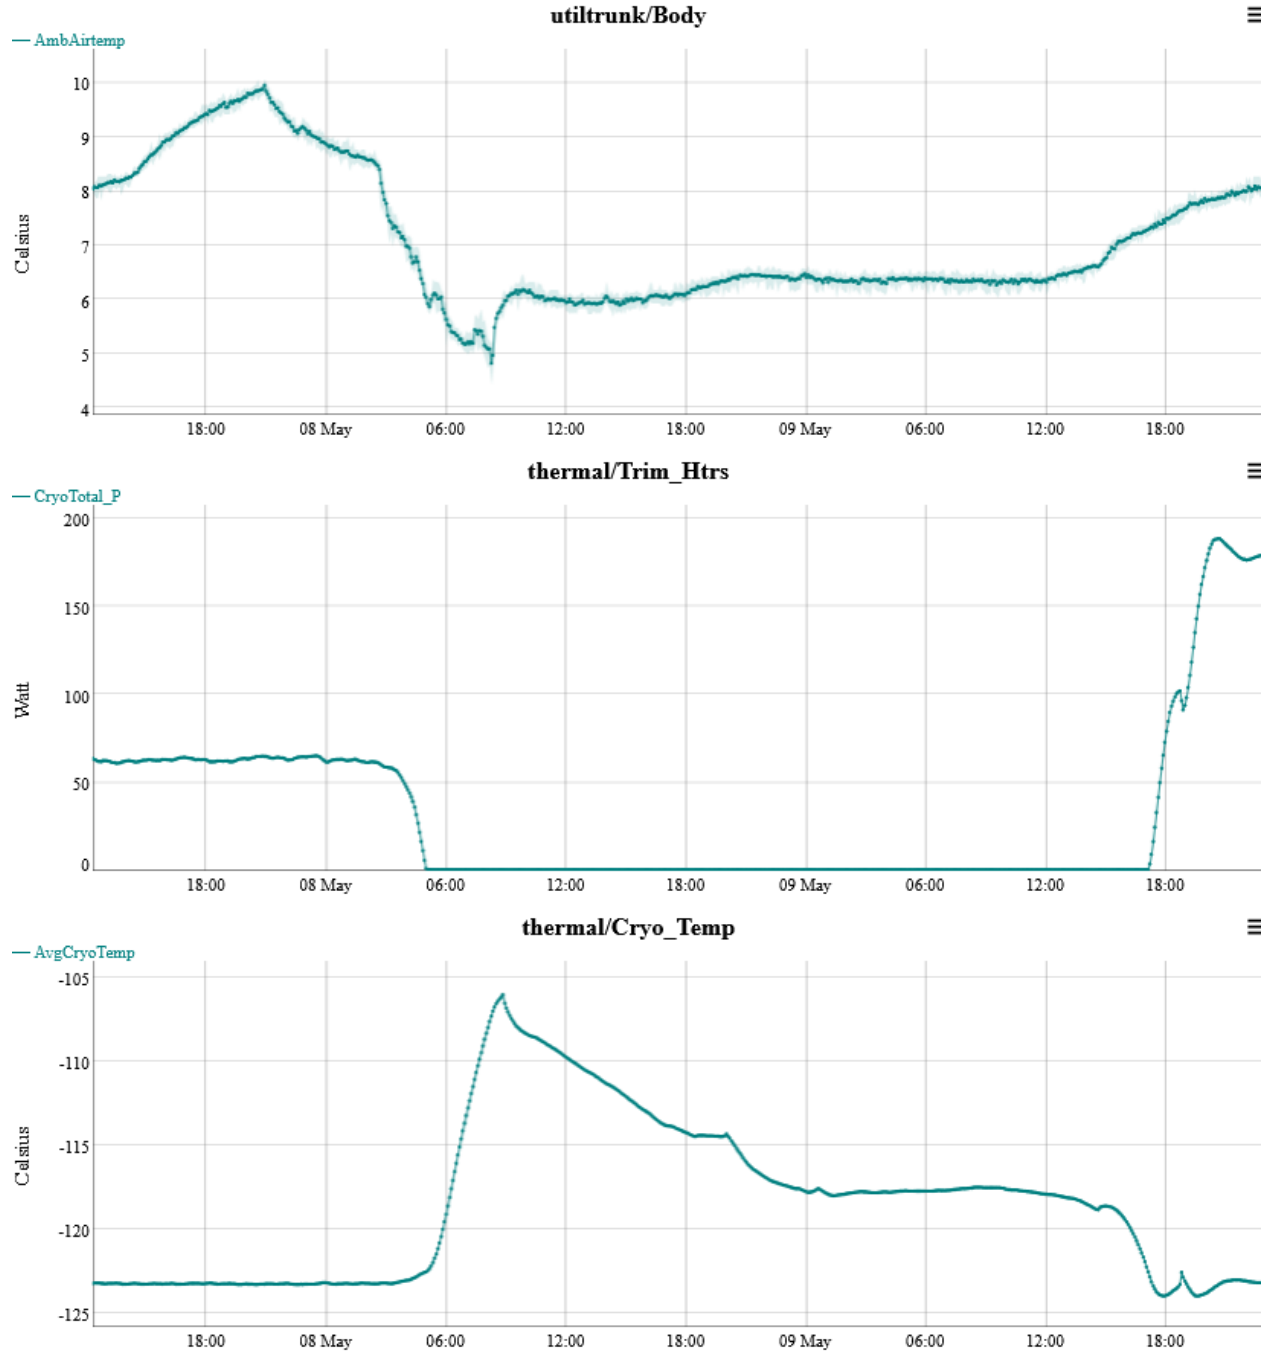
FIGURE 47: Ambient temperature, Cryo trimheat and cryoplate temperature at around 6 am UTC on May 8, 2025

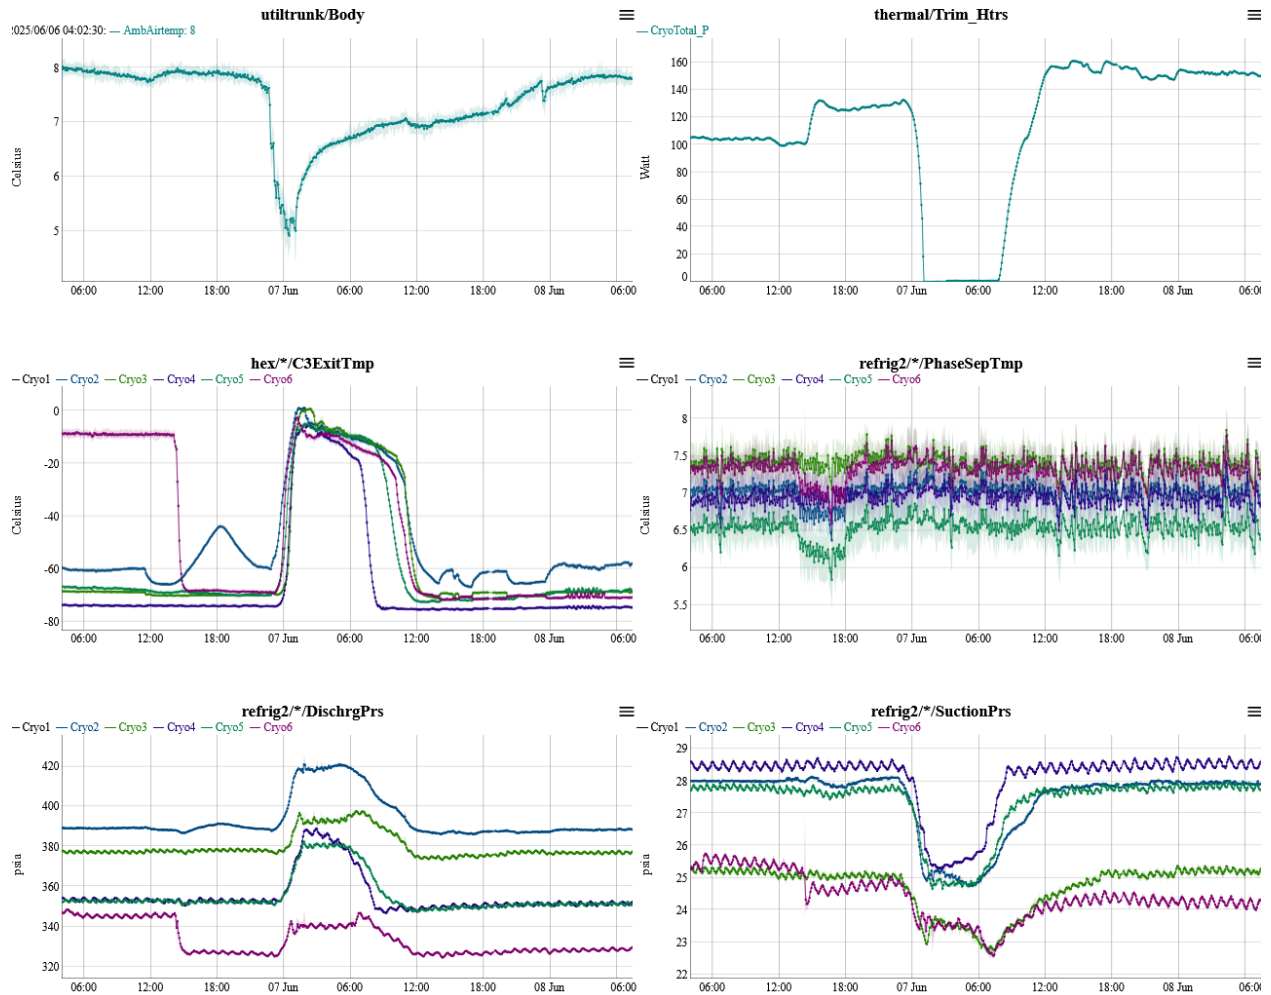
FIGURE 51: Cryo system loss cooling capacity due to low ambient temperature on June 6/June 7 in 2025
