Vera C. Rubin Observatory  
Rubin Observatory Operations

## The LSST Camera commissioning

CTN-007

This technote describes what we found during the LSST Camera commissioning.

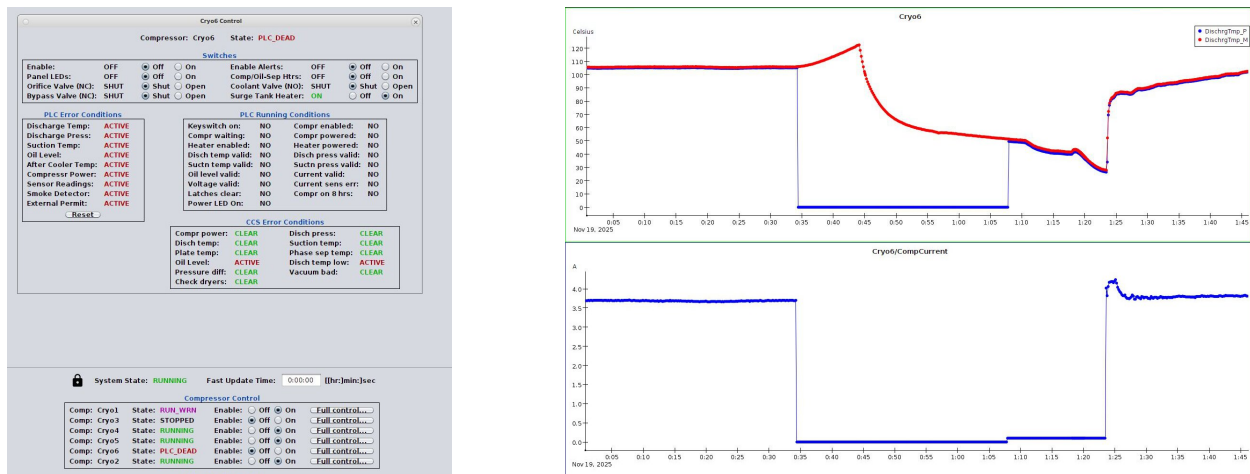
was attributed to a software update elsewhere on the summit mis-setting the glycol set-point in response to bad environmental sensor readings (FRACAS-322, OBS-1394, OBS-1395). The PLC failure itself is suspected to be a problem in the PLC, and its root cause is not known. The CCS logic that closes the coolant valve when a PLC is declared dead was flagged as needing revision (LSSTCCSREFRIG-319 and LSSTCCSREFRIG-332).

FIGURE 4: **CRYO-05**. Left: the CCS Cryo 6 panel during the failure, reporting State: PLC\_DEAD with every PLC error condition ACTIVE. Right: the discharge temperature and compressor current across the event, the temperature rising while the compressor is off (2025-11-19).

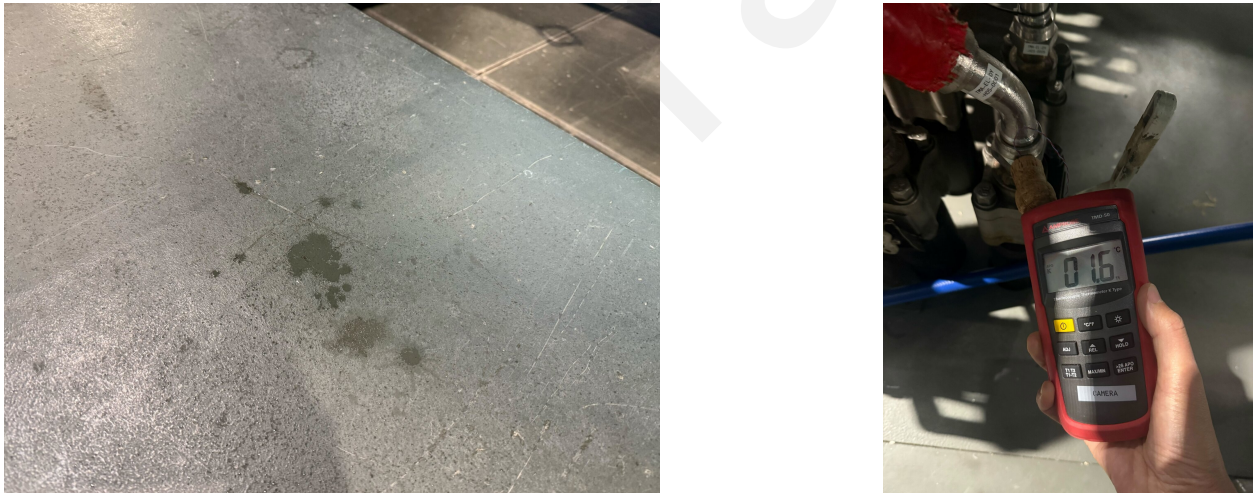
**DYN-04 Condensation and humidity around the Top End Assembly.** *First to last mention 2025-06-14 to 2025-12-16; status **Open**.* The camera region of the Top End Assembly runs more humid than ambient, and the compressed dry air supplied there has little authority over it — the June investigation found the supply had been silently off for an unknown period and that the air reaching the camera is heavily mixed with dome air. In November infrared imaging showed hot spots and a suspected dry-air leak near the heat-exchanger return, and in December water droplets were found on M1M3, traced to condensation on uninsulated Dynalene supply pipes at the Top End Assembly (SUMMIT-11795, OBS-1479). Open at year end, with insulation the proposed fix.

FIGURE 6: **DYN-04.** Left: the liquid found below the camera cable wrap on 16 December, a little left of centre looking into the mirror — the drops that were traced back to the Top End Assembly. Right: the source, measured a week later: an uninsulated Dynalene line at the cable wrap reading 1.6°C on its surface, well below the dew point of the air around it (2025-12-16 and 2025-12-24, #cam-summit-ops).

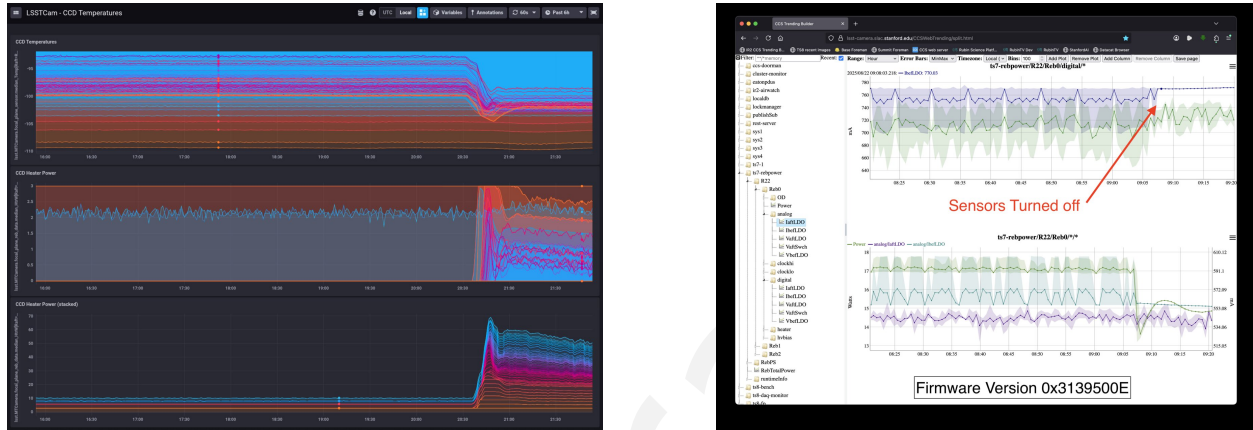
the CCDs run measurably warmer, which was initially misread as lost cryo capacity during the storm. Power-cycling the focal plane and rolling the firmware back confirmed a real power-draw increase of roughly 30 W, and the cause was a register-map conflict in 0x313a5013 that applied maximum heater power — a defect introduced together with the sequencer-override register in 0x31395011 and unnoticed until then. It was fixed by the firmware upgrade to 0x313a5014. See the version history in Table 10.

FIGURE 14: **FW-01.** Left: CCD temperatures and CCD heater power across the firmware roll-back, the step in heater power being the extra draw the faulty build was applying (2025-08-21). Right: the same measurement annotated during the investigation, with the moment the sensors were turned off marked and the firmware version under test named (2025-08-22).

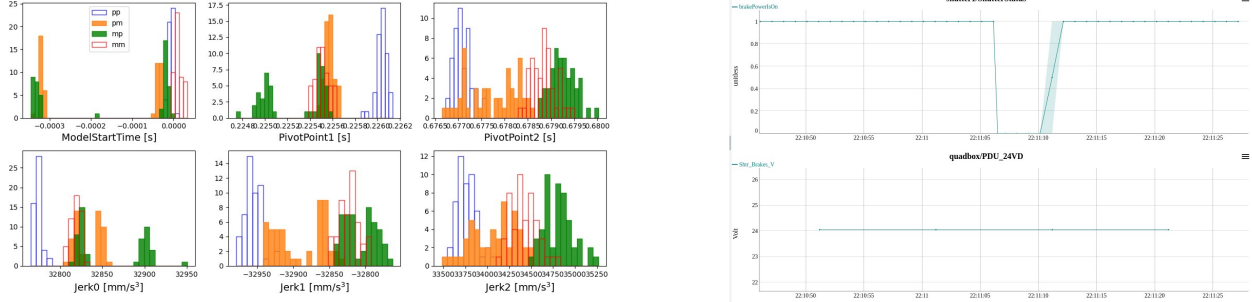
FIGURE 27: **SHT-01**. Left: the shutter motion-profile study of March, fitting model start time, pivot points and jerk for each blade and comparing them with the 2022 reference set (2025-03-24). Right: shutter status and the quadbox 24V supply across one of the stuck-shutter events (2025-04-23).

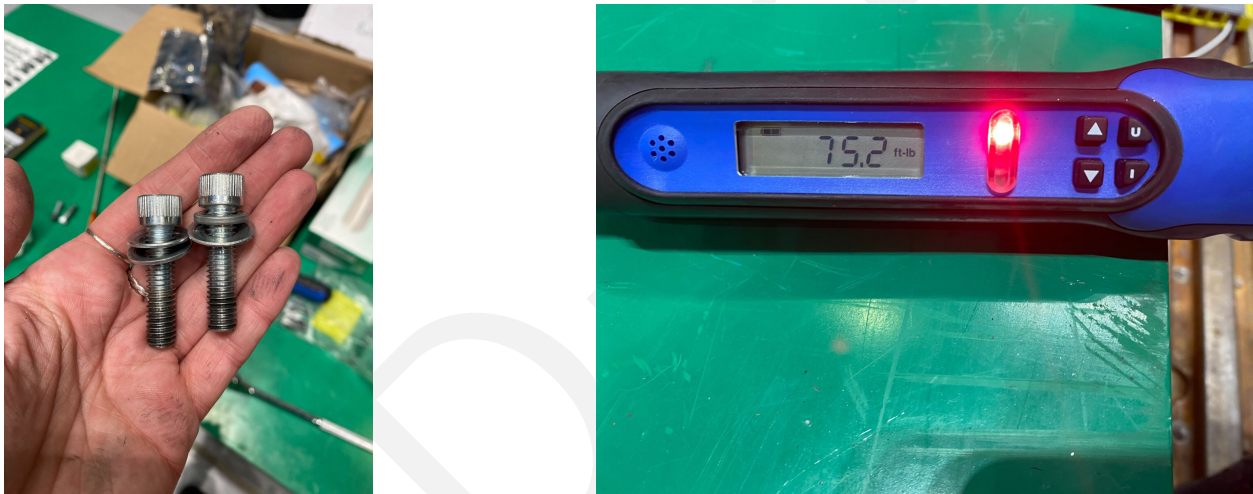
FIGURE 32: **MEC-01.** Two of the sheared 3/8-16 socket-head bolts recovered from the cable wrap, and the bolt test that followed a few days later: 75.2 ft-lb applied with no sign of failure (2025-01-30, #cam-summit-ops).
