# The LSST Camera commissioning

CTN-007

This technote describes what we found during the LSST Camera commissioning.

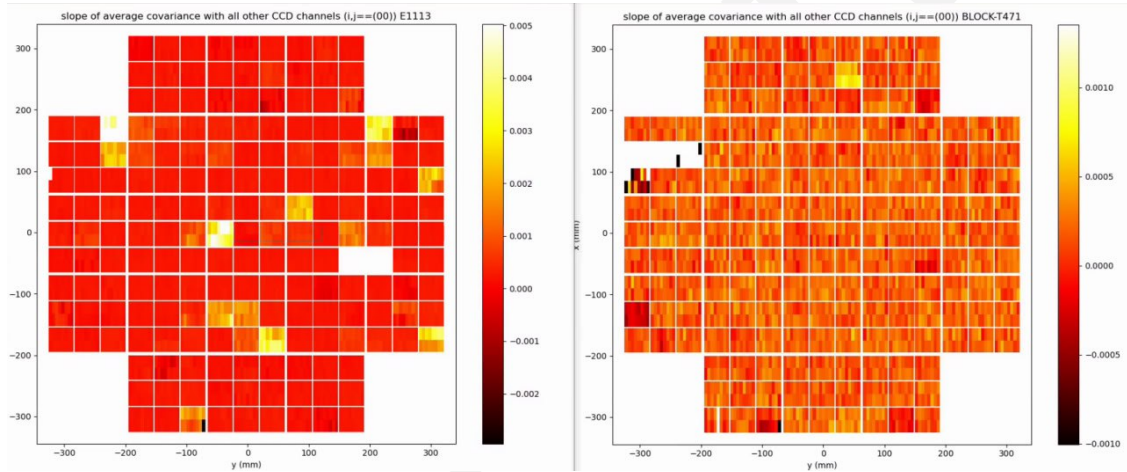
sensor: R23\_S02 (see Figure 34 in that note). This measurement is derived from fits over the variance and spatial covariance curves versus the flux. The curves for the channels in that particular sensor were in fact affected by an excess of variance, which affected not only the noise measurement in bias frames, but also introduced an extra flux-dependent component in the variance. This degraded the gain measurements from the PTC (using  $C_{00}/\mu$ ). This issue also manifested as a flux-dependent covariance between amplifiers in the same sensor, and as an excess in the correlation with the next pixel in the serial direction ( $a_{10}$ ). One way to detect this issue in a systematic manner is to compute the slopes of the covariances between channels versus the flux, and average them over all channels in the sensor (as done in Figure 24). Using this metric, other sensors were found to exhibit a similar issue, but to a smaller degree (same Figure, left plot). Other related metrics (noise correlation between channels, correlations between channels) also pointed to the same sensors.

FIGURE 24: Averages of the slopes of the covariances between channels, for each sensor. Left: during test Run 7. Right: on sky, with the modified ‘RGn20’ readout sequence.

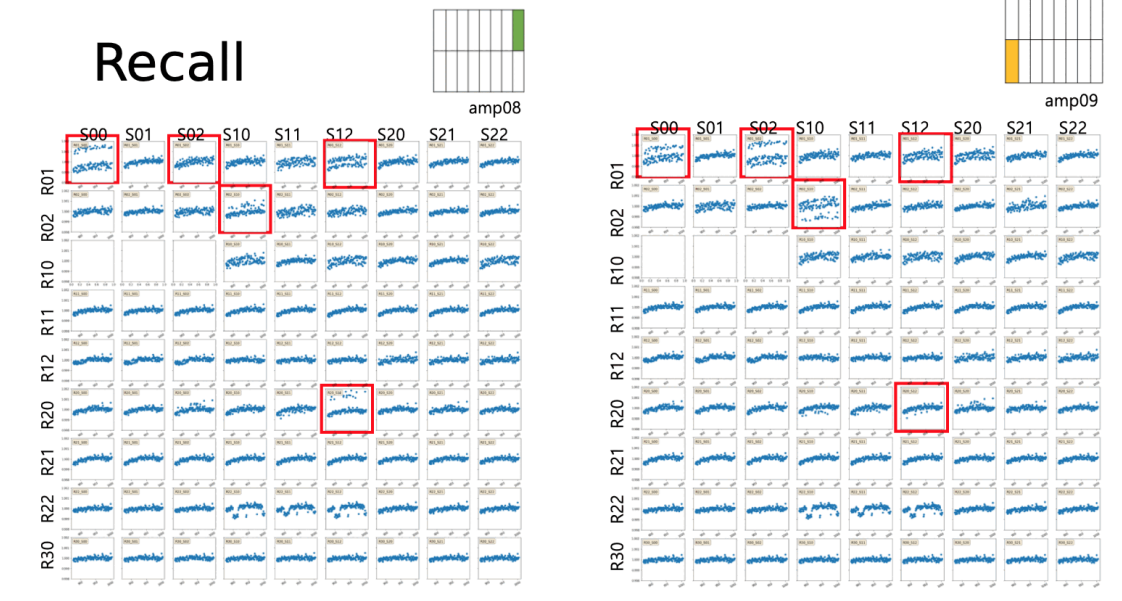
FIGURE 25: Gain measurements per sensor across the focal plane for two amplifiers (amp08, left; amp09, right). Red boxes mark sensors in which the gain moves between discrete states from one acquisition to the next; the difference between states is at the sub-percent level.
