# The LSST Camera commissioning

CTN-007

This technote describes what we found during the LSST Camera commissioning.

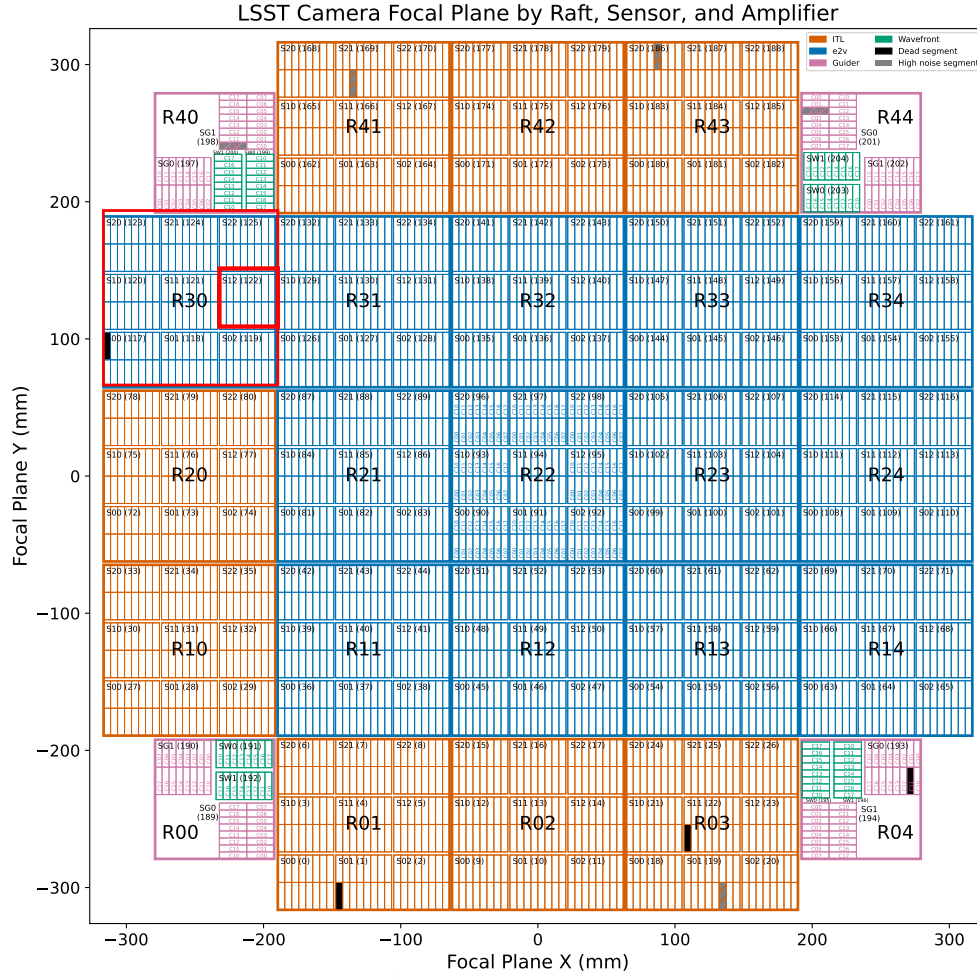
FIGURE 2: LSSTCam focal plane layout, after Plazas Malagón et al. (CTN-001, Fig. 1). The large red box marks R30 = RTM-012 and the small box indicates the sensor S12.

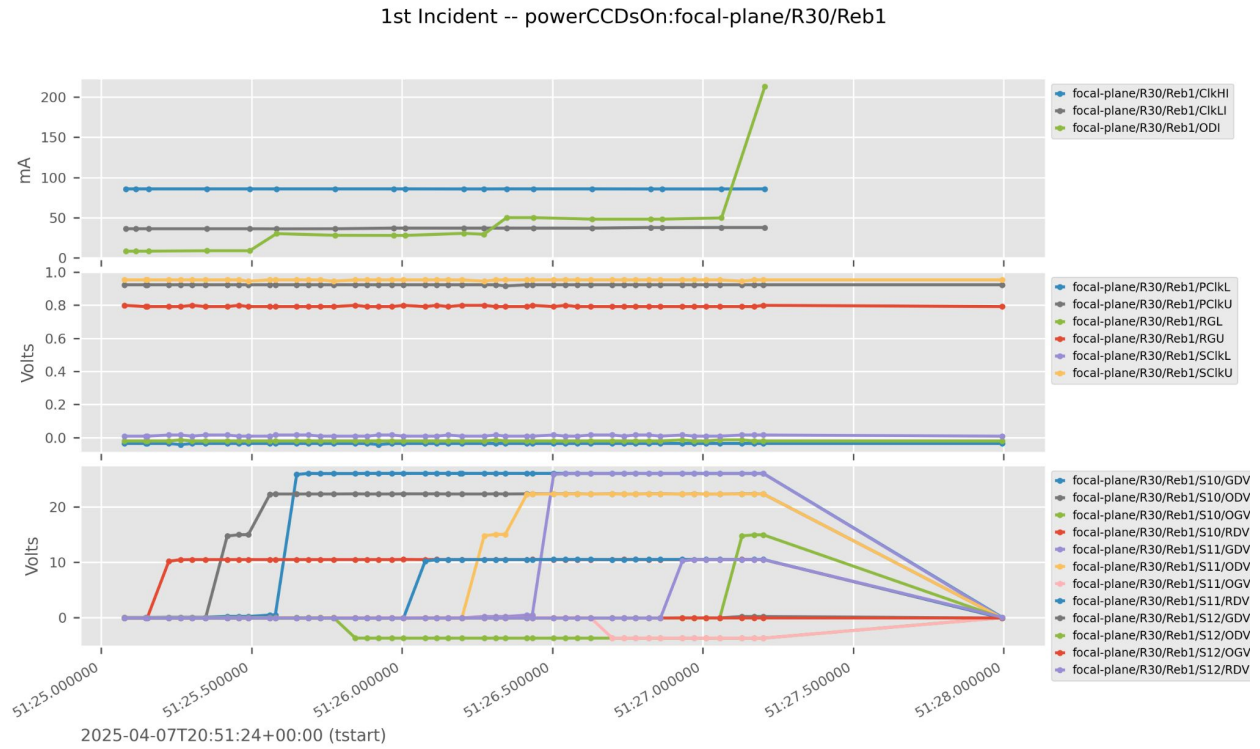
followed by `powerCCDsOn()` FAILED for R30/Reb1 and, 0.8 s later, an automatic `powerCCDsOff()`. In each case the DAC was set back to zero immediately, returning OD to 0 V within 100–140 ms of the step. Bias voltages are read every 5.3 ms and the parent currents every 33 ms, so each trip is documented by only a few samples and the voltage at which the current peaked is loosely constrained.

FIGURE 4: Trending of the first power-on attempt (Marshall, 2025b). Top: the REB parent currents, with ODI (green) leaving its baseline as the bias sequence proceeds and reaching 213 mA. Middle: the clock rails. Bottom: the CCD bias voltages; the last trace to rise, to  $\approx 15$  V, is the OD of S12, and all biases return to zero at 51:28 when the protection has fired and `powerCCDsOff` runs.

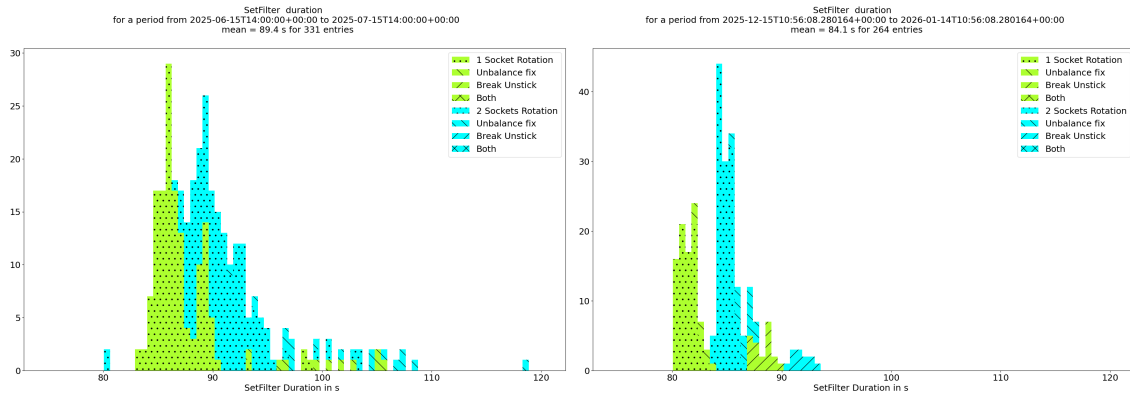
FIGURE 19: Filter change execution time before (left plot) and after (right plot), the carousel clamps maintenance in October 2025 and the November FCS update. The jitter in the execution time of the filter exchanges has been highly reduced.
