# The LSST Camera commissioning

CTN-007

This technote describes what we found during the LSST Camera commissioning.

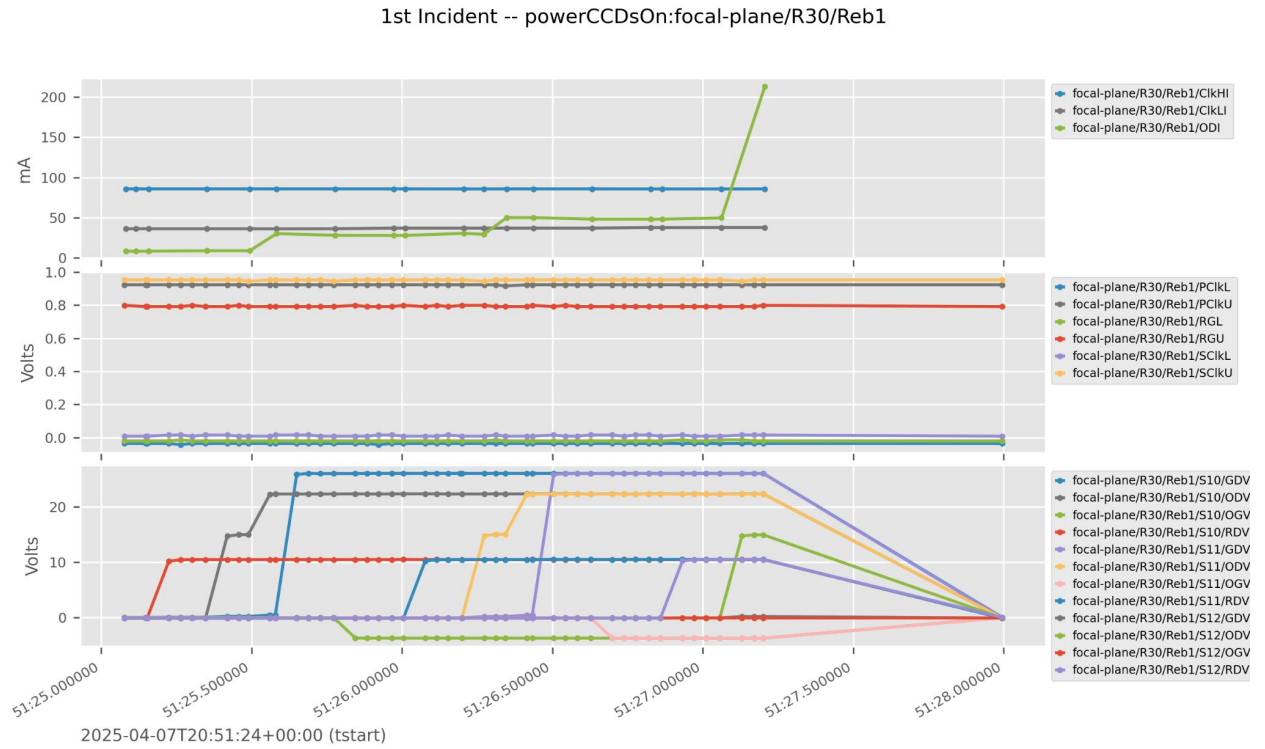
followed by `powerCCDsOn()` FAILED for R30/Reb1 and, 0.8 s later, an automatic `powerCCDsOff()`. In each case the DAC was set back to zero immediately, returning OD to 0 V within 100–140 ms of the step. Bias voltages are read every 5.3 ms and the parent currents every 33 ms, so each trip is documented by only a few samples and the voltage at which the current peaked is loosely constrained.

FIGURE 4: Trending of the first power-on attempt (Marshall, 2025b). Top: the REB parent currents, with ODI (green) leaving its baseline as the bias sequence proceeds and reaching 213 mA. Middle: the clock rails. Bottom: the CCD bias voltages; the last trace to rise, to  $\approx 15$  V, is the OD of S12, and all biases return to zero at 51:28 when the protection has fired and `powerCCDsOff` runs.

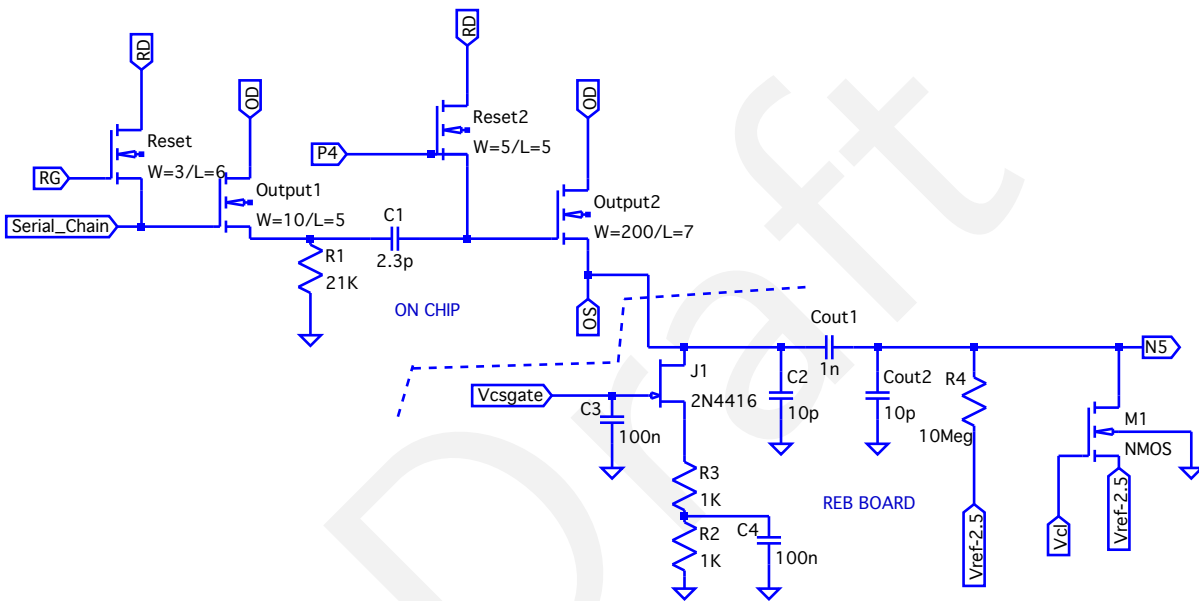
FIGURE 5: The e2v output stage and the first stage of the REB circuit, drawn by C. Lage (Lage, 2025). The two on-chip source followers (*Output1*, *Output2*) are coupled through C1, with the clamp *Reset 2* on that node driven by P4; *Output2* drives the OS pin into the current source J1 on the REB, whose return to ground through R3 and R2 carries the per-segment current monitor. The suspected short is from the OS node to ground.

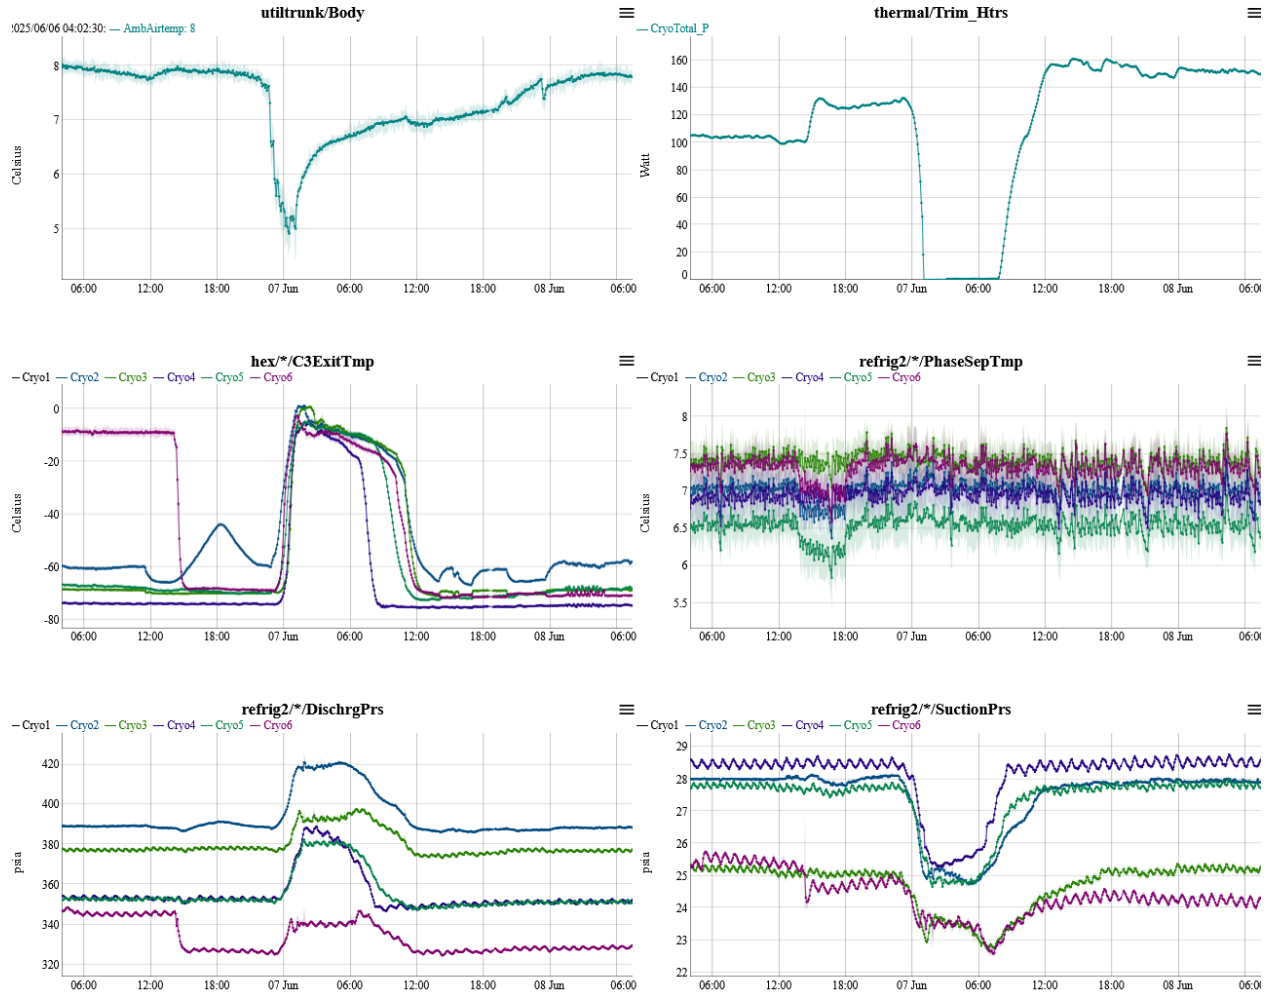
FIGURE 16: Cryo system loss cooling capacity due to low ambient temperature on June 6/June 7 in 2025

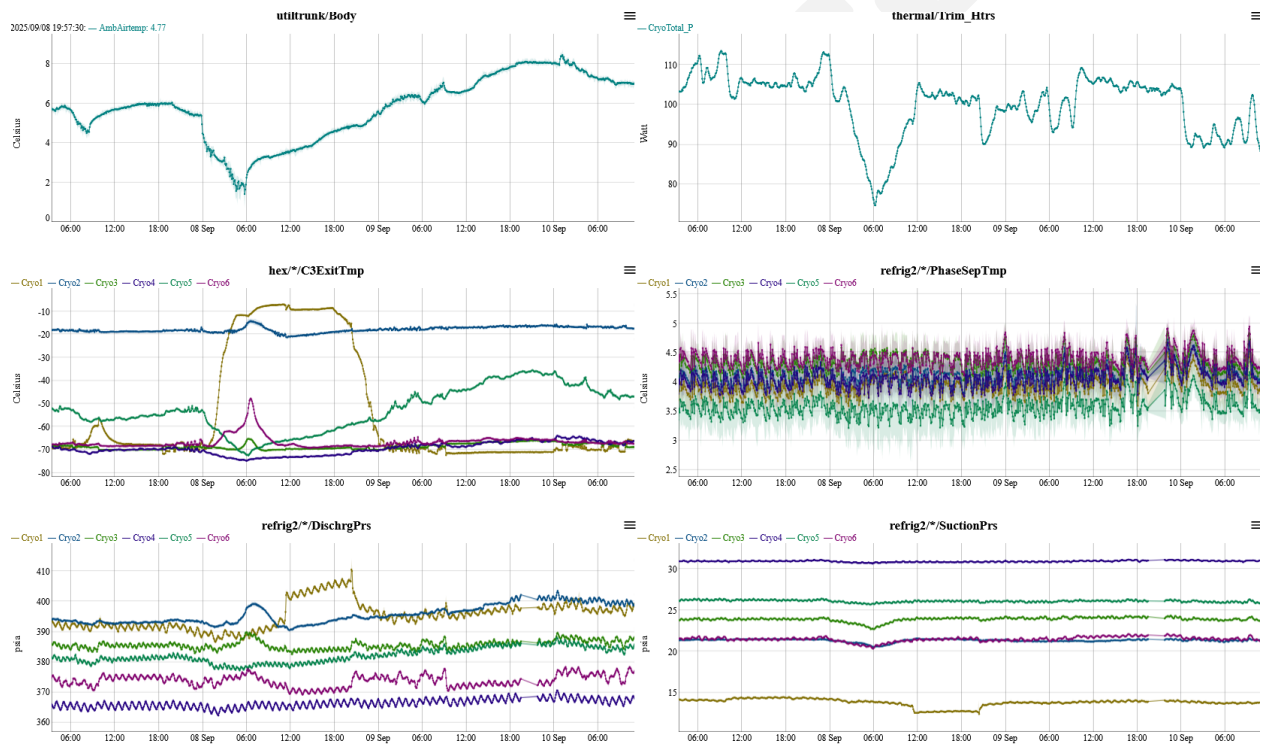
FIGURE 17: Cryo system behavior when ambient temperature reduced to 0.75 C on September 8, 2025

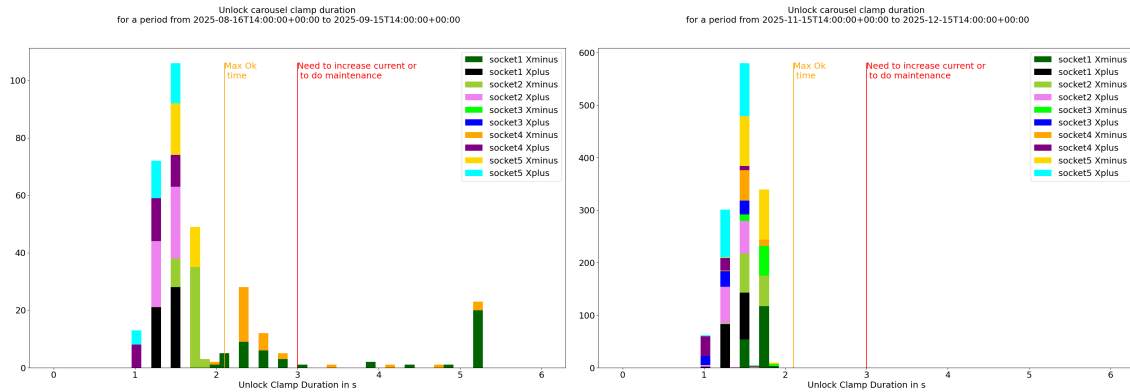
FIGURE 18: Histograms of the filter pins Unlock time before (15 August 2025 to 15 September 2025 , left) and after (15 November 2025 to 15 December 2025 ,right), the carousel clamps maintenance in October 2025

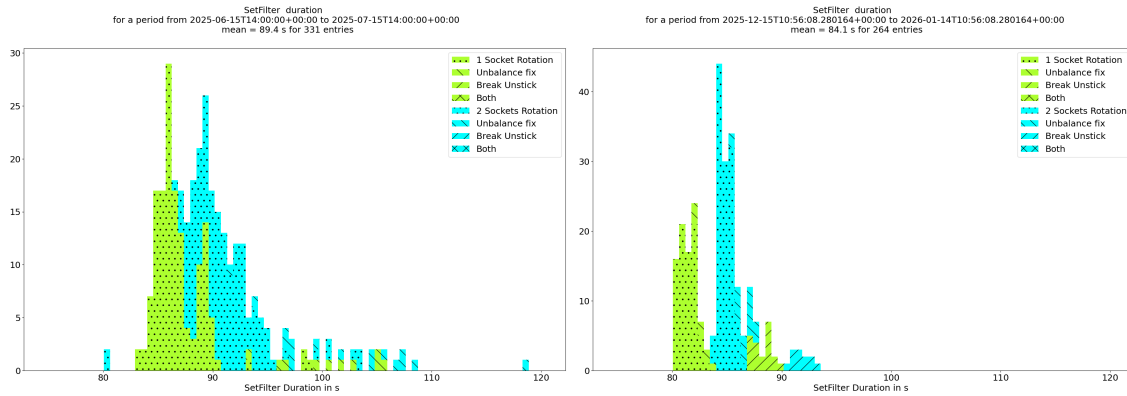
FIGURE 19: Filter change execution time before (left plot) and after (right plot), the carousel clamps maintenance in October 2025 and the November FCS update. The jitter in the execution time of the filter exchanges has been highly reduced.

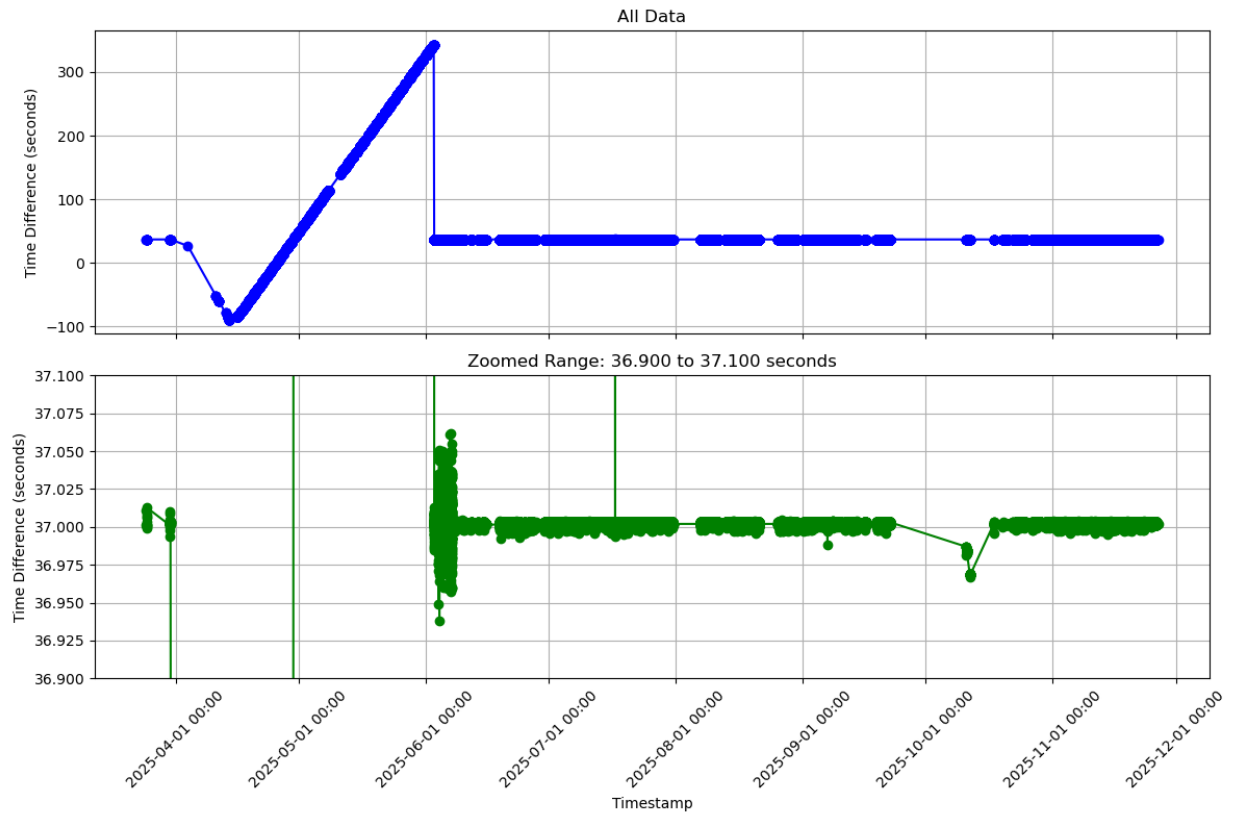
FIGURE 22: Timing between the CCS time when takeExposure was recorded and the time when the motion profile records the startTime. This does not reflect the actual shutter motion timing.

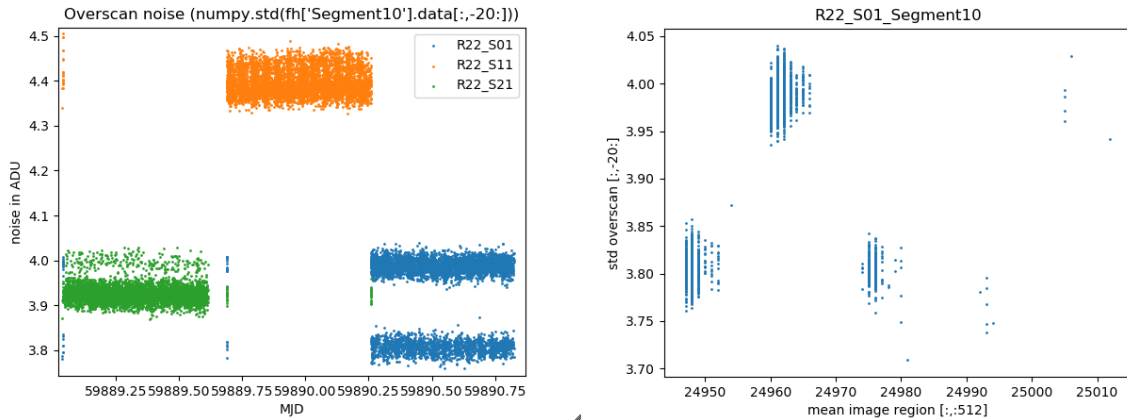
FIGURE 26: Bias multimodality before the natural frequency firmware. Left: overscan noise as a function of time for three sensors of raft R22, showing discrete bands rather than a continuous distribution. Right: overscan noise versus mean image level for R22\_S01, segment 10, where the same behaviour appears as separate clusters.

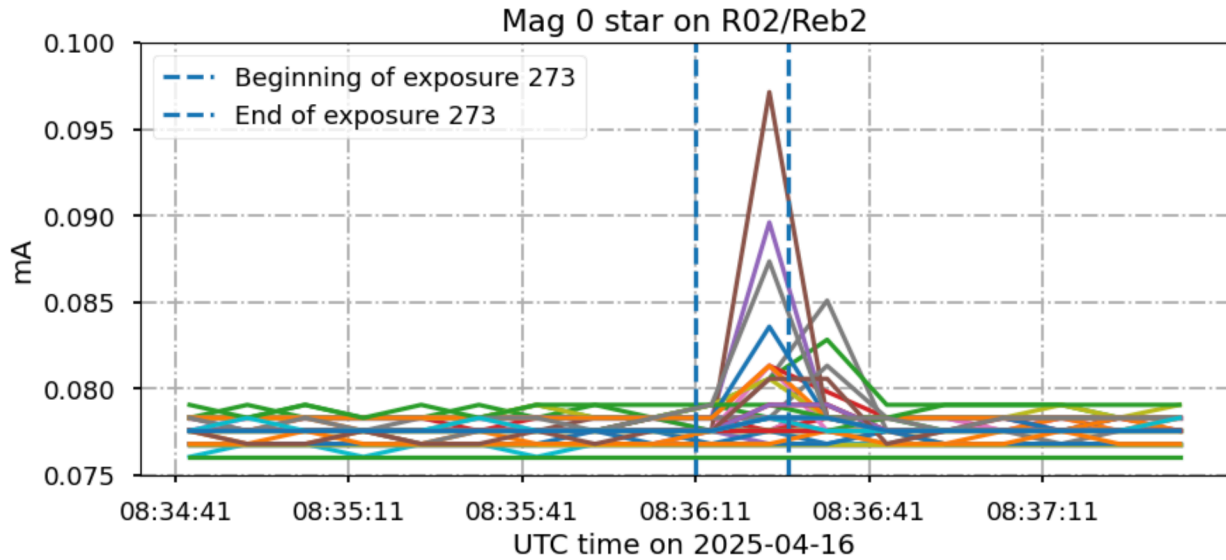
FIGURE 51: The largest bias current excursion observed during the bright star test. The vertical dashed lines indicate the start and end of the exposure. The solid lines indicate the measured current on each REB.
