# The LSST Camera commissioning

CTN-007

This technote describes what we found during the LSST Camera commissioning.

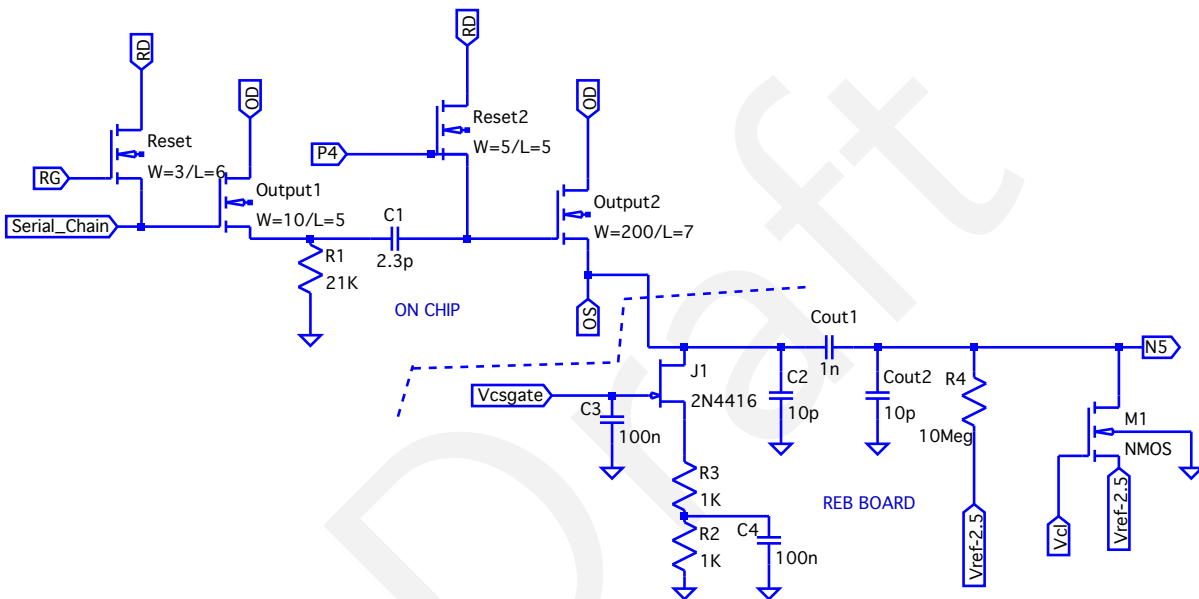
**2.1.1.3 Interpretation.** A shorted segment reading zero current follows from where the currents are measured (Fig. 5). Each segment current is monitored on the low side of that segment's current source, its return to ground, whereas the OD current is measured only as a total, for the CCD's OD supply as a whole. If the output node of a segment is held at 0 V by a short to ground, the current source cannot force its current and the segment monitor reads 0 mA. An open connection reads the same, since a current source cannot impose a current into an unterminated node either.

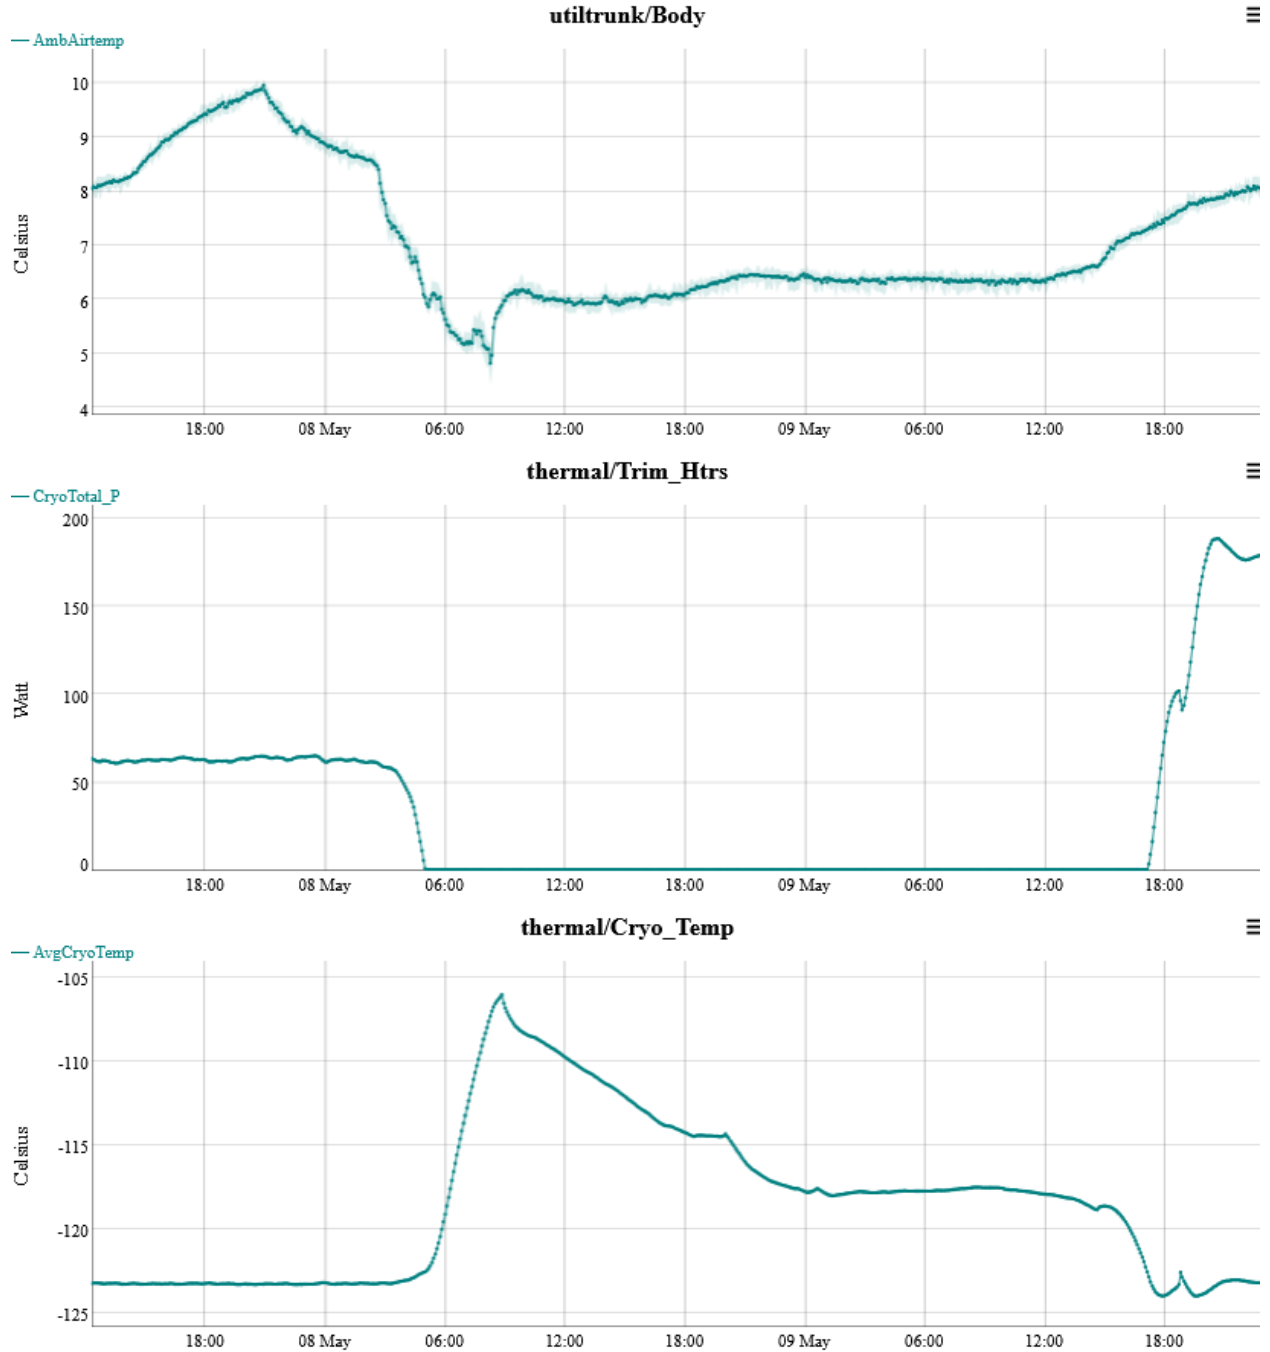
FIGURE 12: Ambient temperature, Cryo trimheat and cryoplate temperature at around 6 am UTC on May 8, 2025

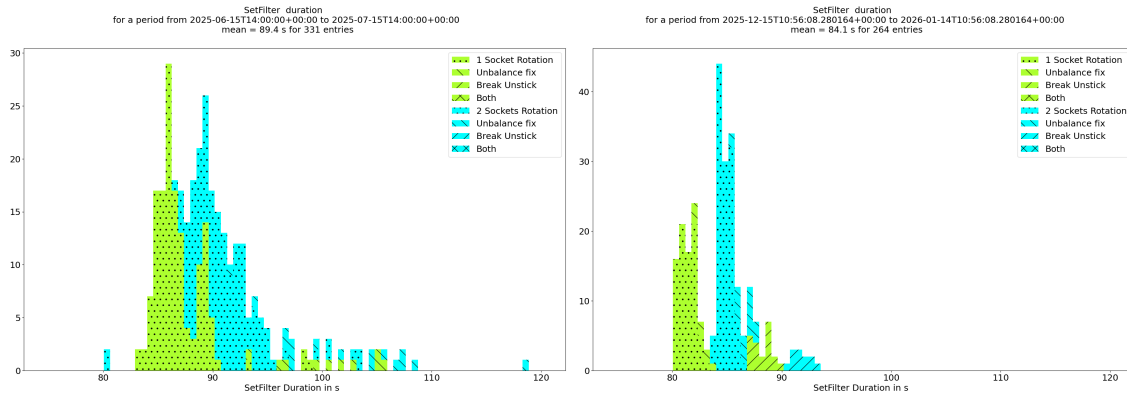
FIGURE 19: Filter change execution time before (left plot) and after (right plot), the carousel clamps maintenance in October 2025 and the November FCS update. The jitter in the execution time of the filter exchanges has been highly reduced.

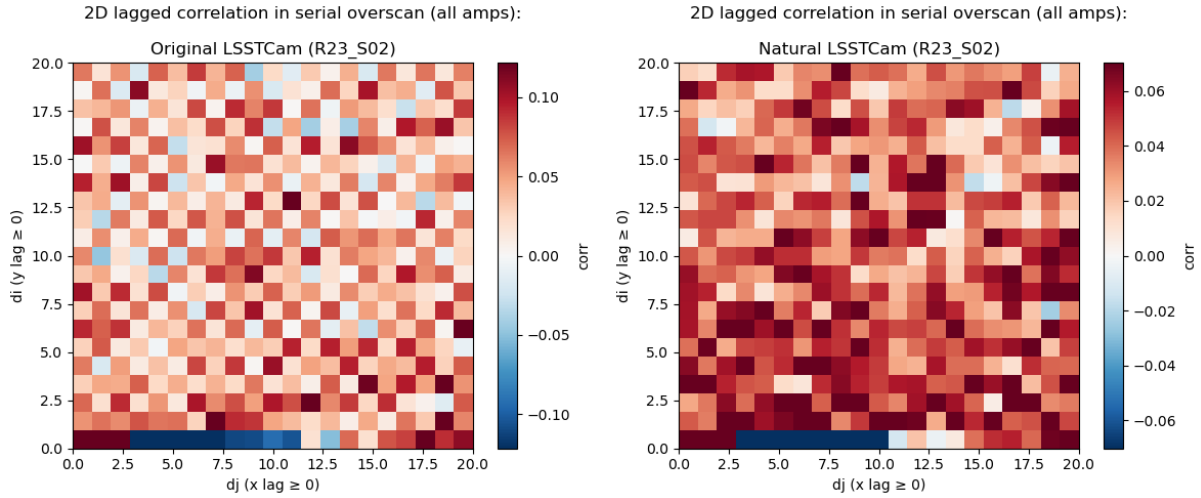
FIGURE 35: Two-dimensional lagged correlation in the serial overscan, all amplifiers of R23\_S02. Left: original configuration (20251216, sequence number 366). Right: natural frequency configuration (20251214, sequence number 211).

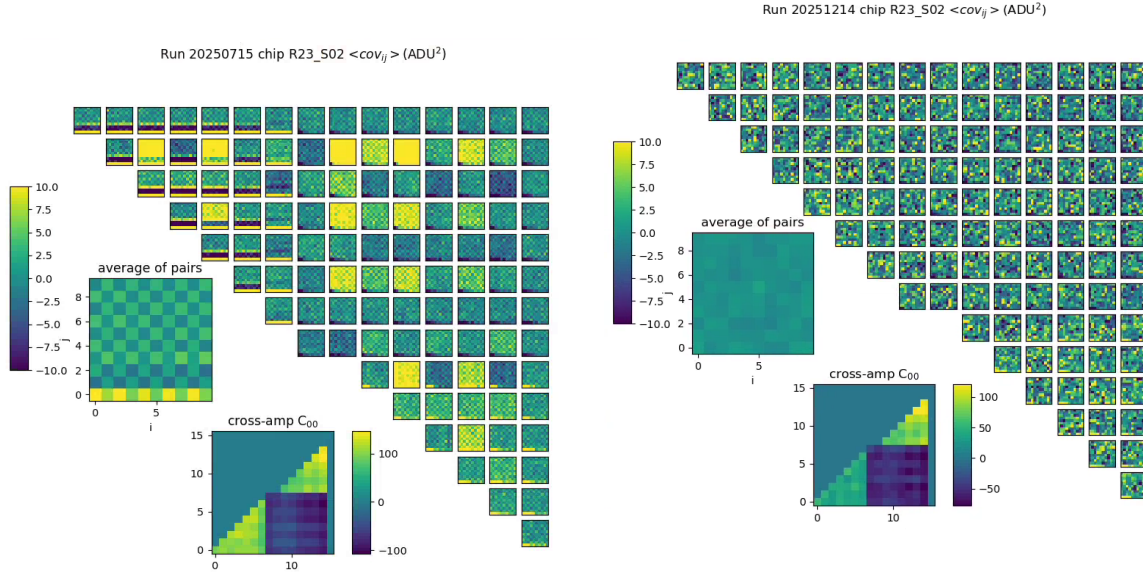
FIGURE 36: Covariances for all channel pairs of R23\_S02, excluding self-correlations, with the average over pairs and the cross-amplifier  $C_{00}$  shown as insets. Left: run 20250715 (original). Right: run 20251214 (natural frequency). The checkerboard in the average of pairs disappears (P. Astier).

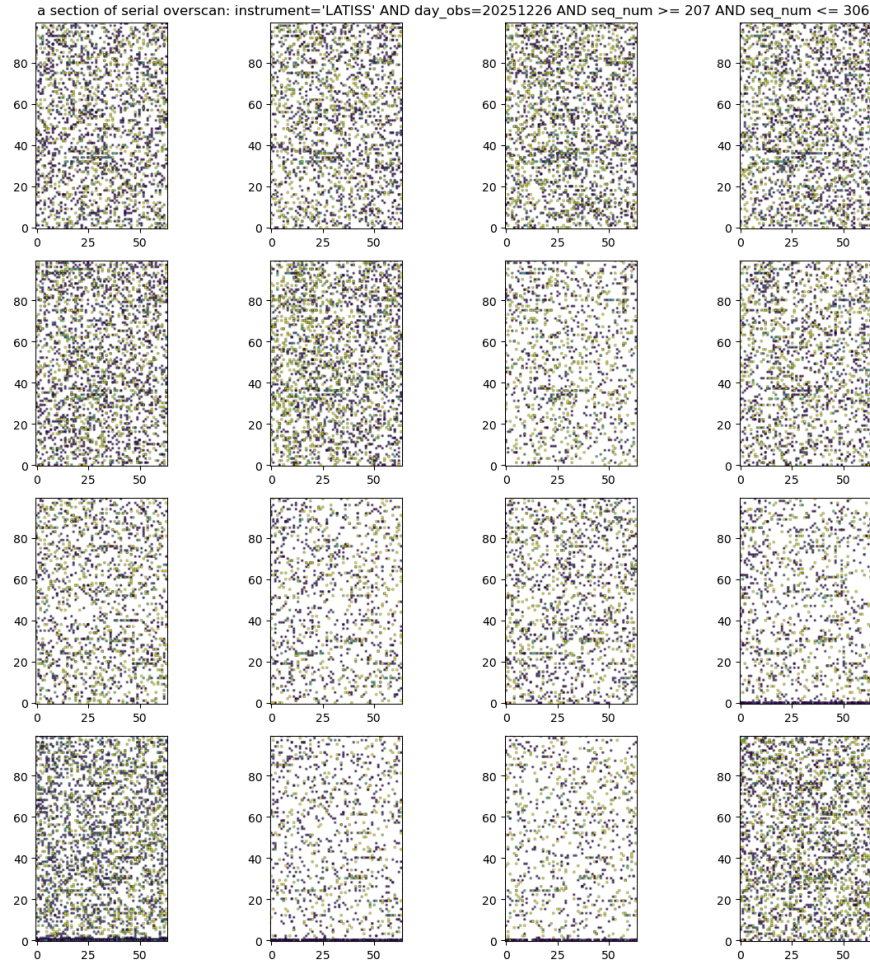
FIGURE 47: A section of the serial overscan for LATISS, 20251226, sequence numbers 207–306, showing the print-through structure.

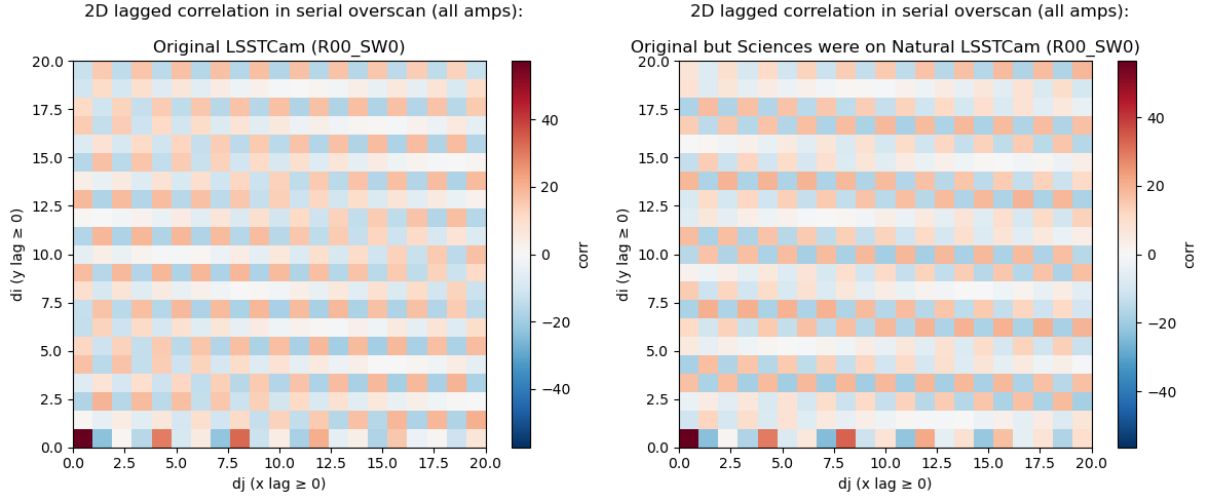
FIGURE 48: Two-dimensional lagged correlation in the serial overscan for R00\_SW0. Left: original configuration. Right: original WREB configuration while the science rafts were running the natural frequency firmware. The pattern persists in both.

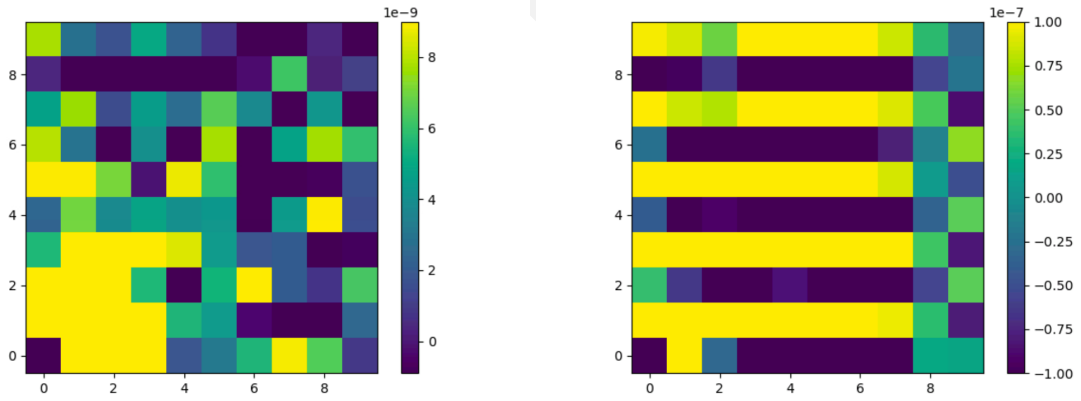
FIGURE 49: A matrix for R40\_SW1\_C13. Left: old run, as expected. Right: new run, with alternating rows and a colour scale two orders of magnitude larger (E. Rykoff).
