Vera C. Rubin Observatory  
Rubin Observatory Operations

# The LSST Camera commissioning

CTN-007

This technote describes what we found during the LSST Camera commissioning.

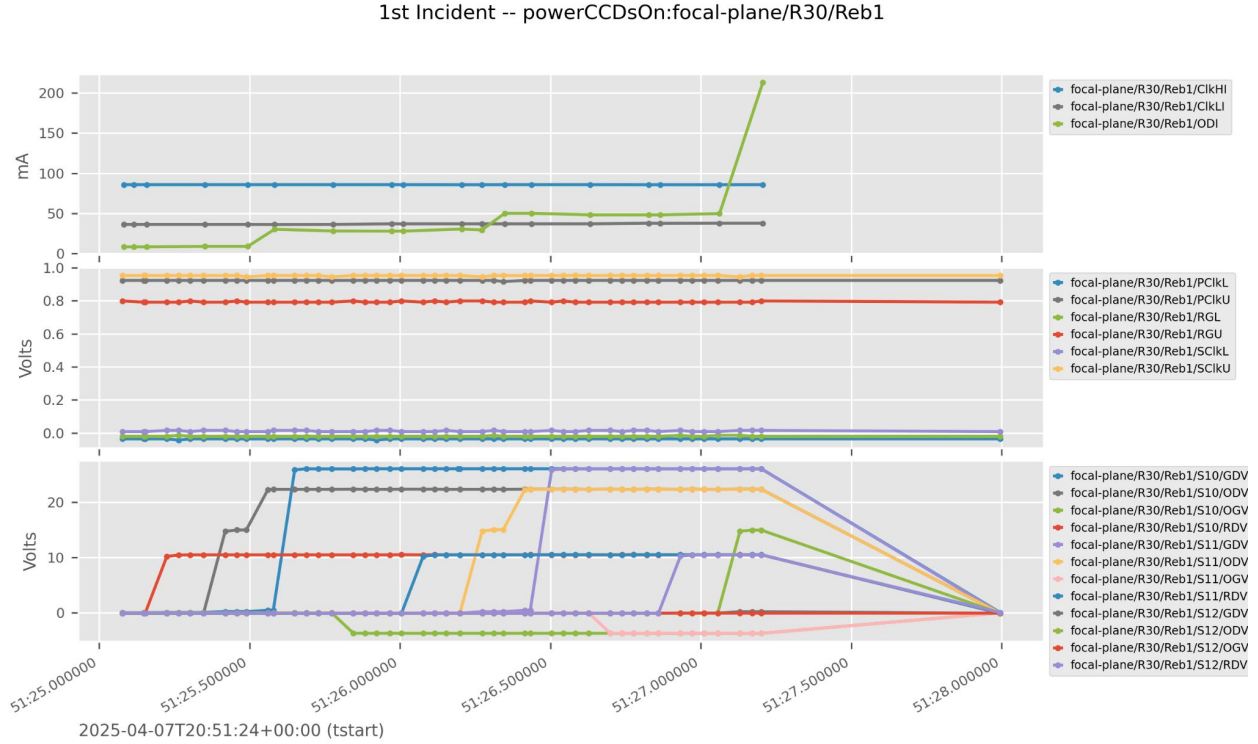
**2.1.1.2 Three over-current trips.** Three attempts to power on R30/Reb1 failed with an OD over-current condition (Fig. 4, Table 2). The log of the first reads

followed by `powerCCDsOn()` FAILED for R30/Reb1 and, 0.8 s later, an automatic `powerCCDsOff()`. In each case the DAC was set back to zero immediately, returning OD to 0 V within 100–140 ms of the step. Bias voltages are read every 5.3 ms and the parent currents every 33 ms, so each trip is documented by only a few samples and the voltage at which the current peaked is loosely constrained.

FIGURE 4: Trending of the first power-on attempt (Marshall, 2025b). Top: the REB parent currents, with ODI (green) leaving its baseline as the bias sequence proceeds and reaching 213 mA. Middle: the clock rails. Bottom: the CCD bias voltages; the last trace to rise, to  $\approx 15$  V, is the OD of S12, and all biases return to zero at 51:28 when the protection has fired and `powerCCDsOff` runs.

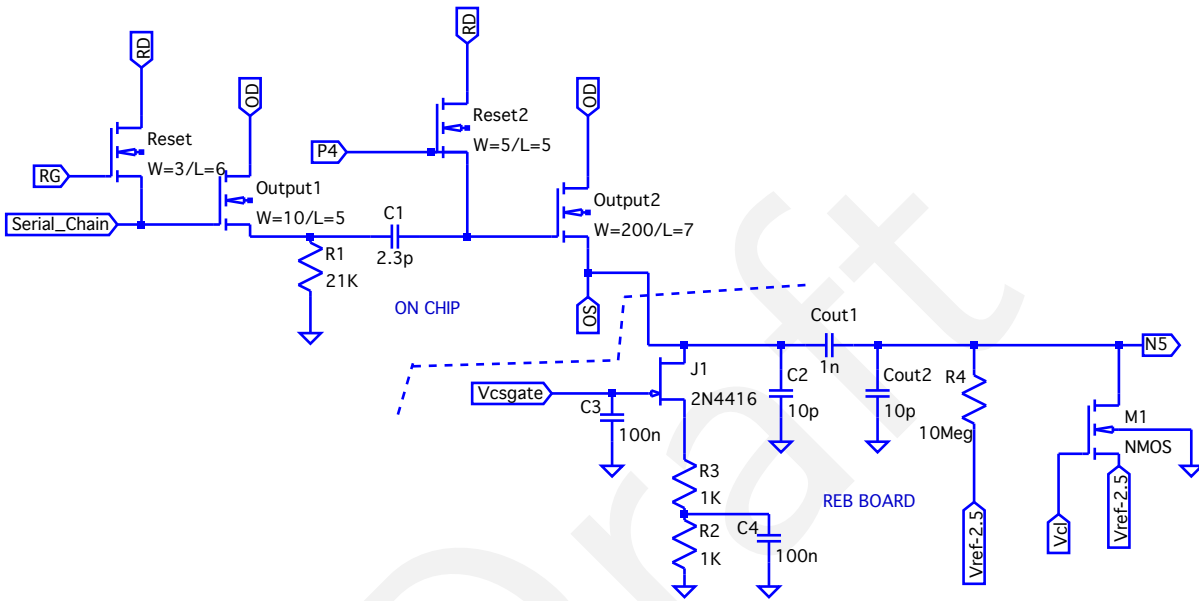
FIGURE 5: The e2v output stage and the first stage of the REB circuit, drawn by C. Lage (Lage, 2025). The two on-chip source followers (*Output1*, *Output2*) are coupled through C1, with the clamp *Reset 2* on that node driven by P4; *Output2* drives the OS pin into the current source J1 on the REB, whose return to ground through R3 and R2 carries the per-segment current monitor. The suspected short is from the OS node to ground.
