Vera C. Rubin Observatory  
Rubin Observatory Operations

# The LSST Camera commissioning

CTN-007

This technote describes what we found during the LSST Camera commissioning.

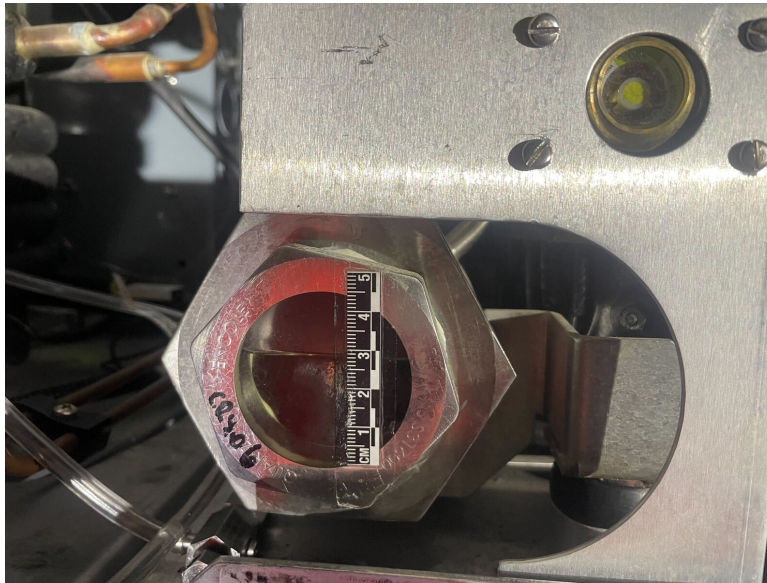
**CRYO-03 Cryo 6 compressor failure.** *First to last mention 2025-04-01 to 2025-06-07; status **Resolved**.* Cryo 6 tripped on a compressor failure on April 1 and stayed out of service. The compressor module was replaced with the Cryo 5 unit from the MRCR between June 2 and June 7 (LCA-14623), and after charging, gas chromatography and additive top-up the circuit returned to service, restoring six of six cryo circuits.

FIGURE 3: **CRYO-03.** Oil level in the sight glass of the Cryo 6 compressor, marked against a scale during the work on the circuit (2025-04-25, #cam-operator).

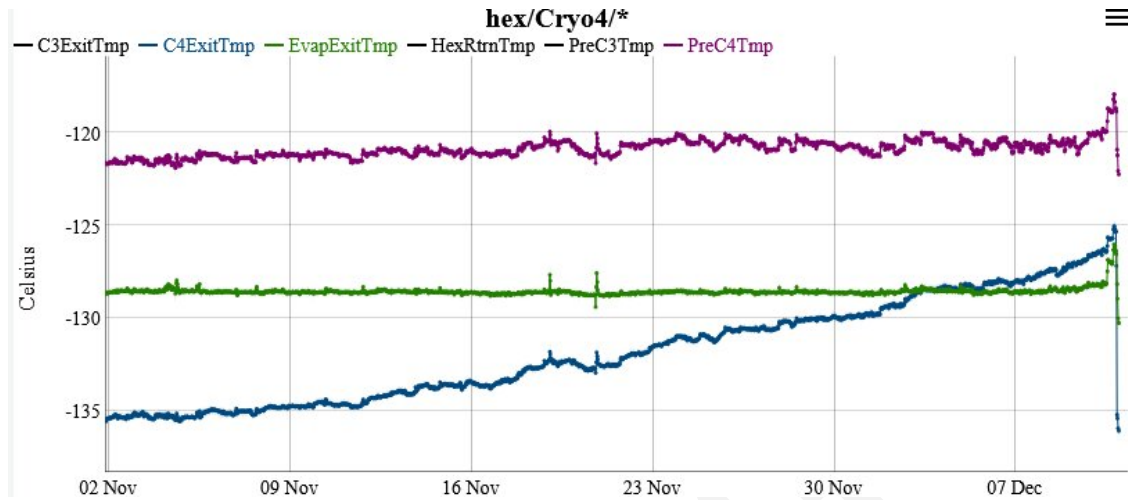
FIGURE 4: **CRYO-04.** The Cryo 4 clog developing through November: the C4 exit temperature (blue) drifts up towards the pre-capillary temperature over five weeks, the signature by which the clog was recognised (2025-12-11, #cam-operator).

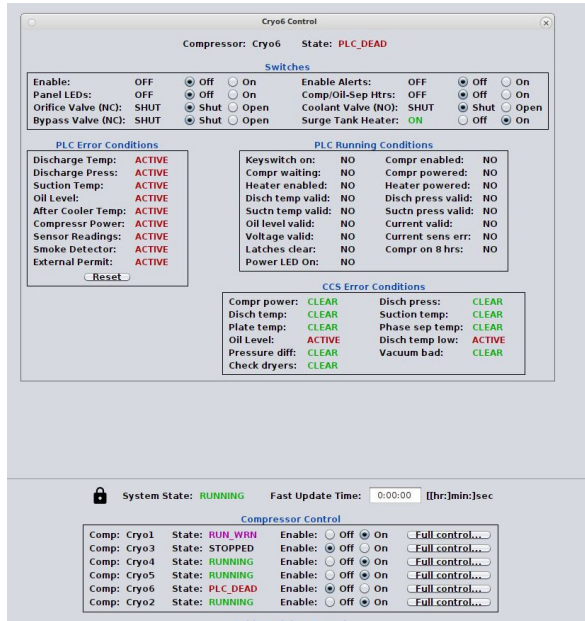
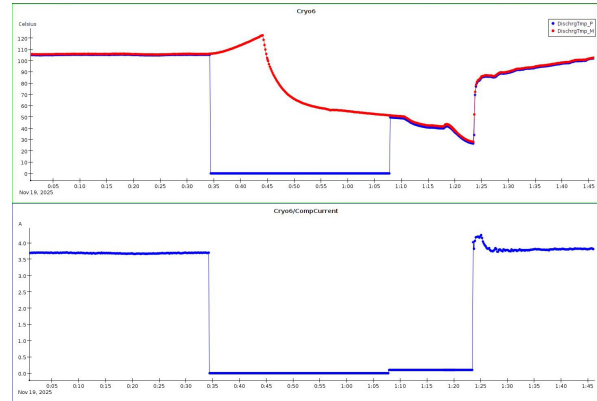
**CRYO-05 Cryo 6 PLC death after an external setpoint change.** *First to last mention 2025-11-18 to 2025-11-19; status **Open**.* On November 19 the Cryo 6 PLC was declared dead at 00:34 UTC with the discharge temperature reading 122 °C and the oil level negative; the PLC recovered by itself 33 minutes later. The overheating of the cabinet that preceded it was attributed to a software update elsewhere on the summit mis-setting the glycol setpoint in response to bad environmental sensor readings (FRACAS-322, OBS-1394, OBS-1395). The PLC failure itself is suspected to be a problem in the PLC, and its root cause is not known. The CCS logic that closes the coolant valve when a PLC is declared dead was flagged as needing revision (LSSTCCSREFRIG-319 and LSSTCCSREFRIG-332).

FIGURE 5: **CRYO-05**. Left: the CCS Cryo 6 panel during the failure, reporting State: PLC\_DEAD with every PLC error condition ACTIVE. Right: the discharge temperature and compressor current across the event, the temperature rising while the compressor is off (2025-11-19).

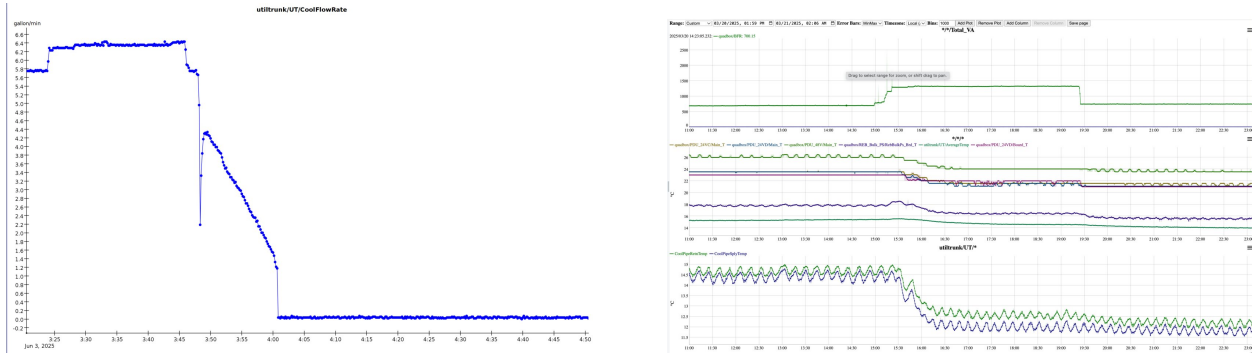
**DYN-01 Recurrent loss of Dynalene flow to the utility trunk.** *First to last mention 2025-01-18 to 2025-12-17; status **Open**.* Dynalene, which cools the utility-trunk electronics, failed repeatedly all year — from control computer (cRIO) reboots and crashes, chiller faults and power events — each time forcing an emergency power-down of CCDs, REBs and often the shutter and filter changer (OBS-1014, FRACAS-321, FRACAS-328). A review of the August 11 event established that the camera tolerates only about 13 minutes without flow before REB power-supply boards approach their 48°C trip limit. The cRIO was replaced on November 4 and a small UPS was added in late November, but outages continued into the second half of December.

FIGURE 6: **DYN-01.** Left: utility-trunk Dynalene flow collapsing to zero, the signature common to every one of these events (2025-06-03). Right: the same loss in March seen across the subsystem — flow, utility-trunk temperatures and the power that had to be shed (2025-03-21).

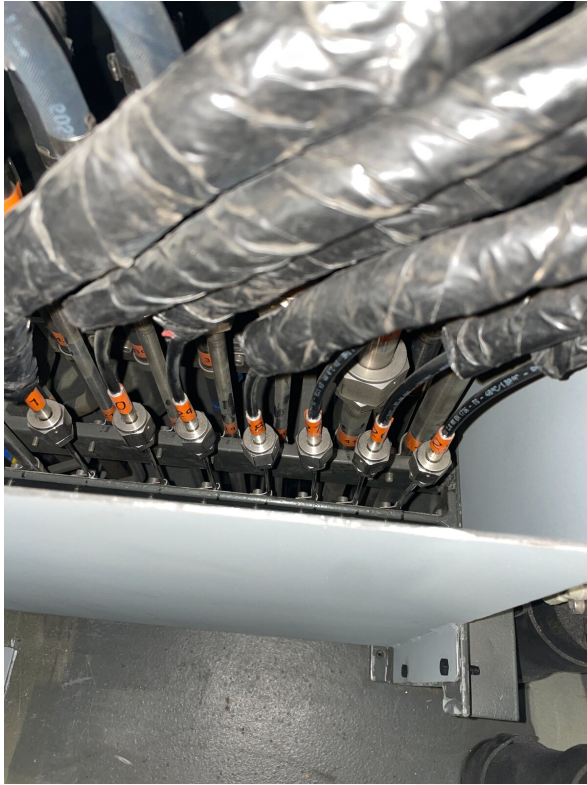
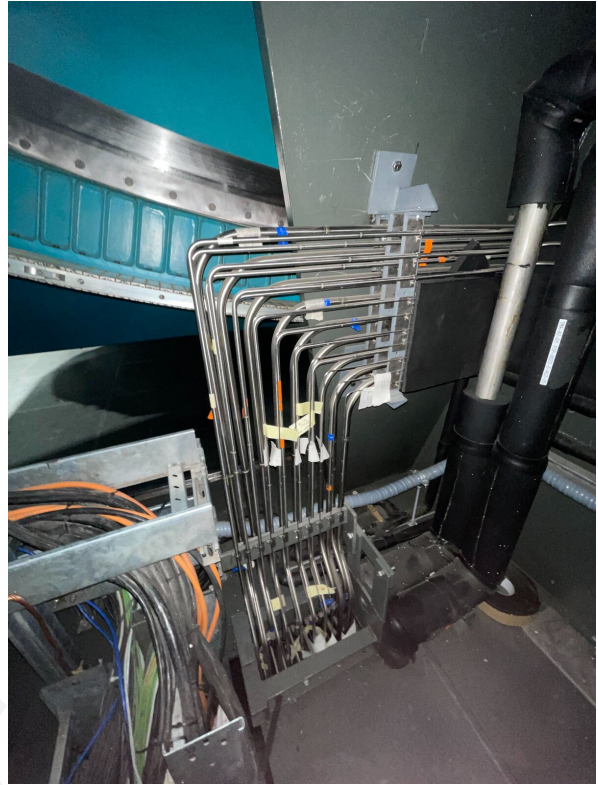
**DYN-04 Condensation and humidity around the Top End Assembly.** *First to last mention 2025-06-14 to 2025-12-16; status **Open**.* The camera region of the Top End Assembly runs more humid than ambient, and the compressed dry air supplied there has little authority over it — the June investigation found the supply had been silently off for an unknown period and that the air reaching the camera is heavily mixed with dome air. In November infrared imaging showed hot spots and a suspected dry-air leak near the heat-exchanger return, and in December water droplets were found on M1M3, traced to condensation on uninsulated Dynalene supply pipes at the Top End Assembly (SUMMIT-11795, OBS-1479). Open at year end, with insulation the proposed fix.

FIGURE 7: **DYN-04.** Refrigeration and Dynalene lines at the Top End Assembly, photographed during the June investigation of humidity and insulation in the camera region; the uninsulated runs of this kind are where the condensation found in December formed (2025-06-14).

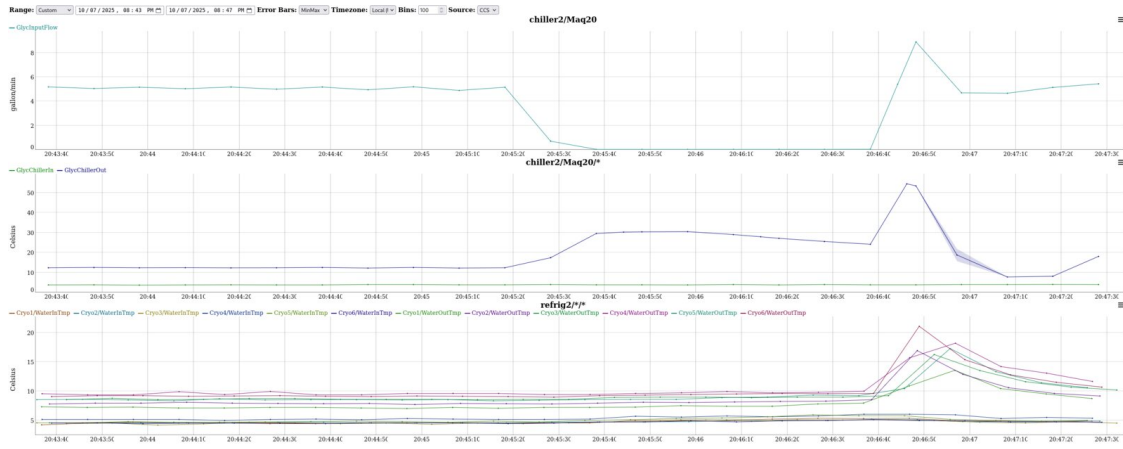
**GLY-01 Glycol flow interruptions to the PCS on power events.** *First to last mention 2025-04-28 to 2025-11-28; status **Resolved**.* Every commercial power glitch or generator transfer stops the glycol recirculation pumps for roughly 70–90 seconds, against an observed PCS chiller trip threshold of 90–120 seconds — so each event is a near miss, and several were not (FRACAS-277, FRACAS-278, FRACAS-279). The identified fix, putting the recirculating pumps on UPS, was still pending throughout 2025; in September, observing on generator power had to be restricted in pointing because of it. The issue was closed in early February 2026, after the period covered here.

FIGURE 8: **GLY-01**. One of the near misses, at second resolution. Glycol input flow to the PCS (top) drops from 5.2 gallons per minute to zero at 20:45:30 and is restored about 70 seconds later; the chiller outlet temperature (middle) had already climbed from 12 to 30°C before the interruption and overshoots to 54°C on restart, and the cryo water-out temperatures (bottom) follow it up. The chiller trips if the flow is lost for 90 to 120 seconds (2025-10-07, #cam-operator).

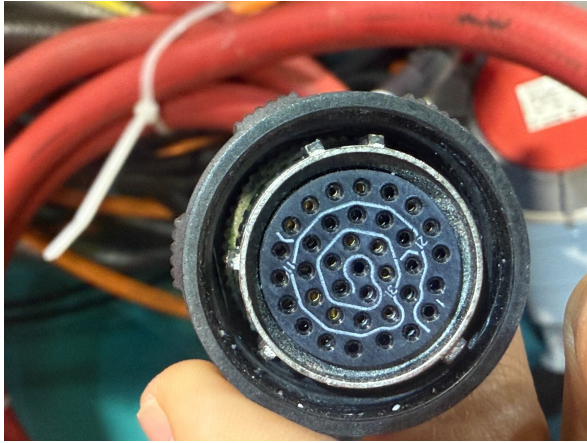
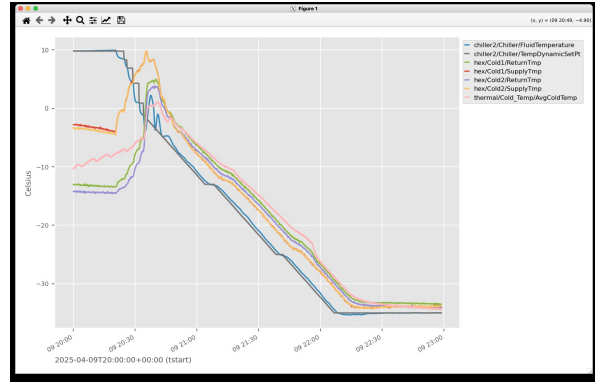
A cluster of PCS chiller problems in spring, all of them traced and fixed: an under-rated 32 A supply breaker against a 50 A service requirement, which tripped the chiller twice in one morning (OBS-826); a stage-1 refrigerant leak that took the chiller out of service for a day and left the camera quiescent overnight; and spurious trips with no real chiller anomaly, traced to an unseated pin in a refrigeration-permit connector on the telescope-side cabling and aggravated by TMA shaking tests (SUMMIT-10642, SUMMIT-10652). The breaker was replaced, the leak repaired and the connector pins and shell renewed.

FIGURE 9: **PCS-01.** Left: the pin face of the refrigeration-permit connector on the telescope-side cabling, whose unseated pin produced the spurious chiller trips (2025-04-11). Right: recovery from the chiller failure two days earlier — chiller-2 fluid temperature and the cold-plate supply and return temperatures being ramped from about +10 to  $-35^{\circ}\text{C}$  (2025-04-09).

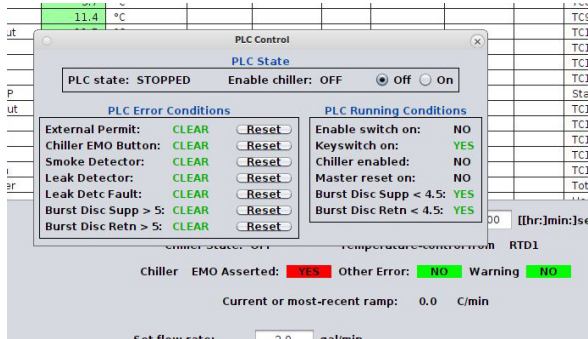
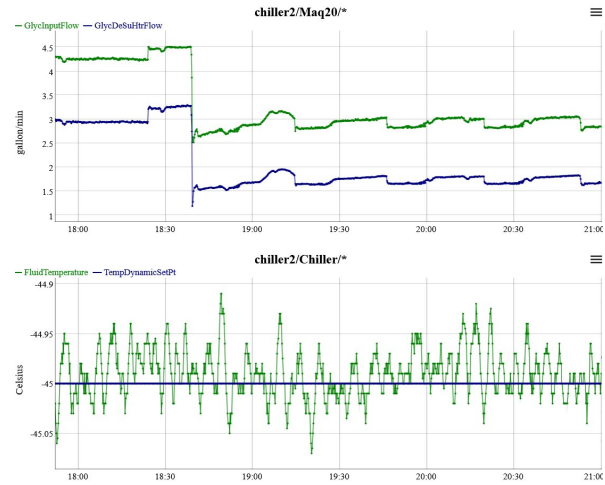
**PCS-02 PCS chiller restart difficulty, and the MRCR unit.** *First to last mention 2025-03-28 to 2025-07-02; status **Open**.* Restarting the chiller is a separate problem from the failures above and was never solved: the unit repeatedly trips on low HFE flow because gas bubbles form in the longer line configuration, which procedure LCA-20281 does not cover. In March it took roughly a dozen attempts over two days, and was recovered only by pressurising the coolant tank; a loud bypass-valve noise during those attempts was later explained as the high-pressure bypass cracking at an 80 psi pump differential. The same behaviour blocked the restart of the unit at the MRCR in July. The MRCR system was found to have failed during the year and is tracked as LSSTCAM-119.

FIGURE 10: **PCS-02**. Left: the chiller PLC panel during a restart attempt, stopped with every error condition clear — the state from which the low-flow trips occur (2025-03-28). Right: glycol input flow and chiller fluid temperature through a sequence of restart attempts (2025-04-11).

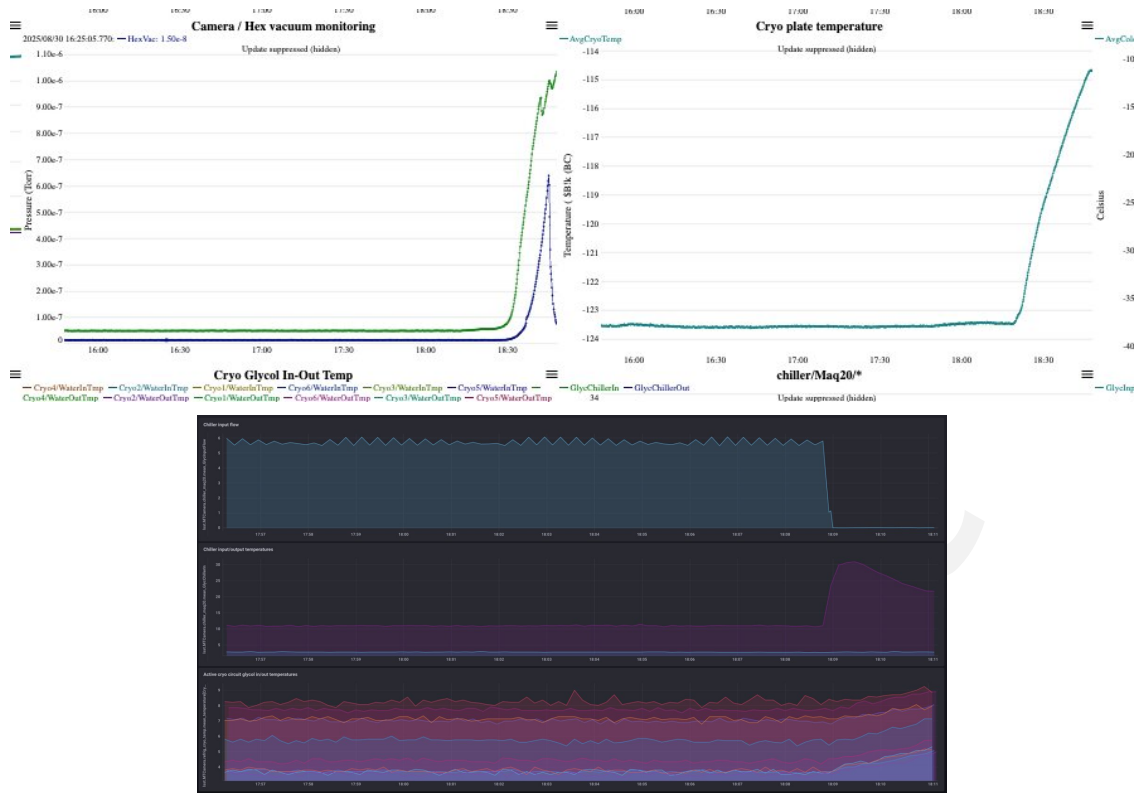
**PWR-01 Site power: grid glitches, generator failure and UPS capacity.** *First to last mention 2025-02-25 to 2025-11-28; status **Open**.* The camera is exposed to the summit's power quality throughout: glitches stick valves closed (FRACAS-282), trip chillers and compressors, and interrupt cooling. The most severe event was August 30, when the generator tripped — its air inlet blocked by ice and snow (FRACAS-299) — leaving the camera on UPS alone with cryostat pressure rising towards the ion-pump shutdown limit, while the server-room UPS exhausted its roughly 30-minute battery (FRACAS-300) and the backup diesel generator was found already out of service. UPS batteries were replaced in November; the underlying exposure remains.

FIGURE 11: **PWR-01**. The generator failure of 30 August as the camera saw it. Top: cryostat and heat-exchanger pressure leaving  $10^{-7}$  Torr and rising past  $1.1 \times 10^{-6}$  from 18:25 onwards, with the cryo plate warming from  $-124$  to  $-113$  °C; this is the rise towards the ion-pump shut-down limit that made the event serious. Bottom: the same twenty minutes at the chiller — glycol input flow collapsing and the chiller outlet temperature stepping up when it goes (2025-08-30).

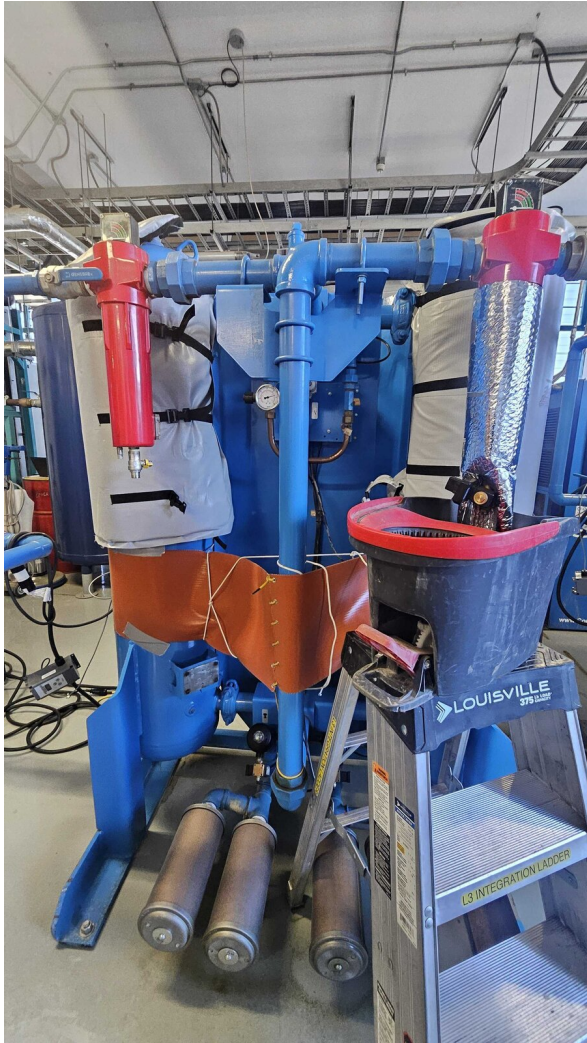
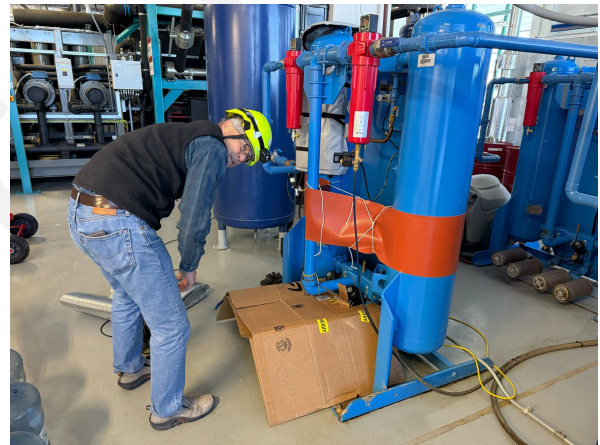
**AIR-01 Compressed dry air supply failures.** *First to last mention 2025-02-27 to 2025-10-08; status **Mitigated**.* Compressed dry air operates the vacuum gate valves and purges the camera body, so its loss is a direct camera concern — including frosting risk on the L3 lens. Supply was cut for two hours for compressor maintenance in February, both Level-1 compressors degraded in August when their dryers froze at  $-8$  °C, and a compressor was lost to a packing-seal failure in October. Insulating jackets on the dryers addressed the freezing mode; single-compressor operation remains a routine condition.

FIGURE 12: **AIR-01.** The compressed-air dryers at Level 1, whose freezing in August stopped the air: the towers with their exhaust and drain lines, and the insulating jacket being fitted (2025-08-23 and 2025-08-26).

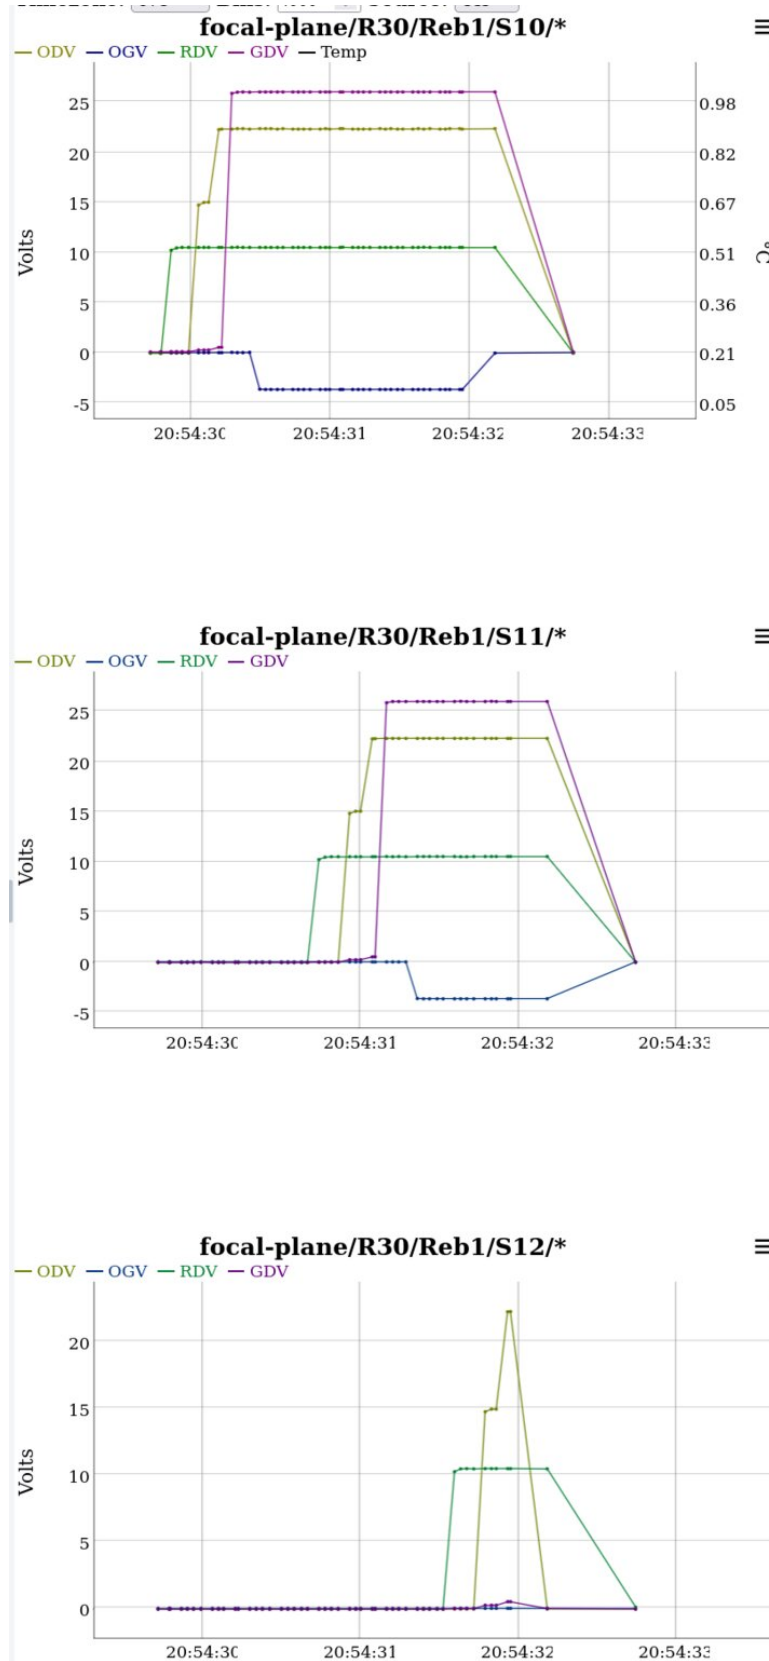
left as the only one switched off camera-wide through May. It was returned to service on June 25–26 running two of three CCDs, which required an R30/Reb1 firmware update and relaxed bias-control limits; the CCD current on S12/Seg17 was noted as anomalously low at that turn-on and again on June 29. The REB has carried its own firmware variant through every subsequent firmware campaign. The workaround — running two of the three CCDs on Reb1 — was implemented on June 25–26 and has been in place since; the fault itself is unresolved. Described in detail in Sections 2.1.1 and 2.1.2.

FIGURE 13: **FP-01**. Bias voltages and currents on R30/Reb1 during the 7 April turn-on attempt, for S10, S11 and S12 from top to bottom; S10 and S11 follow the ramp while S12 trips off (2025-04-07, #cam-operator).

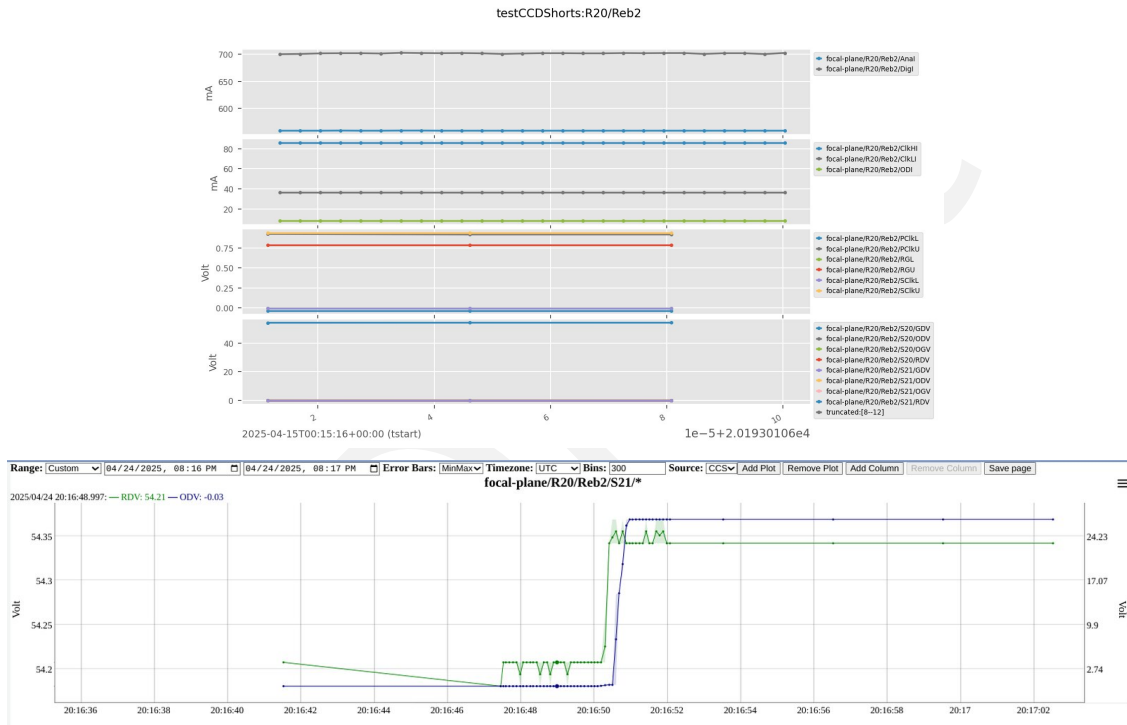
**FP-02 R20/Reb2/S21 unphysical RD voltage read-back.** *First to last mention 2025-04-02 to 2025-04-24; status **Workaround**.* The April 2 CCD shorts test found R20/Reb2/S21 reading an unphysical +54 V RD (reset drain) voltage; power cycling the REB and resetting the RCE did not change it, and the working theory was an open ADC input on the board. The sensor blocked power-on of the raft until April 24, when the erroneous RD reading was configured to be ignored in software and R20 was returned to service. No hardware repair was attempted. Described in detail in Section 2.1.3.

FIGURE 14: **FP-02.** Top: the CCD shorts test on R20/Reb2 of 15 April, which the raft fails on the RD read-back alone — the lowest panel holds one trace pinned near +54 V while every other rail sits where it should (2025-04-15). Bottom: the same channel watched through a power-on the following week, stepping between 54.2 and 54.5 V; a reading that moves, but not to anything physical (2025-04-24).

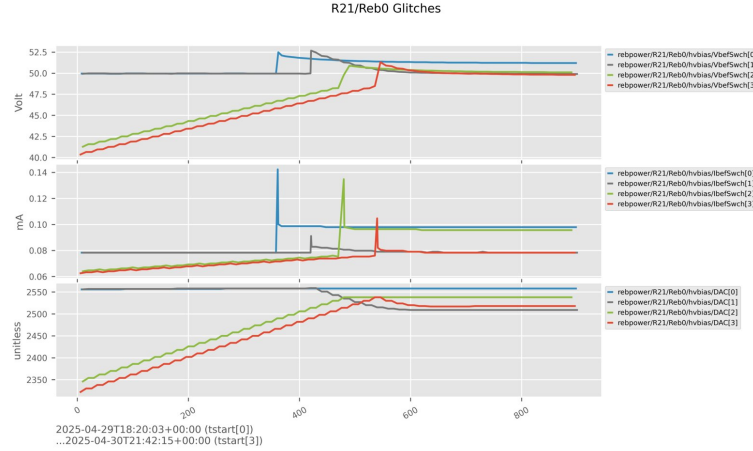
**FP-03 Non-linear HV bias behaviour on R21/Reb0 and R12/Reb0.** *First to last mention 2025-05-05 to 2025-10-25; status **Mitigated**.* R21/Reb0 repeatedly glitched and tripped its HV bias near 50 V, where its DC-DC converter behaves non-linearly, once producing visible tree rings mid-integration. It was set to run permanently at 46 V, and R12/Reb0 later showed similar sensitivity requiring extra care during ramp-up. Managed by lowered setpoints and careful ramping rather than repaired.

FIGURE 15: **FP-03.** The glitches on R21/Reb0: HV bias voltage, current and DAC setting stepping and spiking as the bias is ramped, the behaviour for which the operating point was lowered (2025-05-05, #cam-operator).

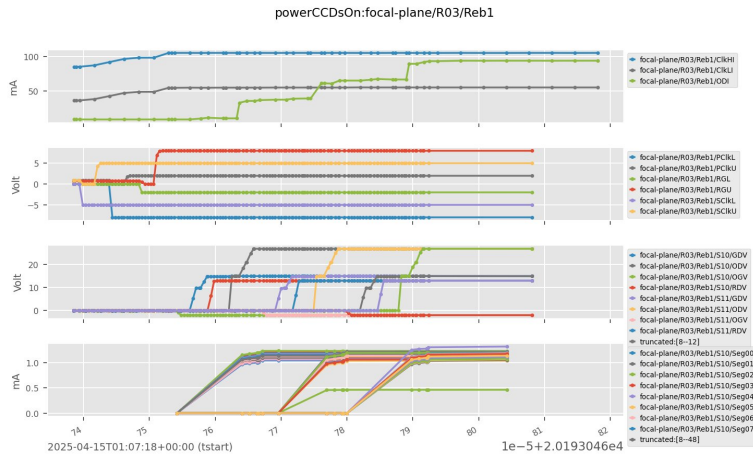
**FP-04 R03/Reb1/S11/Seg00 chronic bad amplifier.** *First to last mention 2025-04-06 to 2025-05-10; status **Workaround**.* A long-standing bad channel described in the logs as having gone “back and forth from working to not, over the last few years”. Its current stayed pinned at 0.5 mA through repeated power cycles in April and May, and the neighbouring Amp16 also failed to return once. The channel cannot be repaired in place; since the impact of a single amplifier is small, the decision is not to repair it and to continue operating with it as it is.

FIGURE 16: **FP-04.** R03/Reb1 being powered on, 15 April. In the bottom panel every segment current rises to about 1.2 mA except one, which stays flat: S11/Seg00, the channel that has gone back and forth for years and did not come back this time either (2025-04-15, #cam-operator).

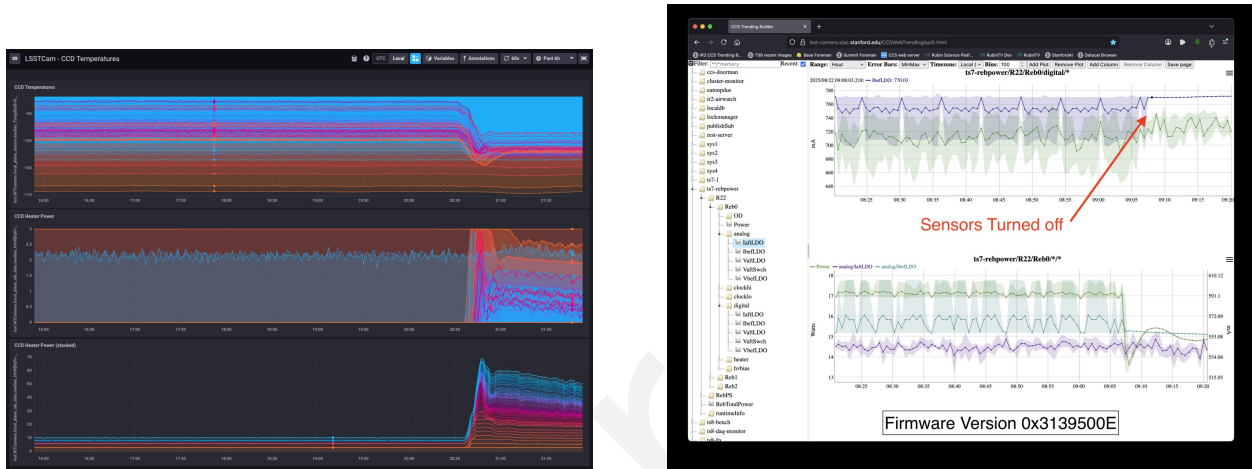
2025-08-23; status **Resolved**. The firmware booted during the August 11 recovery made the CCDs run measurably warmer, which was initially misread as lost cryo capacity during the storm. Power-cycling the focal plane and rolling the firmware back confirmed a real power-draw increase of roughly 30 W, and the cause was a register-map conflict in 0x313a5013 that applied maximum heater power — a defect introduced together with the sequencer-override register in 0x31395011 and unnoticed until then. It was fixed by the firmware upgrade to 0x313a5014. See the version history in Table 10.

FIGURE 18: **FW-01**. Left: CCD temperatures and CCD heater power across the firmware roll-back, the step in heater power being the extra draw the faulty build was applying (2025-08-21). Right: the same measurement annotated during the investigation, with the moment the sensors were turned off marked and the firmware version under test named (2025-08-22).

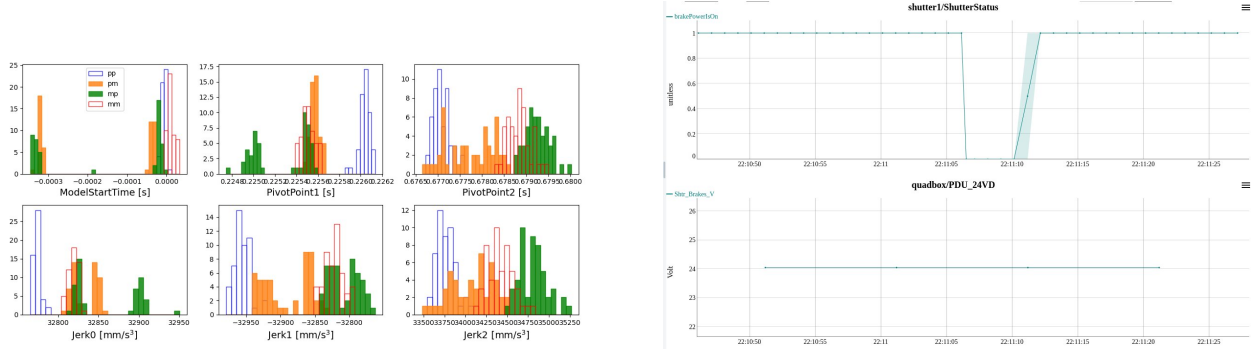
FIGURE 31: **SHT-01.** Left: the shutter motion-profile study of March, fitting model start time, pivot points and jerk for each blade and comparing them with the 2022 reference set (2025-03-24). Right: shutter status and the quadbox 24V supply across one of the stuck-shutter events (2025-04-23).

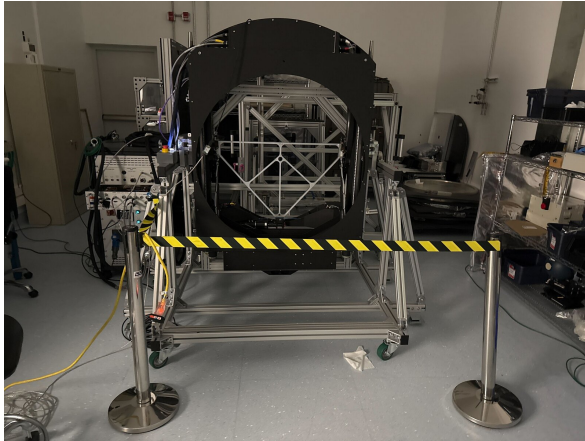
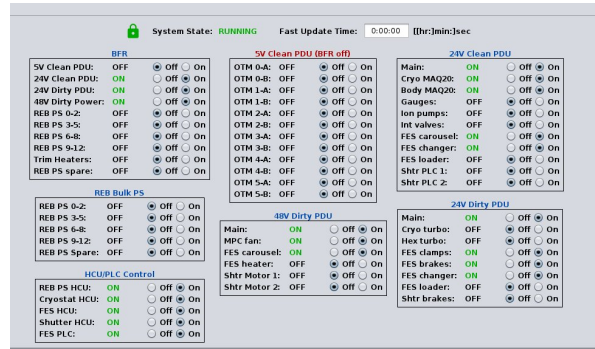
FIGURE 34: **FES-03.** Left: an autochanger on its stand in the clean room, where the homing procedure was qualified (2025-04-07). Right: the quadbox power panel, whose FES carousel, clamp, loader and brake channels are the supplies behind the truck undervoltage faults (2025-02-13).

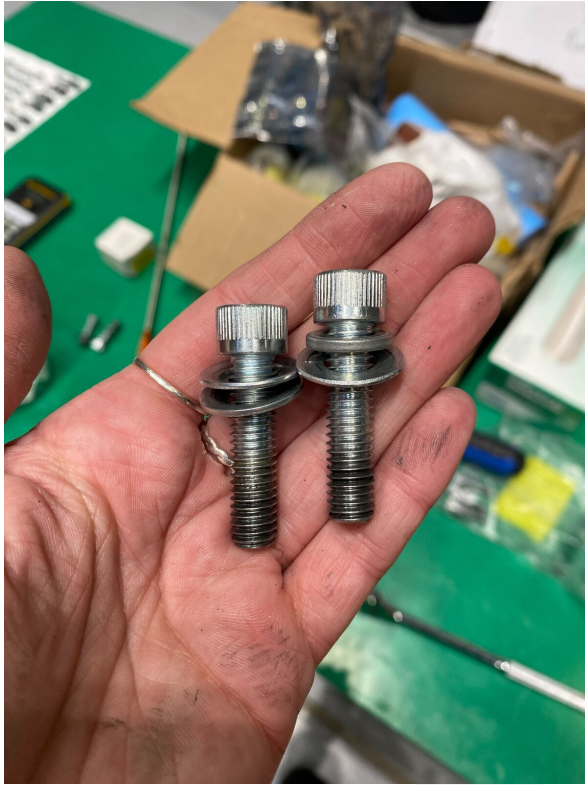
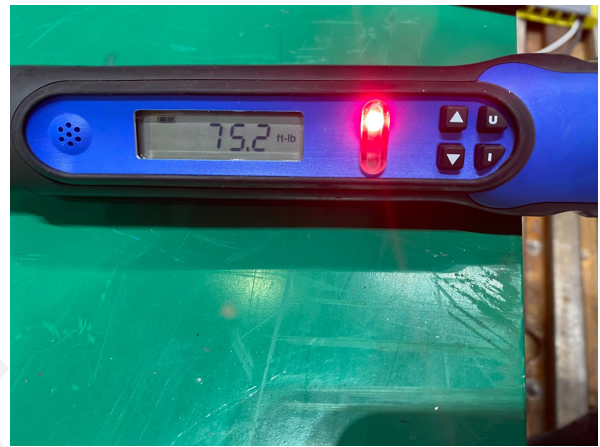
FIGURE 37: **MEC-01.** Two of the sheared 3/8-16 socket-head bolts recovered from the cable wrap, and the bolt test that followed a few days later: 75.2 ft-lb applied with no sign of failure (2025-01-30, #cam-summit-ops).

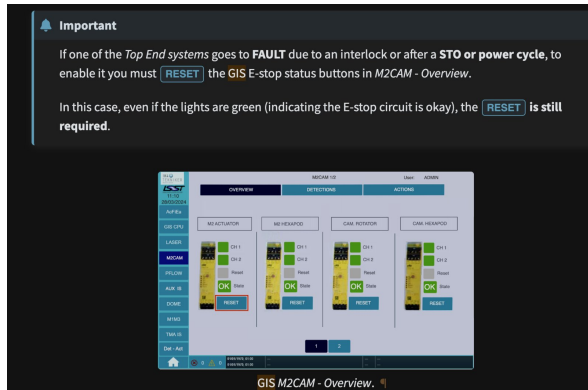
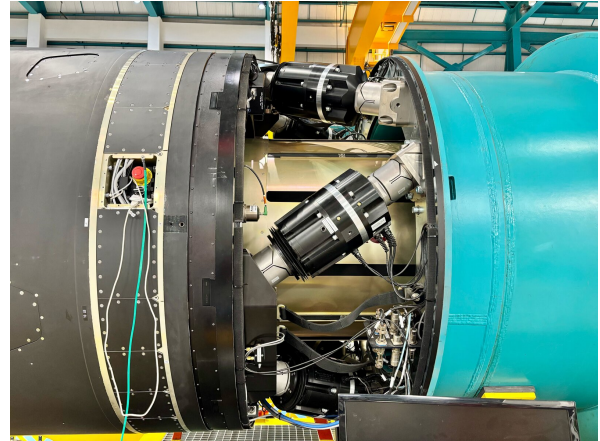
FIGURE 38: **MEC-02.** Left: the operating note for the interlock, which has to be reset from the mount engineering interface after a fault or power cycle even when the status lights are green (2025-09-23). Right: the camera rotator and cable-wrap region on the Top End Assembly (2025-03-03).

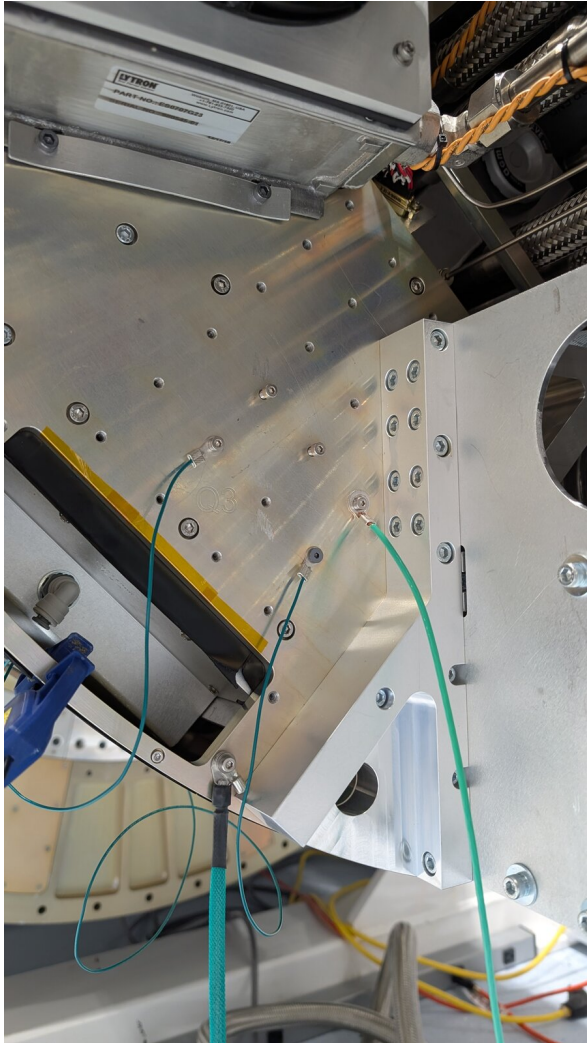
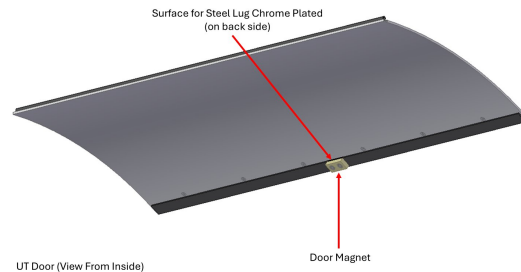
FIGURE 40: **MEC-04.** Left: one of the temporary grounding wires used in the clean room, which had to come off before the utility-trunk skins were installed (2025-01-21). Right: the utility-trunk door seen from inside, with the chrome-plated lug surface and the door magnet marked — the interface a permanent grounding strap has to use (2025-01-21).

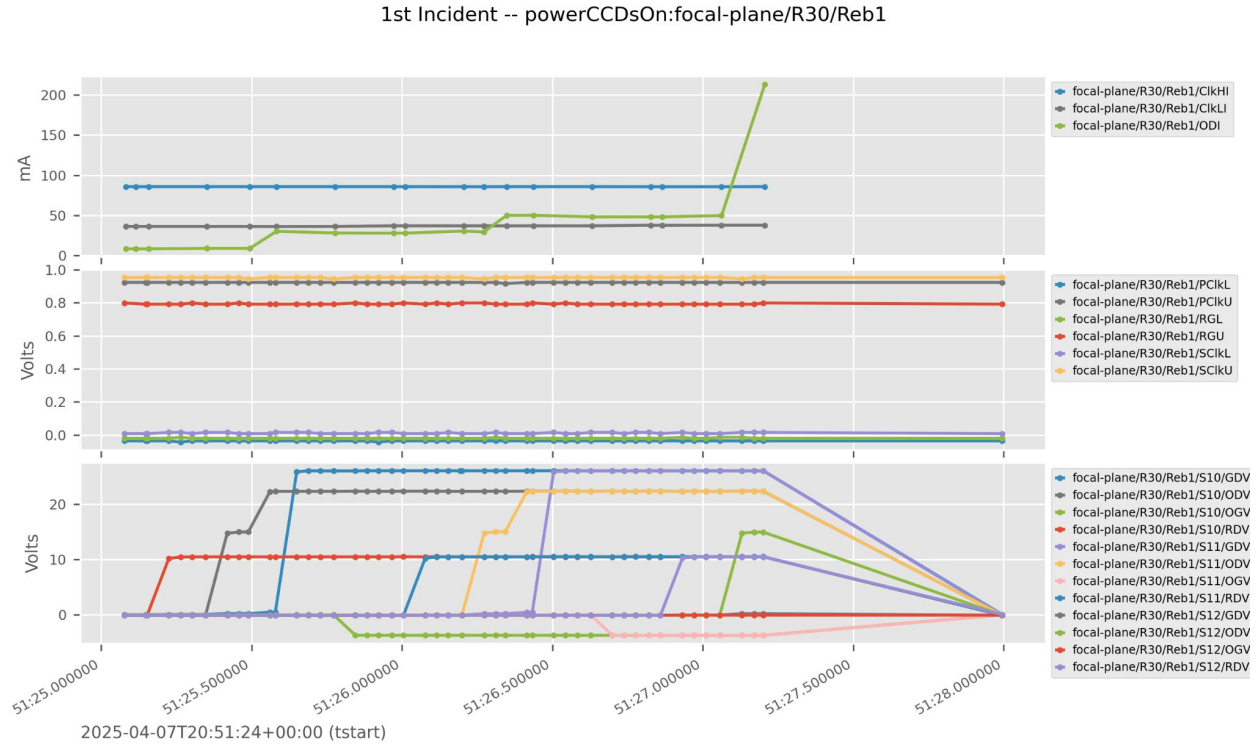
FIGURE 44: Trending of the first power-on attempt (Marshall, 2025b). Top: the REB parent currents, with ODI (green) leaving its baseline as the bias sequence proceeds and reaching 213 mA. Middle: the clock rails. Bottom: the CCD bias voltages; the last trace to rise, to  $\approx 15$  V, is the OD of S12, and all biases return to zero at 51:28 when the protection has fired and powerCCDsOff runs.

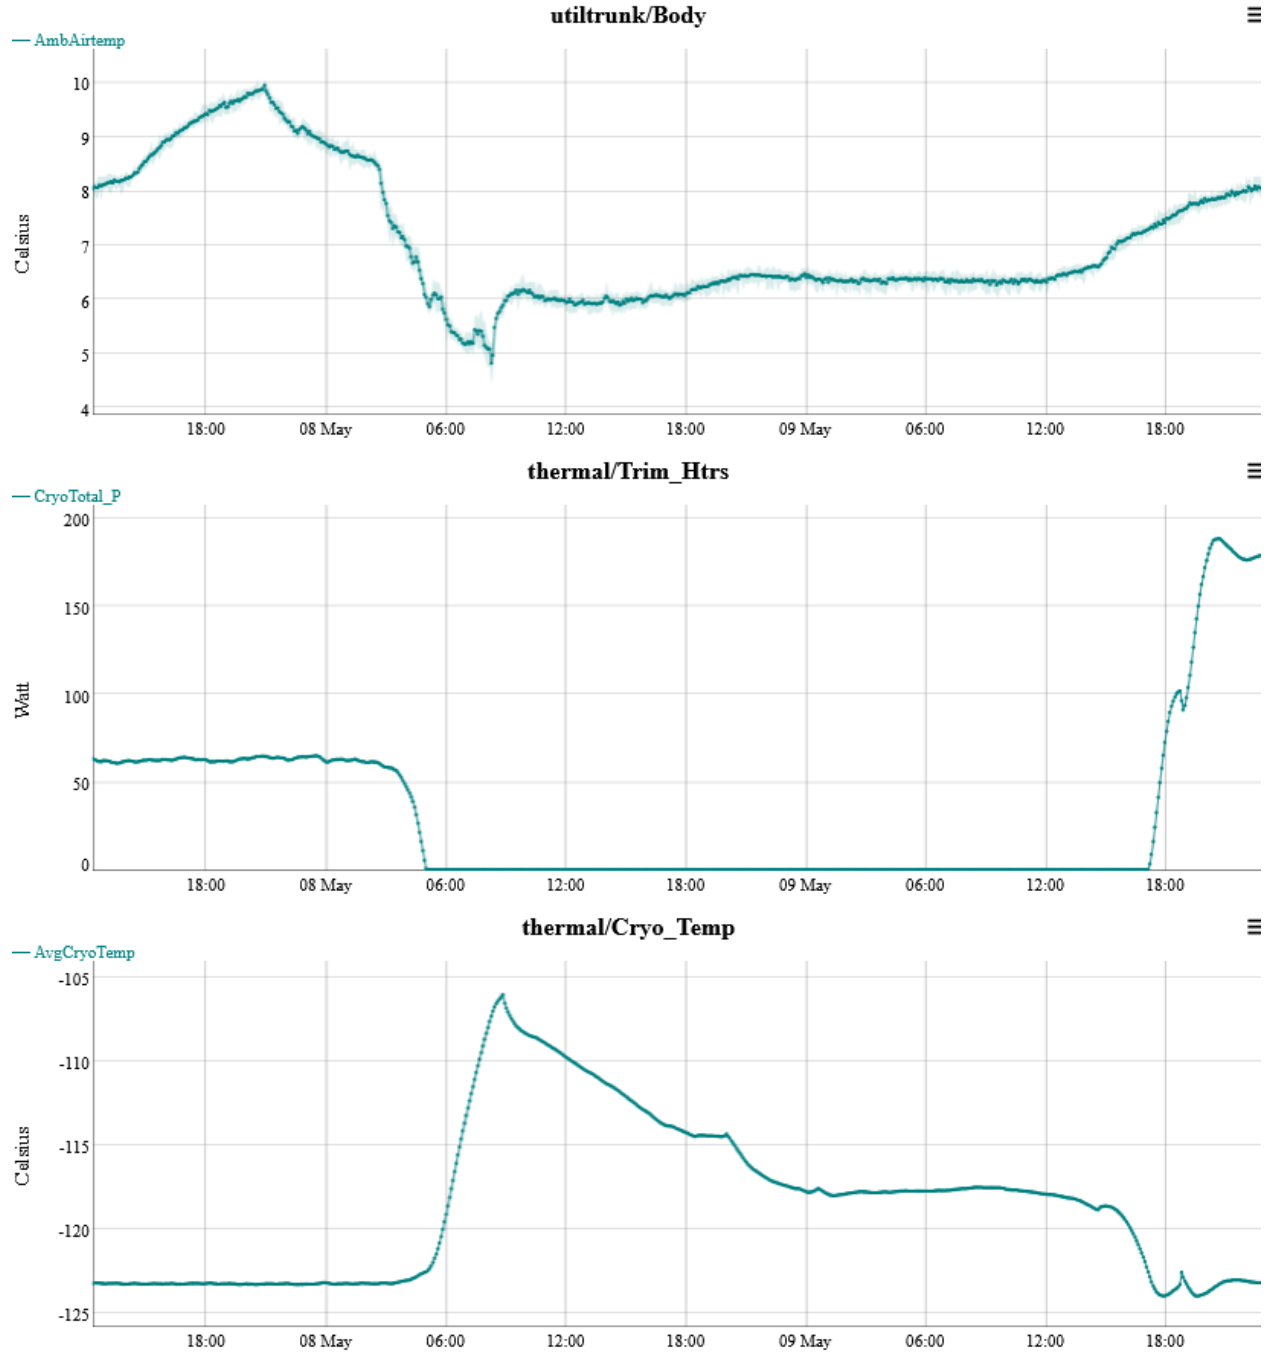
FIGURE 52: Ambient temperature, Cryo trimheat and cryoplate temperature at around 6 am UTC on May 8, 2025

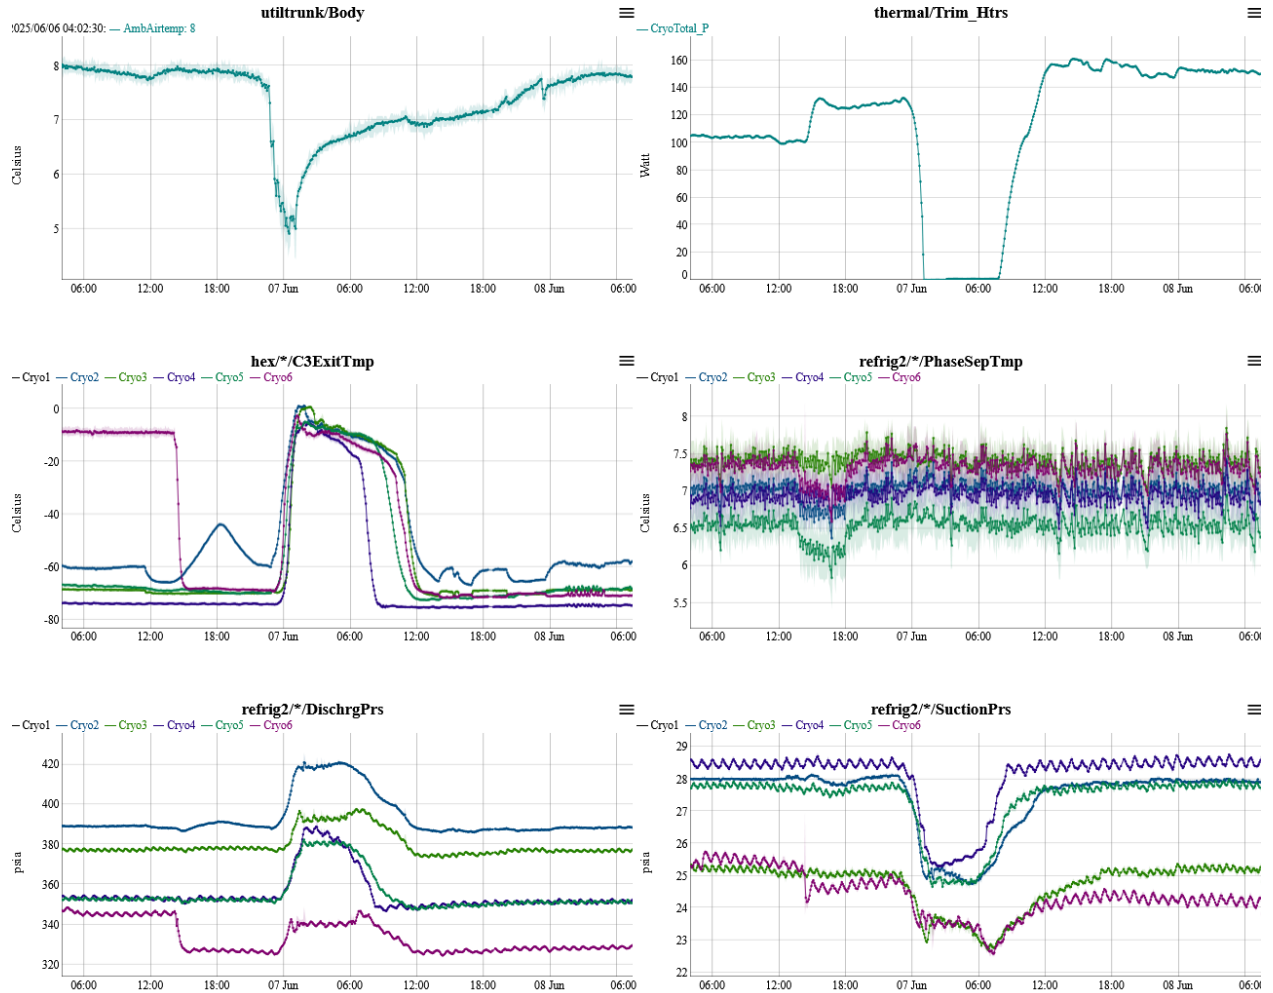
FIGURE 56: Cryo system loss cooling capacity due to low ambient temperature on June 6/June 7 in 2025
