## The LSST Camera commissioning

CTN-007

This technote describes what we found during the LSST Camera commissioning.

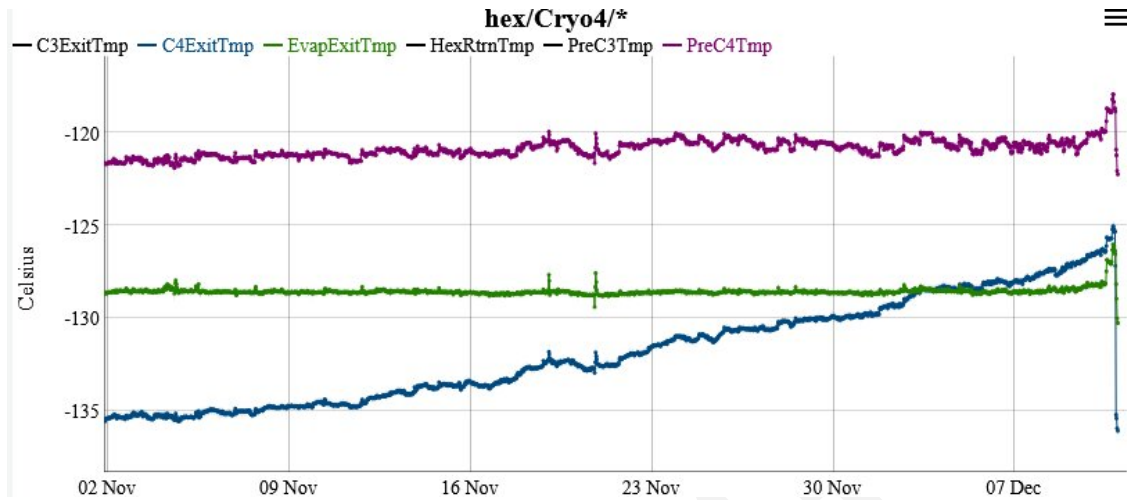
**CRYO-04 Capillary clogs (Cryo 1 cycled clear, Cryo 3 lost, Cryo 4 self-cleared).** *First to last mention 2025-05-12 to 2025-12-11; status **Open**.* The first of the three is Cryo 1, and it is the one that was never named as a clog at the time. The circuit is believed to have been clogged by the recovery activity of around May 10, after which its heat-exchanger return temperature ran persistently low — the condition registered separately as CRYO-02, since what was managed nightly was the dew-point risk rather than the clog behind it. From May 12 the circuit was power-cycled repeatedly, at times daily, in the hope of cycling the obstruction clear; that continued for some months and the circuit did eventually recover, but no single intervention can be identified as the one that cleared it. During the October recharge Cryo 3 developed a clog — the capillary is the suspected location — that survived repeated power cycles, refrigerant additions and running the telescope horizontal; the circuit was given up on October 20 and the camera has run on five of six circuits since. A second clog, on the Cryo 4 capillary, developed in early December, drove cryo trim heat down to about 1 W, and cleared spontaneously on the evening of December 10 without intervention. The open question is whether contamination was introduced into Cryo 3 during the October maintenance itself; it was on that suspicion that revisions to the evacuation and charging procedure and to filter-dryer replacement (LCA-14625, LCA-17726) were proposed. Cryo 3 was still out of service at year end.

FIGURE 3: **CRYO-04.** The Cryo 4 clog developing through November: the C4 exit temperature (blue) drifts up towards the pre-capillary temperature over five weeks, the signature by which the clog was recognised (2025-12-11, #cam-operator).

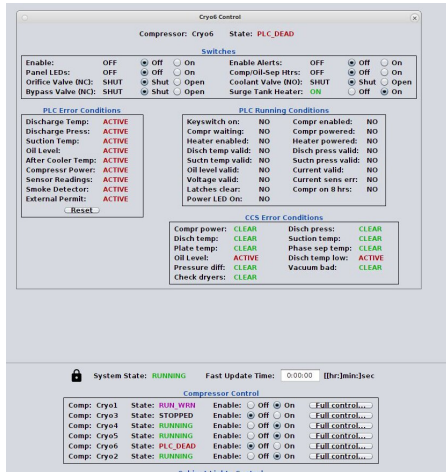
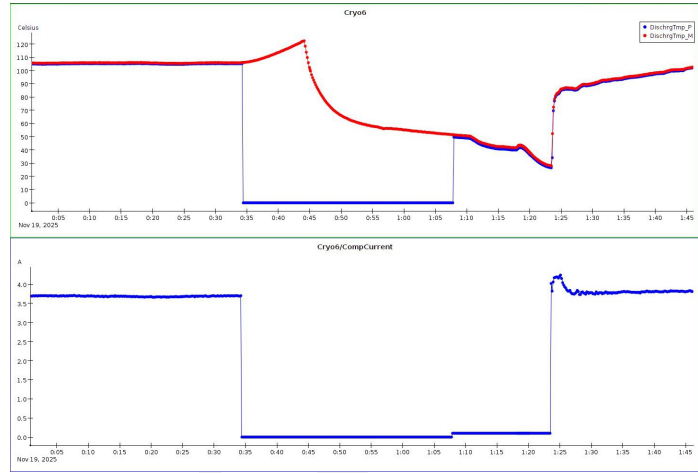
**CRYO-05 Cryo 6 PLC death after an external setpoint change.** *First to last mention 2025-11-18 to 2025-11-19; status **Open**.* On November 19 the Cryo 6 PLC was declared dead at 00:34 UTC with the discharge temperature reading 122 °C and the oil level negative; the PLC recovered by itself 33 minutes later. The overheating of the cabinet that preceded it was attributed to a software update elsewhere on the summit mis-setting the glycol setpoint in response to bad environmental sensor readings (FRACAS-322, OBS-1394, OBS-1395). The PLC failure itself is suspected to be a problem in the PLC, and its root cause is not known. The CCS logic that closes the coolant valve when a PLC is declared dead was flagged as needing revision (LSSTCCSREFRIG-319 and LSSTCCSREFRIG-332).

FIGURE 4: **CRYO-05**. Left: the CCS Cryo 6 panel during the failure, reporting State: PLC\_DEAD with every PLC error condition ACTIVE. Right: the discharge temperature and compressor current across the event, the temperature rising while the compressor is off (2025-11-19).

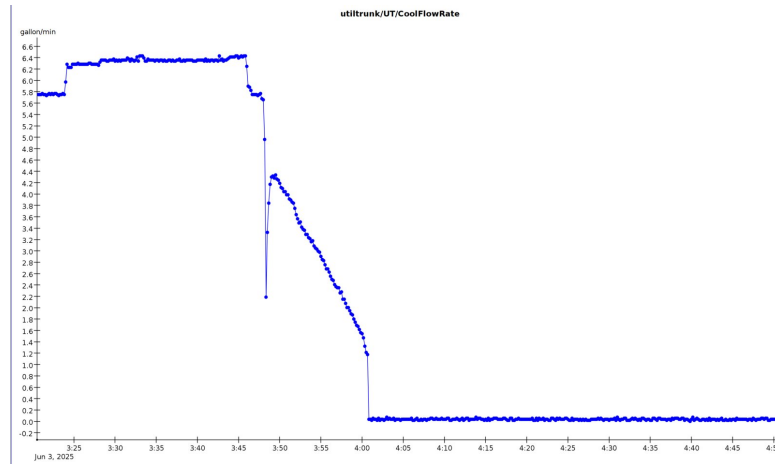
**DYN-01 Recurrent loss of Dynalene flow to the utility trunk.** *First to last mention 2025-01-18 to 2025-12-17; status **Open**.* Dynalene, which cools the utility-trunk electronics, failed repeatedly all year — from control computer (cRIO) reboots and crashes, chiller faults and power events — each time forcing an emergency power-down of CCDs, REBs and often the shutter and filter changer (OBS-1014, FRACAS-321, FRACAS-328). A review of the August 11 event established that the camera tolerates only about 13 minutes without flow before REB power-supply boards approach their 48°C trip limit. The cRIO was replaced on November 4 and a small UPS was added in late November, but outages continued into the second half of December.

FIGURE 5: **DYN-01.** Utility-trunk Dynalene flow collapsing to zero. This is the signature the events have in common: whatever the cause upstream — a cRIO reboot, a chiller fault, a power event — what the camera sees is the flow going away, and from that moment it has about thirteen minutes before the REB power-supply boards approach their 48 °C trip limit (2025-06-03, #cam-operator).

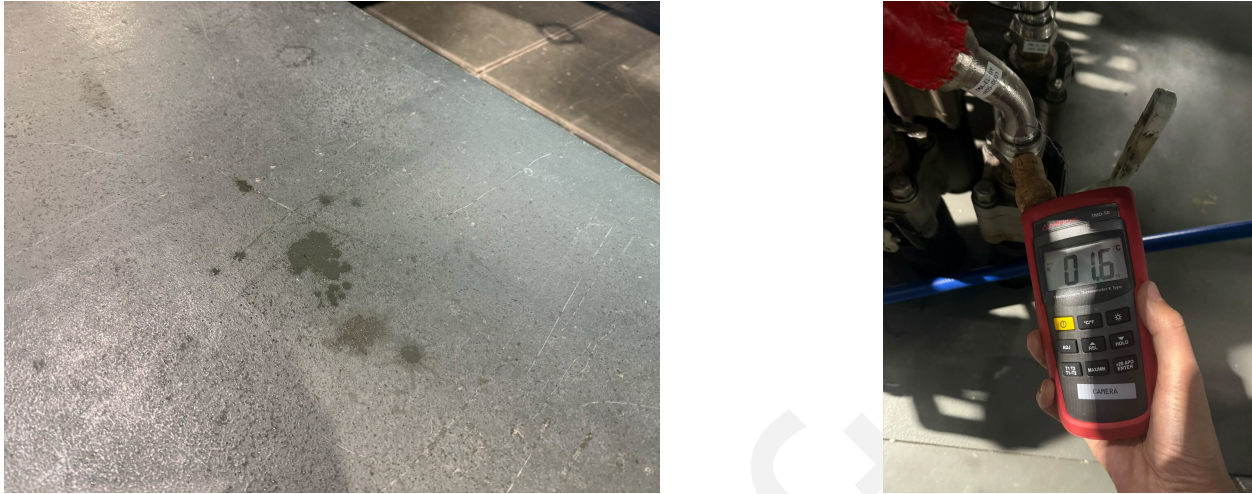
**DYN-04 Condensation and humidity around the Top End Assembly.** *First to last mention 2025-06-14 to 2025-12-16; status **Open**.* The camera region of the Top End Assembly runs more humid than ambient, and the compressed dry air supplied there has little authority over it — the June investigation found the supply had been silently off for an unknown period and that the air reaching the camera is heavily mixed with dome air. In November infrared imaging showed hot spots and a suspected dry-air leak near the heat-exchanger return, and in December water droplets were found on M1M3, traced to condensation on uninsulated Dynalene supply pipes at the Top End Assembly (SUMMIT-11795, OBS-1479). Open at year end, with insulation the proposed fix.

FIGURE 6: **DYN-04.** Left: the liquid found below the camera cable wrap on 16 December, a little left of centre looking into the mirror — the drops that were traced back to the Top End Assembly. Right: the source, measured a week later: an uninsulated Dynalene line at the cable wrap reading 1.6 °C on its surface, well below the dew point of the air around it (2025-12-16 and 2025-12-24, #cam-summit-ops).

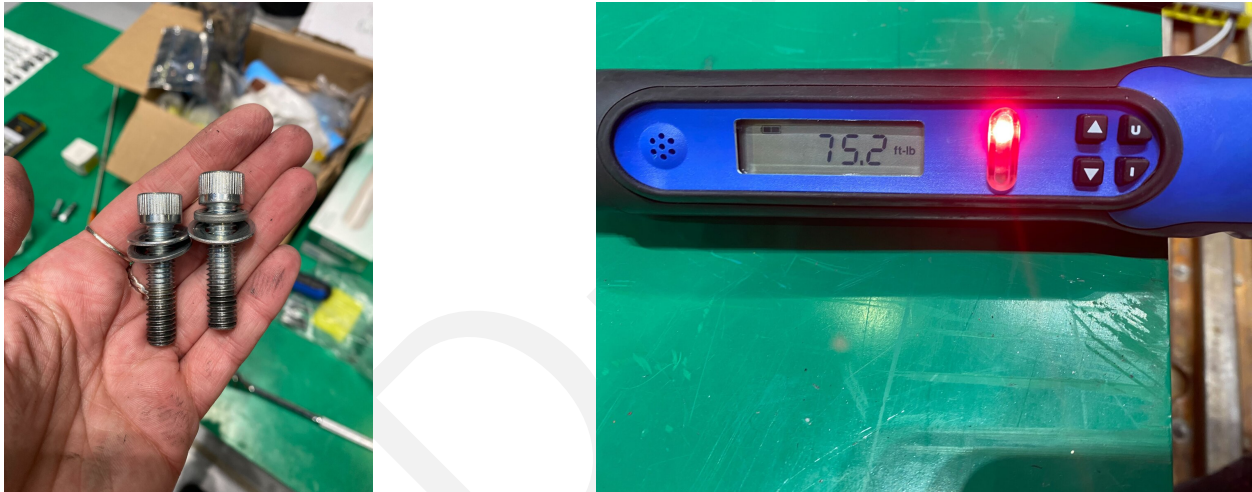
FIGURE 32: **MEC-01.** Two of the sheared 3/8-16 socket-head bolts recovered from the cable wrap, and the bolt test that followed a few days later: 75.2 ft-lb applied with no sign of failure (2025-01-30, #cam-summit-ops).

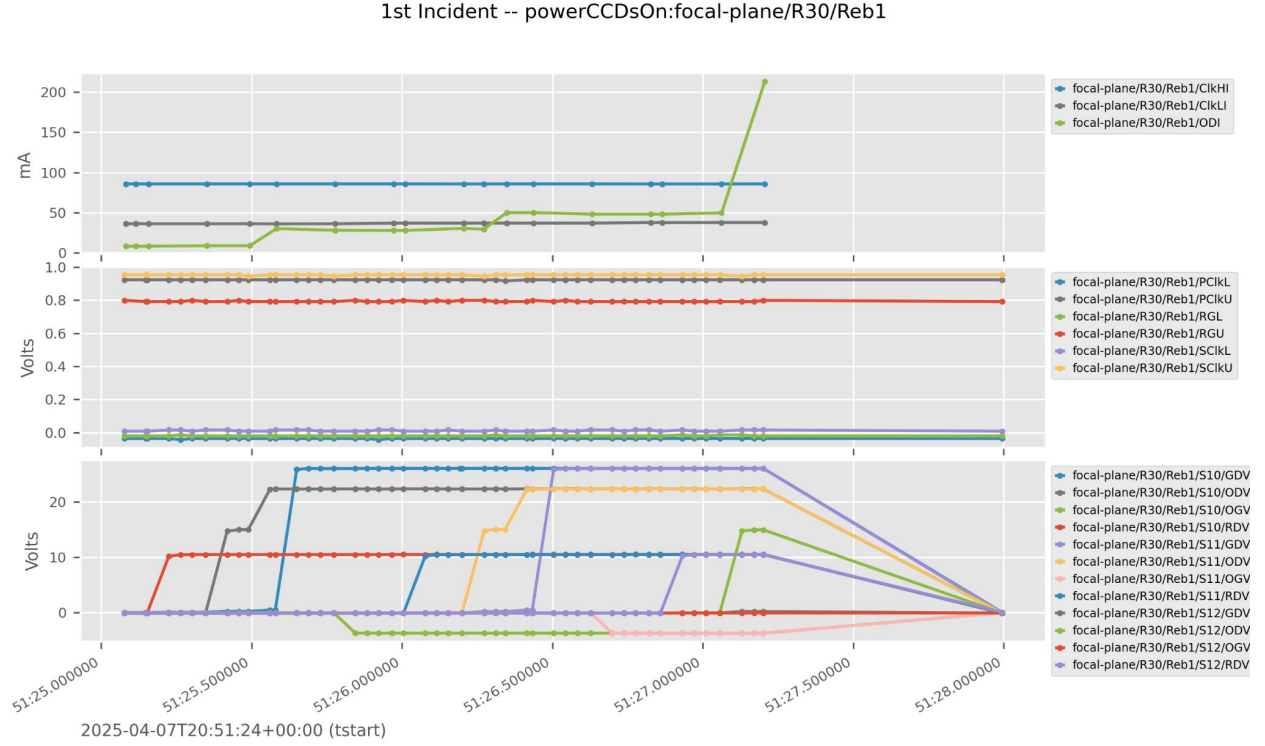
FIGURE 39: Trending of the first power-on attempt (Marshall, 2025b). Top: the REB parent currents, with ODI (green) leaving its baseline as the bias sequence proceeds and reaching 213 mA. Middle: the clock rails. Bottom: the CCD bias voltages; the last trace to rise, to  $\approx 15$  V, is the OD of S12, and all biases return to zero at 51:28 when the protection has fired and powerCCDsOff runs.

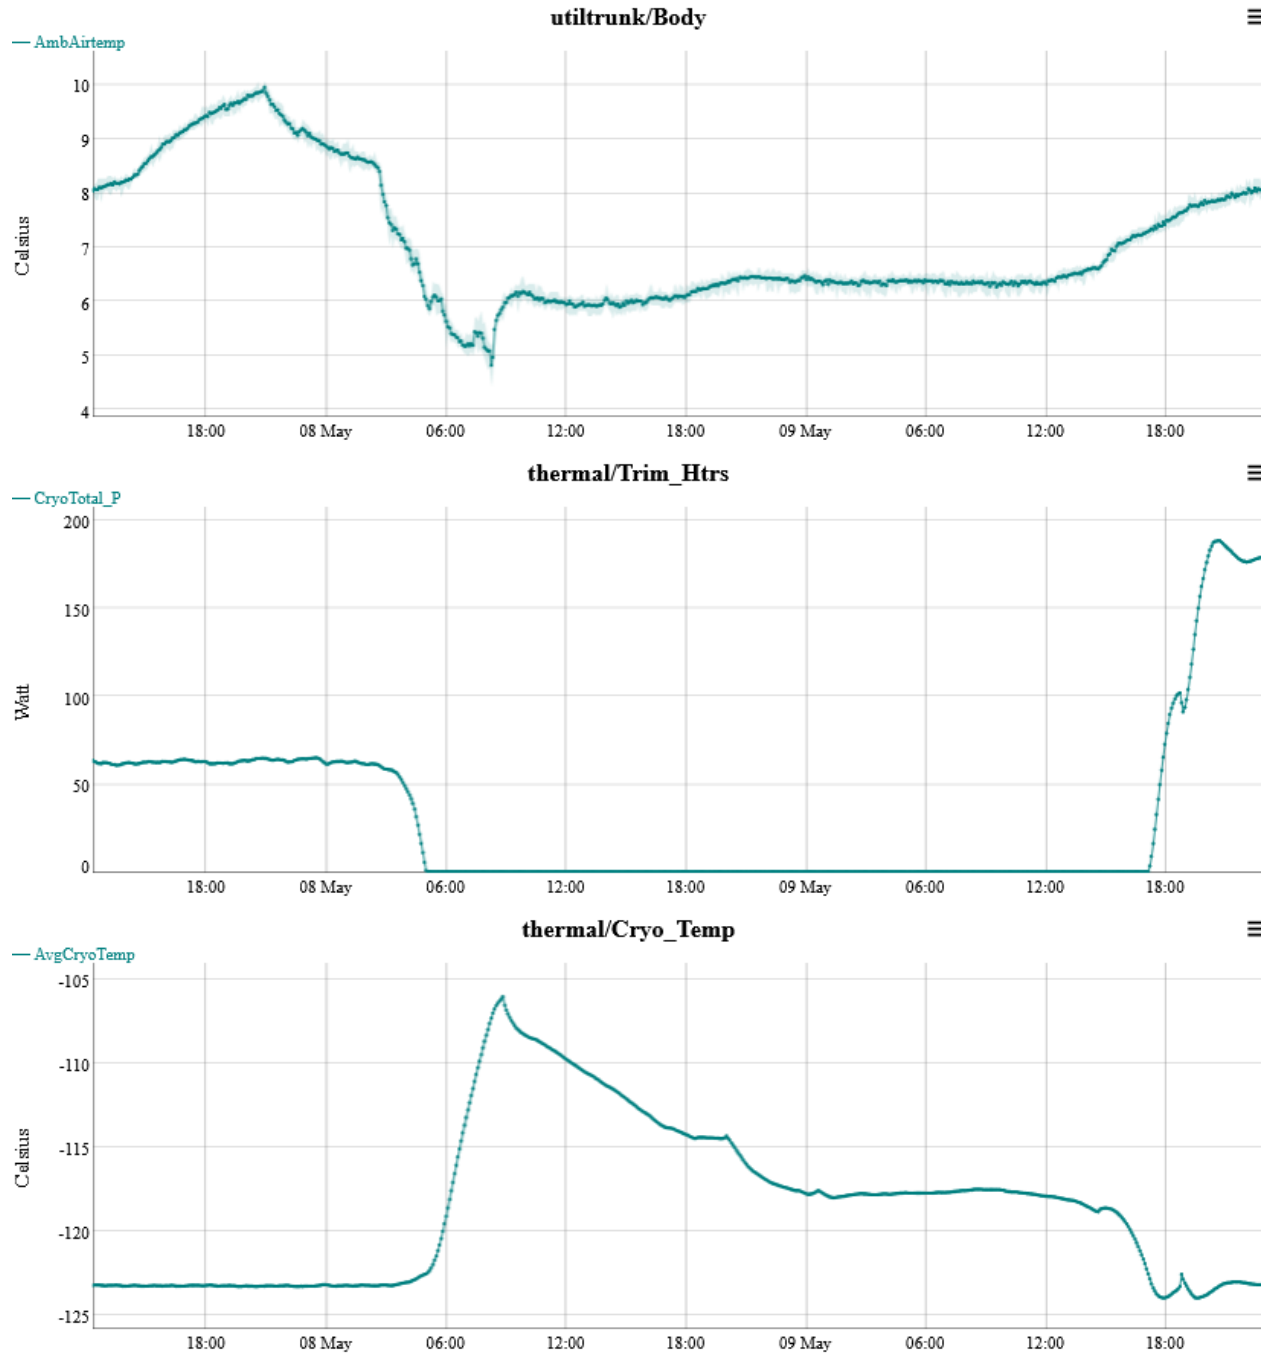
FIGURE 47: Ambient temperature, Cryo trimheat and cryoplate temperature at around 6 am UTC on May 8, 2025
