Vera C. Rubin Observatory  
Rubin Observatory Operations

## The LSST Camera commissioning

CTN-007

This technote describes what we found during the LSST Camera commissioning.

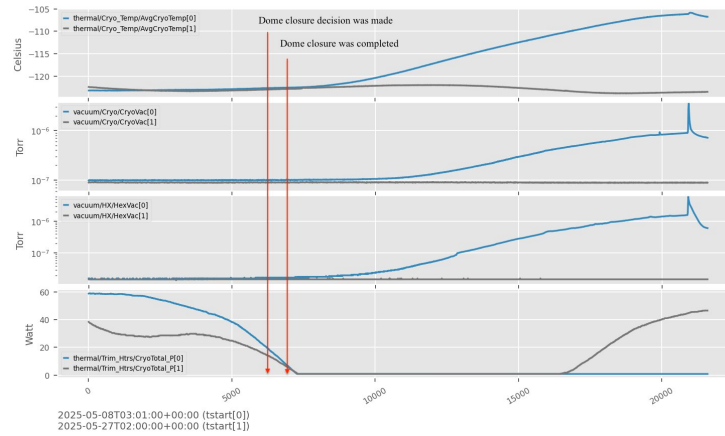
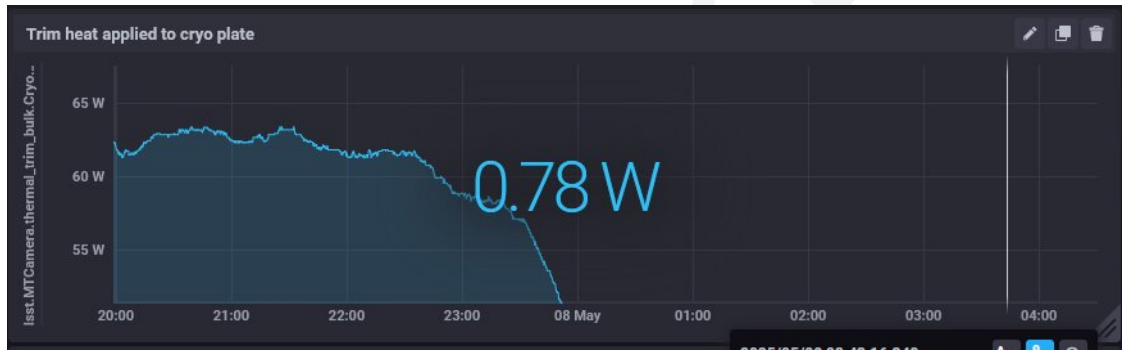
FIGURE 2: **CRYO-01**. Top: the 8 May loss of capacity as it was reconstructed afterwards — cryo temperatures, cryostat and heat-exchanger vacuum and the cryo-plate trim heat, with the moments the dome-closure decision was taken and completed marked (2025-05-27). Bottom: trim heat applied to the cryo plate falling to 0.78 W, the floor at which the plate can no longer be held in control (2025-05-25).

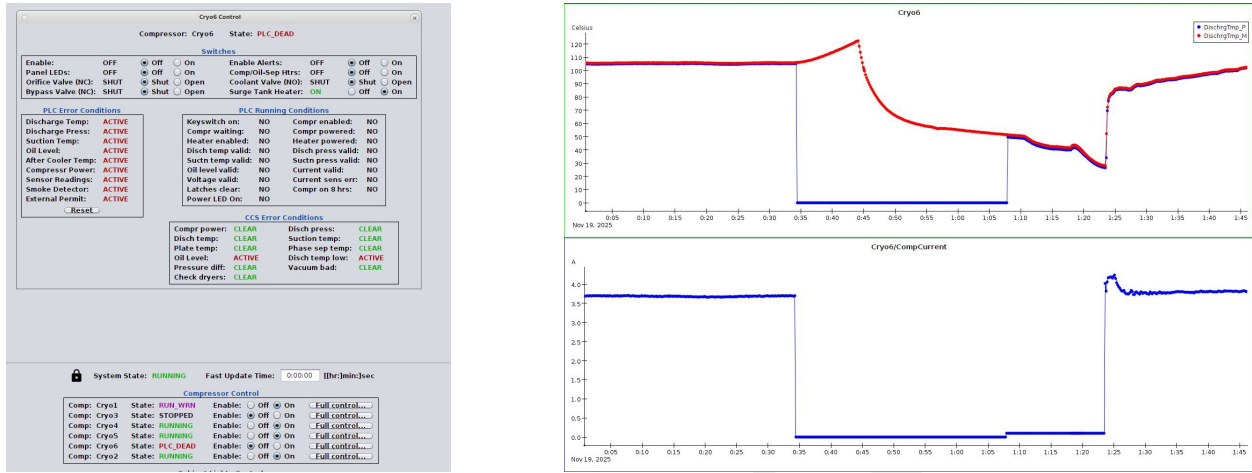
**CRYO-05 Cryo 6 PLC death after an external setpoint change.** *First to last mention 2025-11-18 to 2025-11-19; status **Open**.* On November 19 the Cryo 6 PLC was declared dead at 00:34 UTC with the discharge temperature reading 122 °C and the oil level negative; the PLC recovered by itself 33 minutes later. The overheating of the cabinet that preceded it was attributed to a software update elsewhere on the summit mis-setting the glycol set-point in response to bad environmental sensor readings (FRACAS-322, OBS-1394, OBS-1395). The PLC failure itself is suspected to be a problem in the PLC, and its root cause is not known. The CCS logic that closes the coolant valve when a PLC is declared dead was flagged as needing revision (LSSTCCSREFRIG-319 and LSSTCCSREFRIG-332).

FIGURE 4: **CRYO-05**. Left: the CCS Cryo 6 panel during the failure, reporting State: PLC\_DEAD with every PLC error condition ACTIVE. Right: the discharge temperature and compressor current across the event, the temperature rising while the compressor is off (2025-11-19).

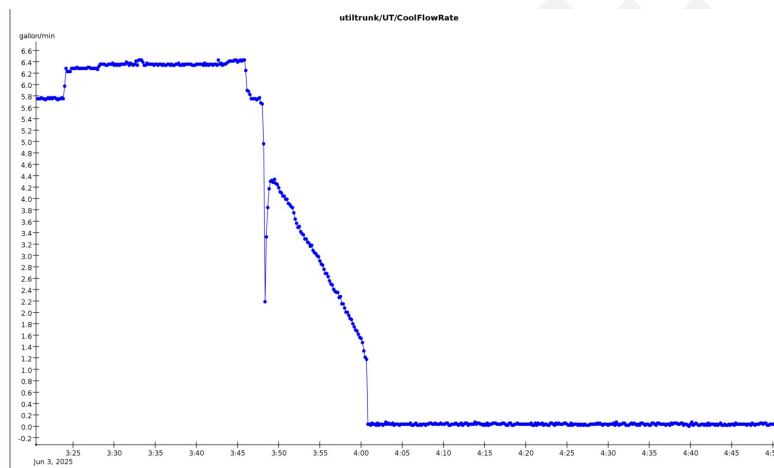
**DYN-01 Recurrent loss of Dynalene flow to the utility trunk.** *First to last mention 2025-01-18 to 2025-12-17; status **Open**.* Dynalene, which cools the utility-trunk electronics, failed repeatedly all year — from control computer (cRIO) reboots and crashes, chiller faults and power events — each time forcing an emergency power-down of CCDs, REBs and often the shutter and filter changer (OBS-1014, FRACAS-321, FRACAS-328). A review of the August 11 event established that the camera tolerates only about 13 minutes without flow before REB power-supply boards approach their 48°C trip limit. The cRIO was replaced on November 4 and a small UPS was added in late November, but outages continued into the second half of December.

FIGURE 5: **DYN-01.** Utility-trunk Dynalene flow collapsing to zero. This is the signature the events have in common: whatever the cause upstream — a cRIO reboot, a chiller fault, a power event — what the camera sees is the flow going away, and from that moment it has about thirteen minutes before the REB power-supply boards approach their 48°C trip limit (2025-06-03, #cam-operator).

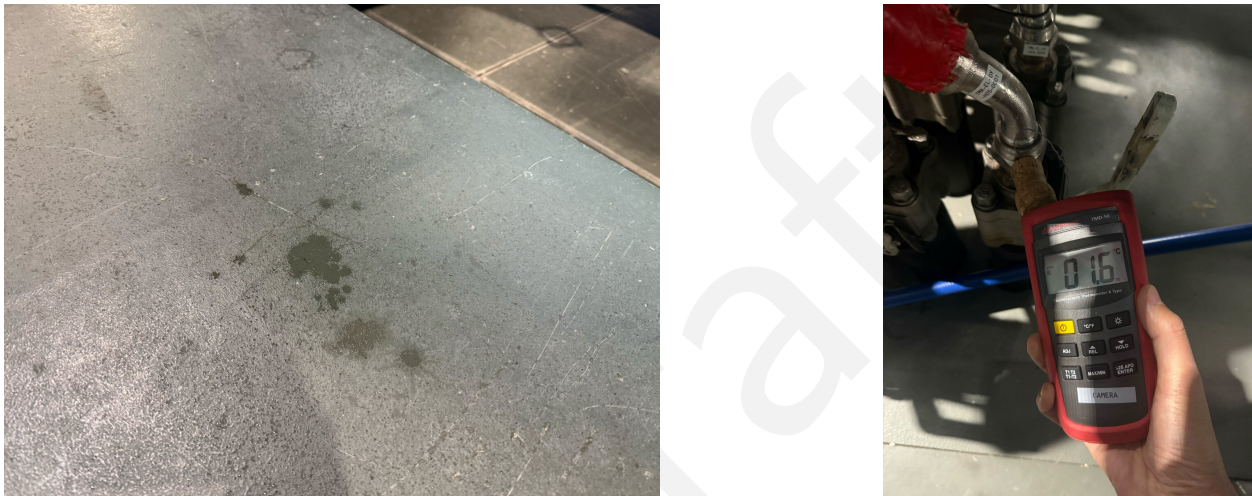
**DYN-04 Condensation and humidity around the Top End Assembly.** *First to last mention 2025-06-14 to 2025-12-16; status **Open**.* The camera region of the Top End Assembly runs

more humid than ambient, and the compressed dry air supplied there has little authority over it — the June investigation found the supply had been silently off for an unknown period and that the air reaching the camera is heavily mixed with dome air. In November infrared imaging showed hot spots and a suspected dry-air leak near the heat-exchanger return, and in December water droplets were found on M1M3, traced to condensation on uninsulated Dynalene supply pipes at the Top End Assembly (SUMMIT-11795, OBS-1479). Open at year end, with insulation the proposed fix.

FIGURE 6: **DYN-04**. Left: the liquid found below the camera cable wrap on 16 December, a little left of centre looking into the mirror — the drops that were traced back to the Top End Assembly. Right: the source, measured a week later: an uninsulated Dynalene line at the cable wrap reading 1.6°C on its surface, well below the dew point of the air around it (2025-12-16 and 2025-12-24, #cam-summit-ops).

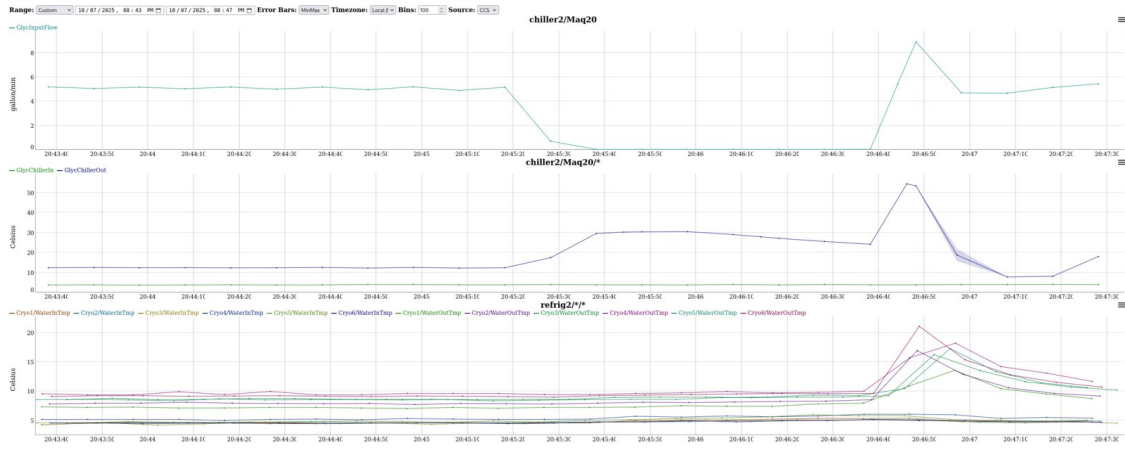
**GLY-01 Glycol flow interruptions to the PCS on power events.** *First to last mention 2025-04-28 to 2025-11-28; status **Resolved**.* Every commercial power glitch or generator transfer stops the glycol recirculation pumps for roughly 70–90 seconds, against an observed PCS chiller trip threshold of 90–120 seconds — so each event is a near miss, and several were not (FRACAS-277, FRACAS-278, FRACAS-279). The identified fix, putting the recirculating pumps on UPS, was still pending throughout 2025; in September, observing on generator power had to be restricted in pointing because of it. The issue was closed in early February 2026, after the period covered here.

FIGURE 7: **GLY-01**. One of the near misses, at second resolution. Glycol input flow to the PCS (top) drops from 5.2 gallons per minute to zero at 20:45:30 and is restored about 70 seconds later; the chiller outlet temperature (middle) had already climbed from 12 to 30°C before the interruption and overshoots to 54°C on restart, and the cryo water-out temperatures (bottom) follow it up. The chiller trips if the flow is lost for 90 to 120 seconds (2025-10-07, #cam-operator).

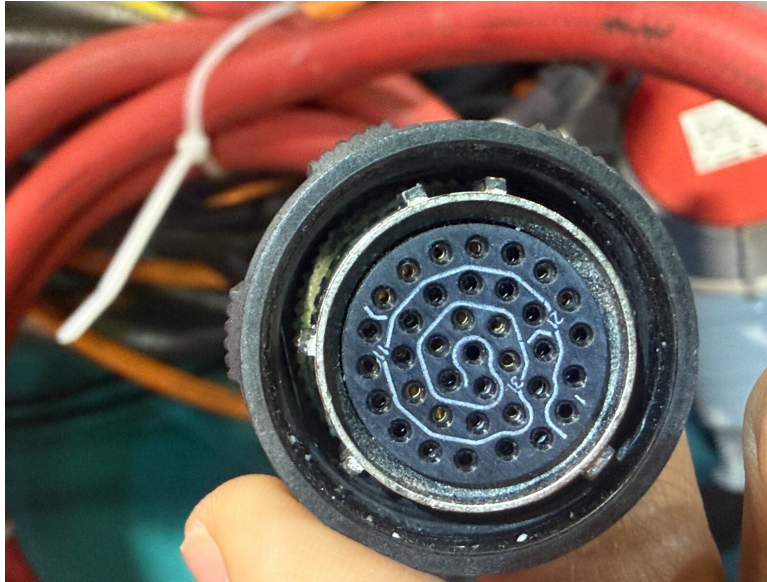
A cluster of PCS chiller problems in spring, all of them traced and fixed: an under-rated 32 A supply breaker against a 50 A service requirement, which tripped the chiller twice in one morning (OBS-826); a stage-1 refrigerant leak that took the chiller out of service for a day and left the camera quiescent overnight; and spurious trips with no real chiller anomaly, traced to an unseated pin in a refrigeration-permit connector on the telescope-side cabling and aggravated by TMA shaking tests (SUMMIT-10642, SUMMIT-10652). The breaker was replaced, the leak repaired and the connector pins and shell renewed.

FIGURE 8: **PCS-01.** The pin face of the refrigeration-permit connector on the telescope-side cabling. An unseated pin here is what produced the spurious chiller trips — no chiller anomaly, a permit signal that came and went as the TMA moved. The pins and the shell were renewed (2025-04-11, #cam-operator).

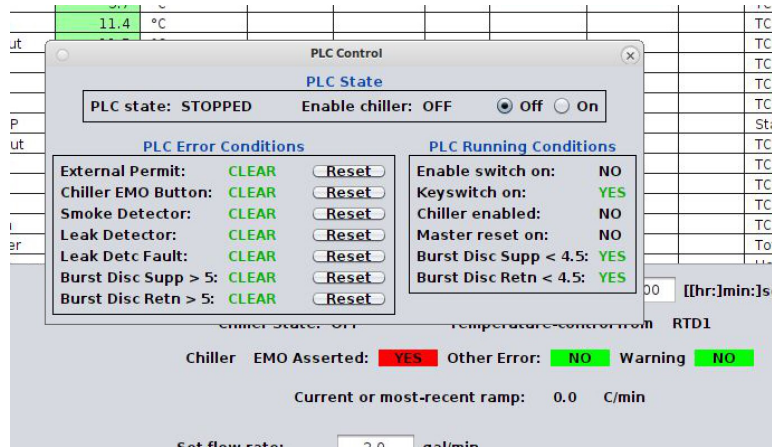
**PCS-02 PCS chiller restart difficulty, and the MRCR unit.** *First to last mention 2025-03-28 to 2025-07-02; status **Open**.* Restarting the chiller is a separate problem from the failures above and was never solved: the unit repeatedly trips on low HFE flow because gas bubbles form in the longer line configuration, which procedure LCA-20281 does not cover. In March it took roughly a dozen attempts over two days, and was recovered only by pressurising the coolant tank; a loud bypass-valve noise during those attempts was later explained as the high-pressure bypass cracking at an 80 psi pump differential. The same behaviour blocked the restart of the unit at the MRCR in July. The MRCR system was found to have failed during the year and is tracked as LSSTCAM-119.

FIGURE 9: **PCS-02.** The chiller PLC panel during a restart attempt: stopped, with every error condition clear. Nothing is reported as wrong, and the unit will still trip on low HFE flow when it is asked to start again — which is why the restarts took about a dozen attempts over two days (2025-03-28, #cam-operator).

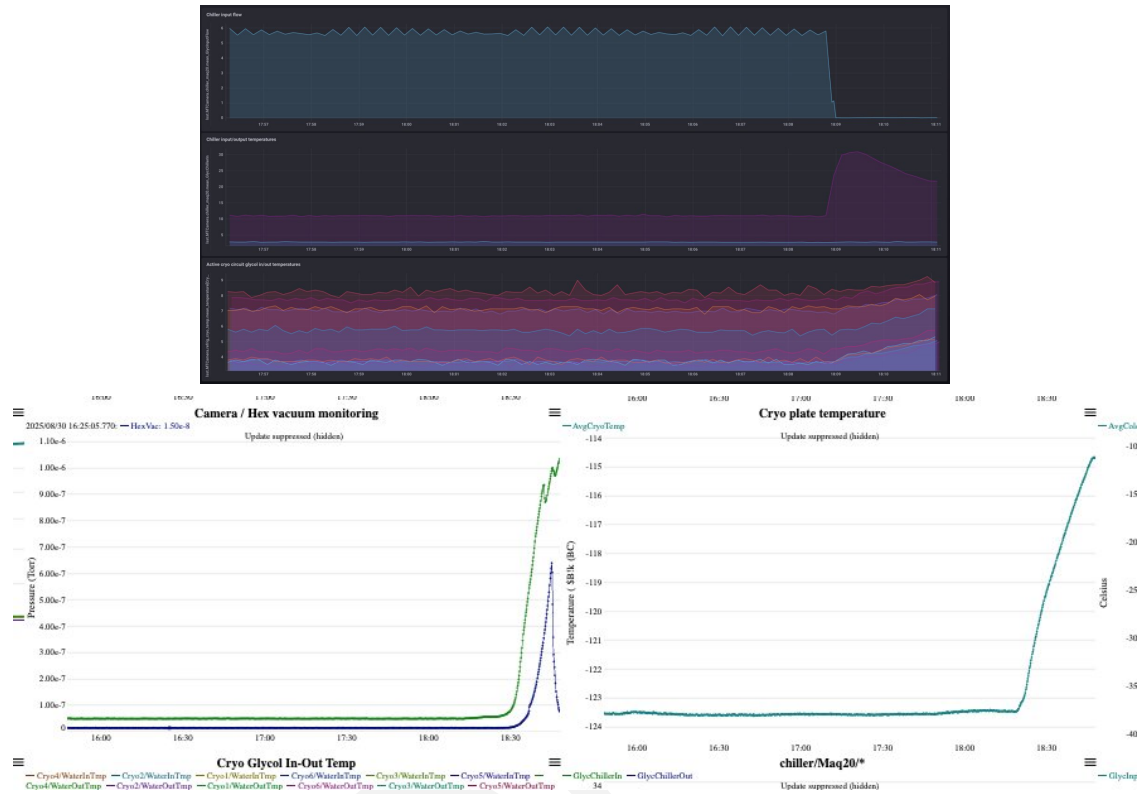
**PWR-01 Site power: grid glitches, generator failure and UPS capacity.** *First to last mention 2025-02-25 to 2025-11-28; status **Open**.* The camera is exposed to the summit's power quality throughout: glitches stick valves closed (FRACAS-282), trip chillers and compressors, and interrupt cooling. The most severe event was August 30, when the generator tripped — its air inlet blocked by ice and snow (FRACAS-299) — and left the camera on UPS alone. The damage was not done by the loss of power to the camera itself but through the cooling chain: the glycol feeding the cryo circuits stopped with the recirculation pumps (GLY-01), the cryo systems were lost, and with them the cryostat pressure began to rise towards the ion-pump shutdown limit, at one point estimated to be about fifteen minutes away. The REBs and REB power supplies were shut down by hand while this was happening; generator power returned first and the pressure recovered. Separately the server-room UPS exhausted its roughly 30-minute battery (FRACAS-300) and the backup diesel generator was found already out of service. UPS batteries were replaced in November; the underlying exposure remains.

FIGURE 10: **PWR-01.** The chain of 30 August, in the order it happened. Top: glycol input flow to the chiller collapsing when the generator trips, and the chiller outlet temperature stepping up as it goes — “No glycol flow to chiller. Tripped.” The cryo circuits go with it. Bottom: the consequence some twenty minutes later — cryostat and heat-exchanger pressure leaving  $10^{-7}$  Torr and rising past  $1.1 \times 10^{-6}$ , with the cryo plate warming from  $-124$  towards  $-113$  °C at about  $0.6$  °C per minute. The ion-pump shutdown limit was estimated to be fifteen minutes away when generator power came back (2025-08-30).

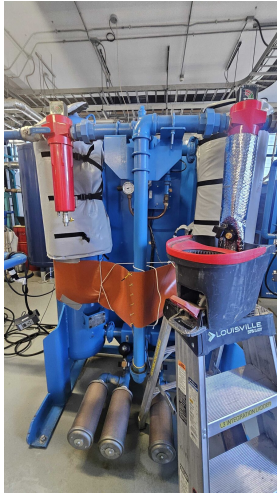
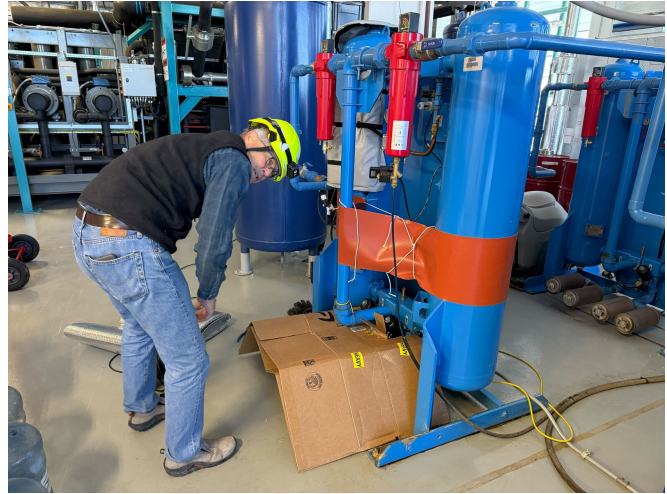
**AIR-01 Compressed dry air supply failures.** *First to last mention 2025-02-27 to 2025-10-08; status **Mitigated**.* Compressed dry air operates the vacuum gate valves and purges the camera body, so its loss is a direct camera concern — including frosting risk on the L3 lens. Supply was cut for two hours for compressor maintenance in February, both Level-1 compressors degraded in August when their dryers froze at  $-8$  °C, and a compressor was lost to a packing-seal failure in October. Insulating jackets on the dryers addressed the freezing mode; single-compressor operation remains a routine condition.

FIGURE 11: **AIR-01.** The compressed-air dryers at Level 1, whose freezing in August stopped the air: the towers with their exhaust and drain lines, and the insulating jacket being fitted (2025-08-23 and 2025-08-26).

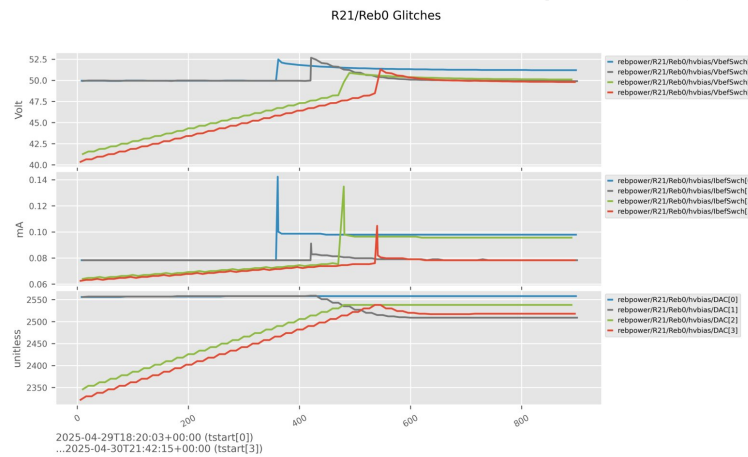
**FP-03 Non-linear HV bias behaviour on R21/Reb0 and R12/Reb0.** *First to last mention 2025-05-05 to 2025-10-25; status **Mitigated**.* R21/Reb0 repeatedly glitched and tripped its HV bias near 50 V, where its DC-DC converter behaves non-linearly, once producing visible tree rings mid-integration. It was set to run permanently at 46 V, and R12/Reb0 later showed similar sensitivity requiring extra care during ramp-up. Managed by lowered setpoints and careful ramping rather than repaired.

FIGURE 12: **FP-03.** The glitches on R21/Reb0: HV bias voltage, current and DAC setting stepping and spiking as the bias is ramped, the behaviour for which the operating point was lowered (2025-05-05, #cam-operator).

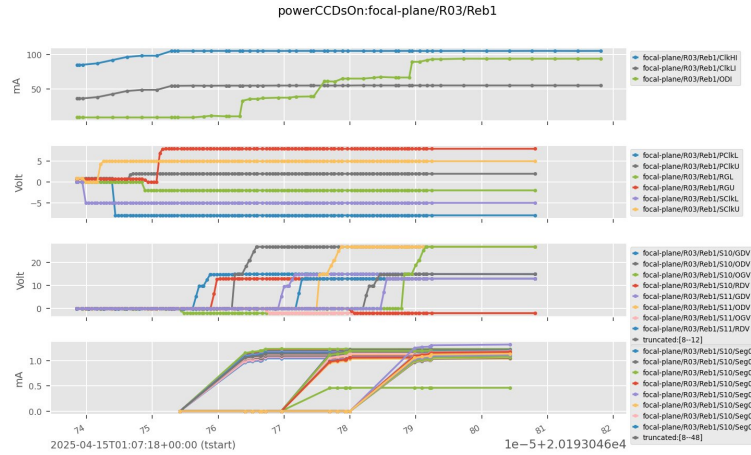
**FP-04 R03/Reb1/S11/Seg00 chronic bad amplifier.** *First to last mention 2025-04-06 to 2025-05-10; status **Workaround**.* A long-standing bad channel described in the logs as having gone “back and forth from working to not, over the last few years”. Its current stayed pinned at 0.5 mA through repeated power cycles in April and May, and the neighbouring Amp16 also failed to return once. The channel cannot be repaired in place; since the impact of a single amplifier is small, the decision is not to repair it and to continue operating with it as it is.

FIGURE 13: **FP-04.** R03/Reb1 being powered on, 15 April. In the bottom panel every segment current rises to about 1.2 mA except one, which stays flat: S11/Seg00, the channel that has gone back and forth for years and did not come back this time either (2025-04-15, #cam-operator).

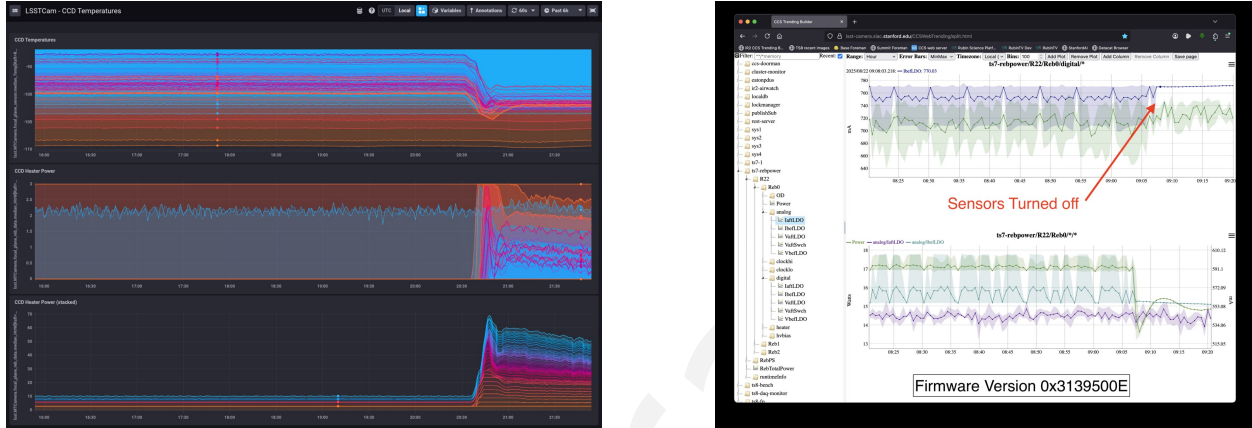
the CCDs run measurably warmer, which was initially misread as lost cryo capacity during the storm. Power-cycling the focal plane and rolling the firmware back confirmed a real power-draw increase of roughly 30 W, and the cause was a register-map conflict in 0x313a5013 that applied maximum heater power — a defect introduced together with the sequencer-override register in 0x31395011 and unnoticed until then. It was fixed by the firmware upgrade to 0x313a5014. See the version history in Table 10.

FIGURE 14: **FW-01.** Left: CCD temperatures and CCD heater power across the firmware roll-back, the step in heater power being the extra draw the faulty build was applying (2025-08-21). Right: the same measurement annotated during the investigation, with the moment the sensors were turned off marked and the firmware version under test named (2025-08-22).

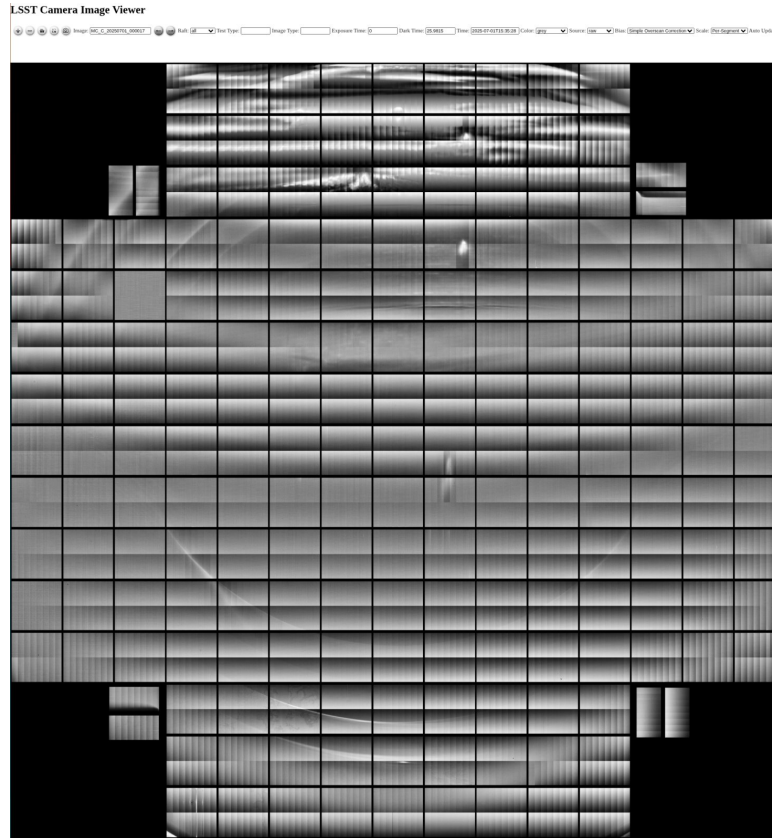
**CCS-02 Idle clear: from guider clearing noise to default operation.** *First to last mention 2025-04-16 to 2025-07-04; status **Resolved**.* Guider idle-clearing was found in April to inject noise into neighbouring sensors during bias readout, making early bias images unusable and producing stripes in wavefront images (LSSTCCSRAFTS-778). The proper fix — a non-guider idle-clear scheme — arrived with CCS 41.0.4 in late June, needed two further locking fixes (skipped invocations piling up, and a sequencer-reload race that showed up as a runaway clock current on R30/Reb2), and was declared operational on June 30. Idle clear has been the default for all on-sky observations since early July, replacing continuous all-day biases.

FIGURE 21: **CCS-02.** A bias exposure with the guider running: the structure across the upper rafts is the artefact that idle clear was introduced to remove (2025-07-01).

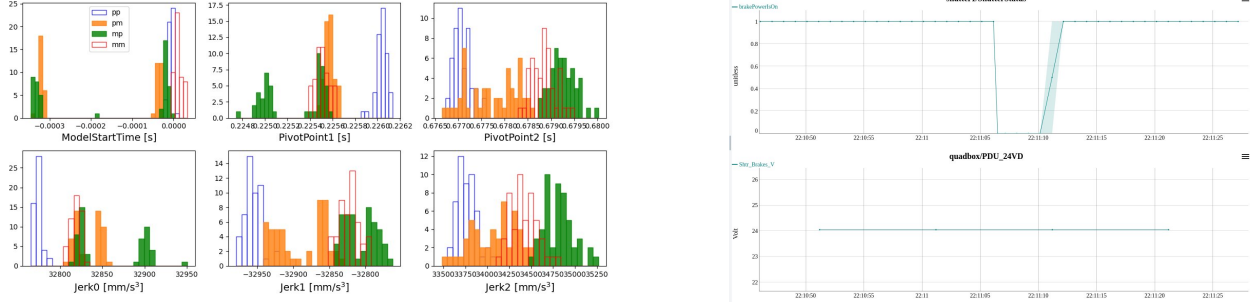
FIGURE 27: **SHT-01**. Left: the shutter motion-profile study of March, fitting model start time, pivot points and jerk for each blade and comparing them with the 2022 reference set (2025-03-24). Right: shutter status and the quadbox 24V supply across one of the stuck-shutter events (2025-04-23).

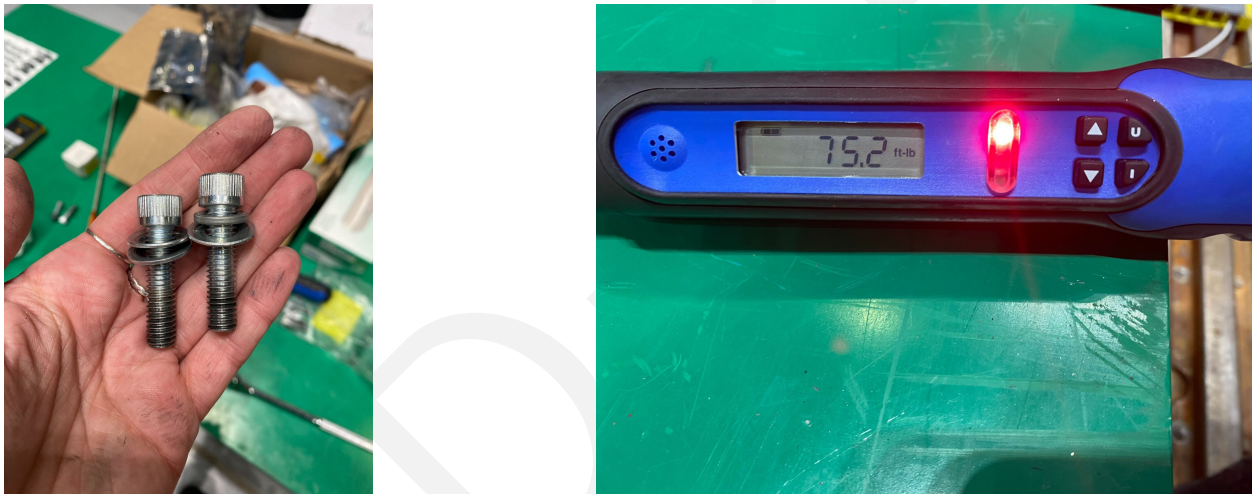
FIGURE 32: **MEC-01.** Two of the sheared 3/8-16 socket-head bolts recovered from the cable wrap, and the bolt test that followed a few days later: 75.2 ft-lb applied with no sign of failure (2025-01-30, #cam-summit-ops).

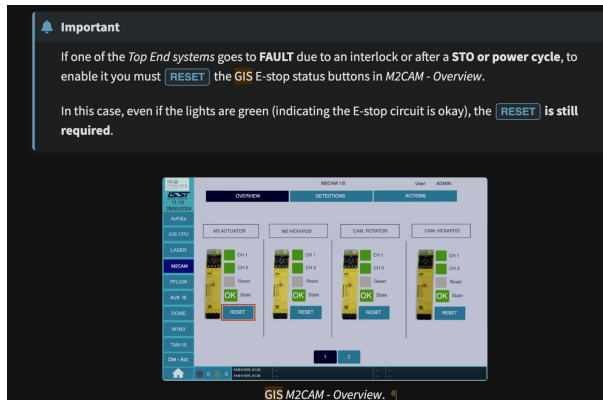
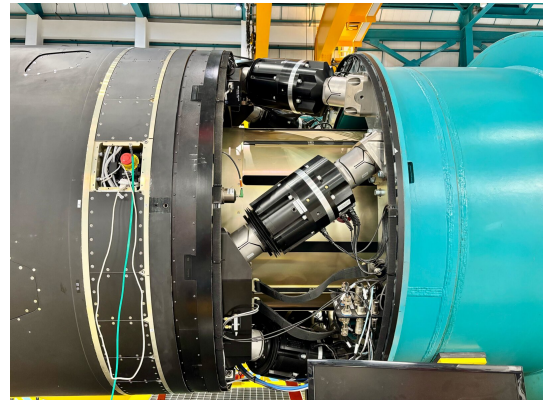
FIGURE 33: **MEC-02.** Left: the operating note for the interlock, which has to be reset from the mount engineering interface after a fault or power cycle even when the status lights are green (2025-09-23). Right: the camera rotator and cable-wrap region on the Top End Assembly (2025-03-03).

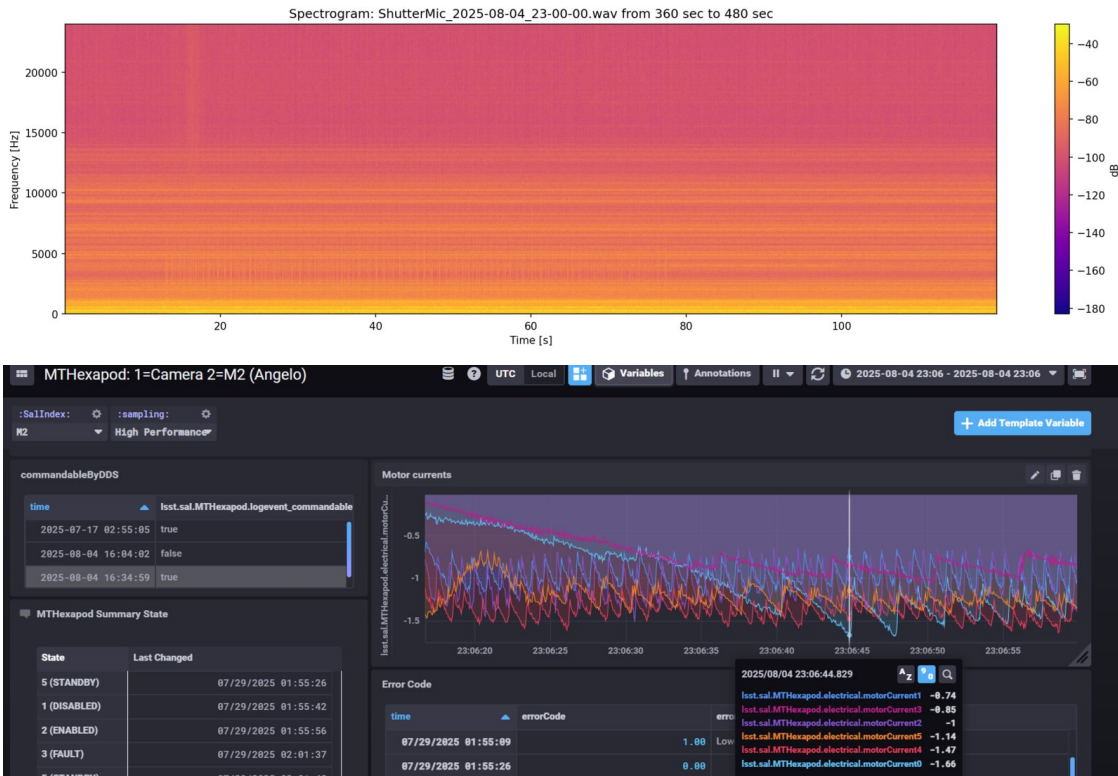
FIGURE 34: **MEC-03.** The August analysis. Top: spectrogram of the shutter microphone recording of 2025-08-04, with the click visible as a vertical line across the band at about 18 s into the excerpt. Bottom: M2-hexapod telemetry for the same minute — the hexapod is holding position, not moving, while its six actuator currents oscillate in the zigzag pattern that first made it the suspect (2025-08-05, #cam-operator). The September recurrence, which ruled out the safety-barrier explanation, is not illustrated here: the camera hexapod was the one moving then.

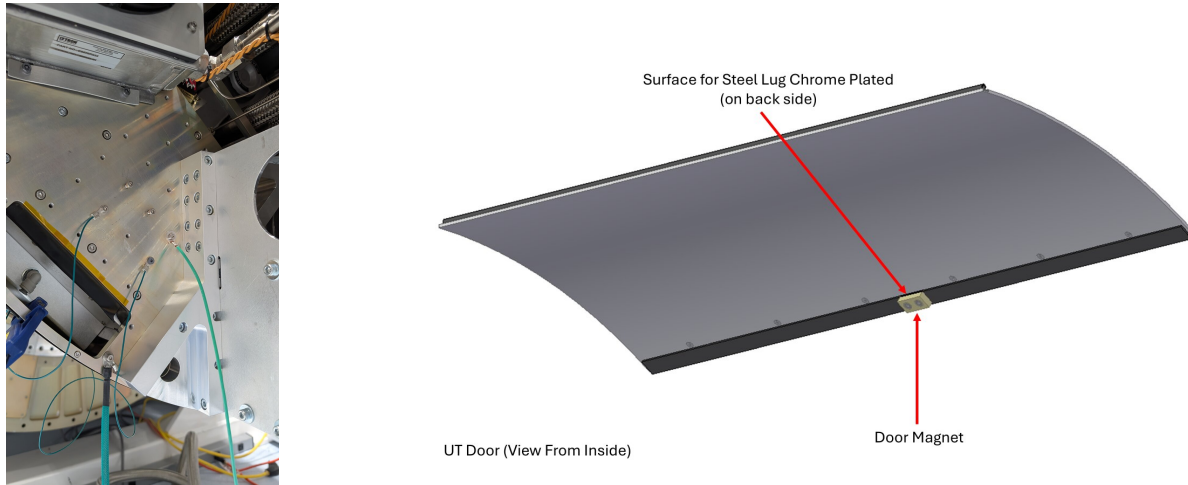
**FP-06 REB power-supply trips suspected to be electrostatic discharge.** *First to last mention 2025-01-21 to 2025-04-29; status **Open**.* Recalled in January: in September 2024 there had been one or two REB power-supply trips that seemed to correlate with people touching or standing near the utility trunk, which is what put the camera-door grounding question (MEC-04) on the agenda in the first place. A concrete case followed on April 29, when R21/Reb0 tripped during carbon-snow cleaning of M2 with no light-leak explanation and was tentatively attributed to an electrostatic discharge. The investigation is tracked in the dedicated channel #cam-issues-esd. The door interface a permanent strap has to use is shown in Figure 35.

FIGURE 35: **MEC-04.** Left: one of the temporary grounding wires used in the clean room, which had to come off before the utility-trunk skins were installed (2025-01-21). Right: the utility-trunk door seen from inside, with the chrome-plated lug surface and the door magnet marked — the interface a permanent grounding strap has to use (2025-01-21).

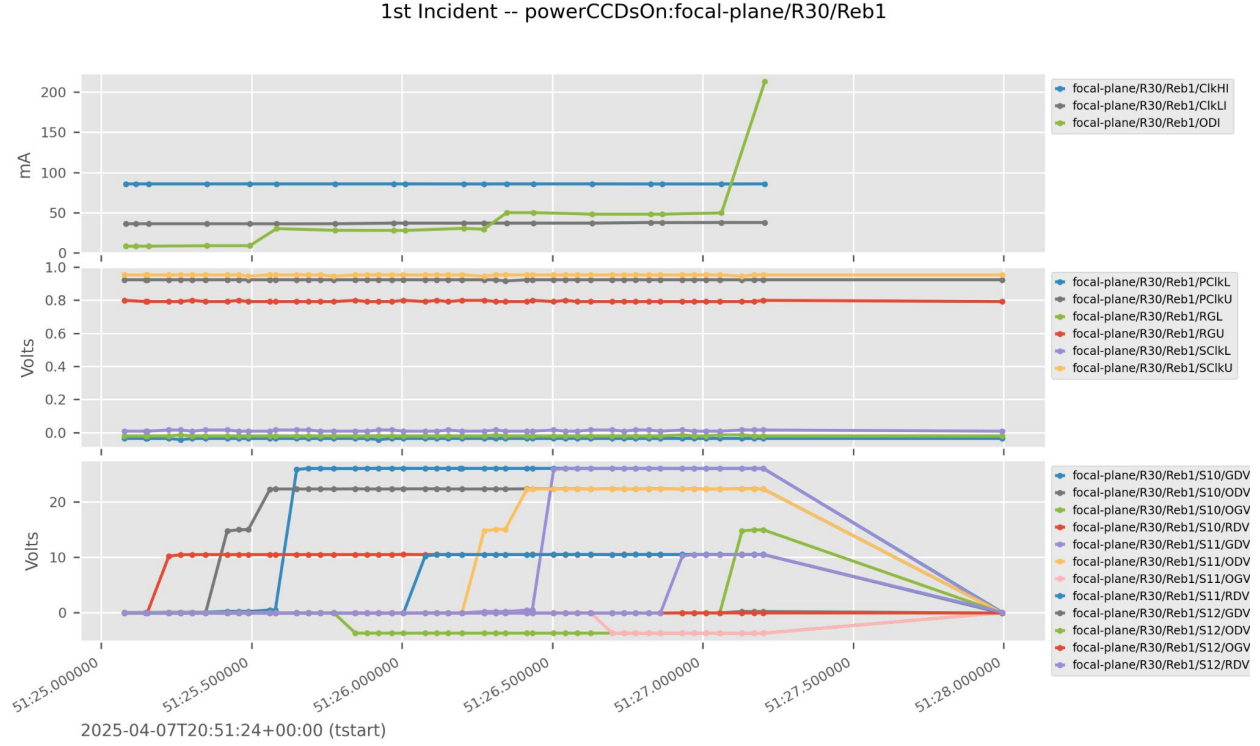
FIGURE 39: Trending of the first power-on attempt (Marshall, 2025b). Top: the REB parent currents, with ODI (green) leaving its baseline as the bias sequence proceeds and reaching 213 mA. Middle: the clock rails. Bottom: the CCD bias voltages; the last trace to rise, to  $\approx 15$  V, is the OD of S12, and all biases return to zero at 51:28 when the protection has fired and powerCCDsOff runs.

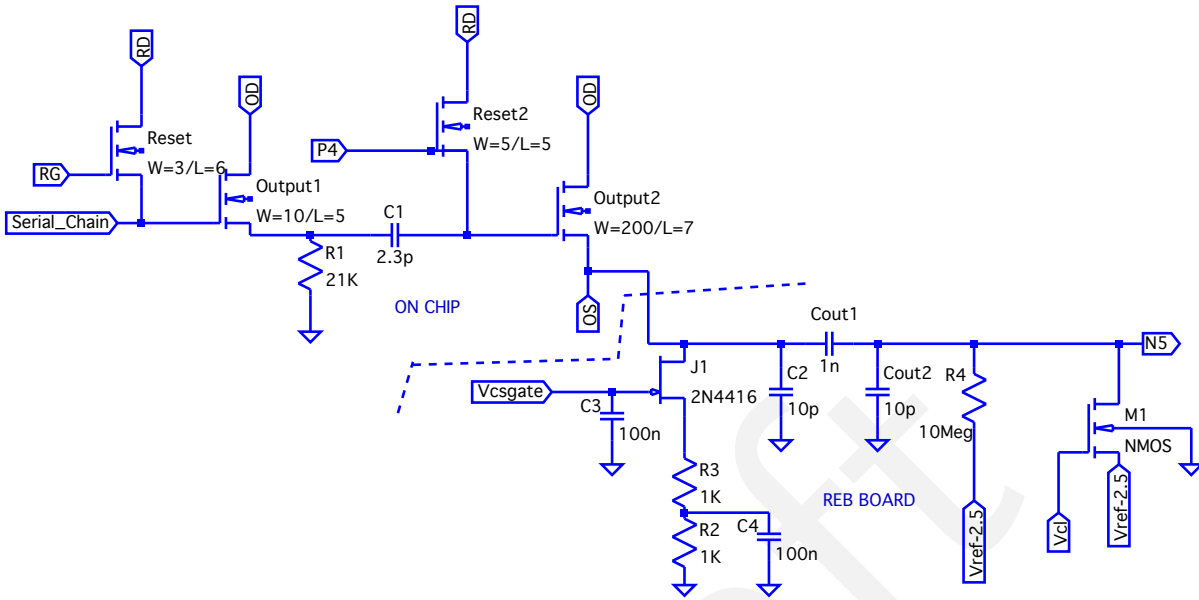
FIGURE 40: The e2v output stage and the first stage of the REB circuit, drawn by C. Lage (Lage, 2025). The two on-chip source followers (*Output1*, *Output2*) are coupled through *C1*, with the clamp *Reset 2* on that node driven by *P4*; *Output2* drives the *OS* pin into the current source *J1* on the REB, whose return to ground through *R3* and *R2* carries the per-segment current monitor. The suspected short is from the *OS* node to ground.

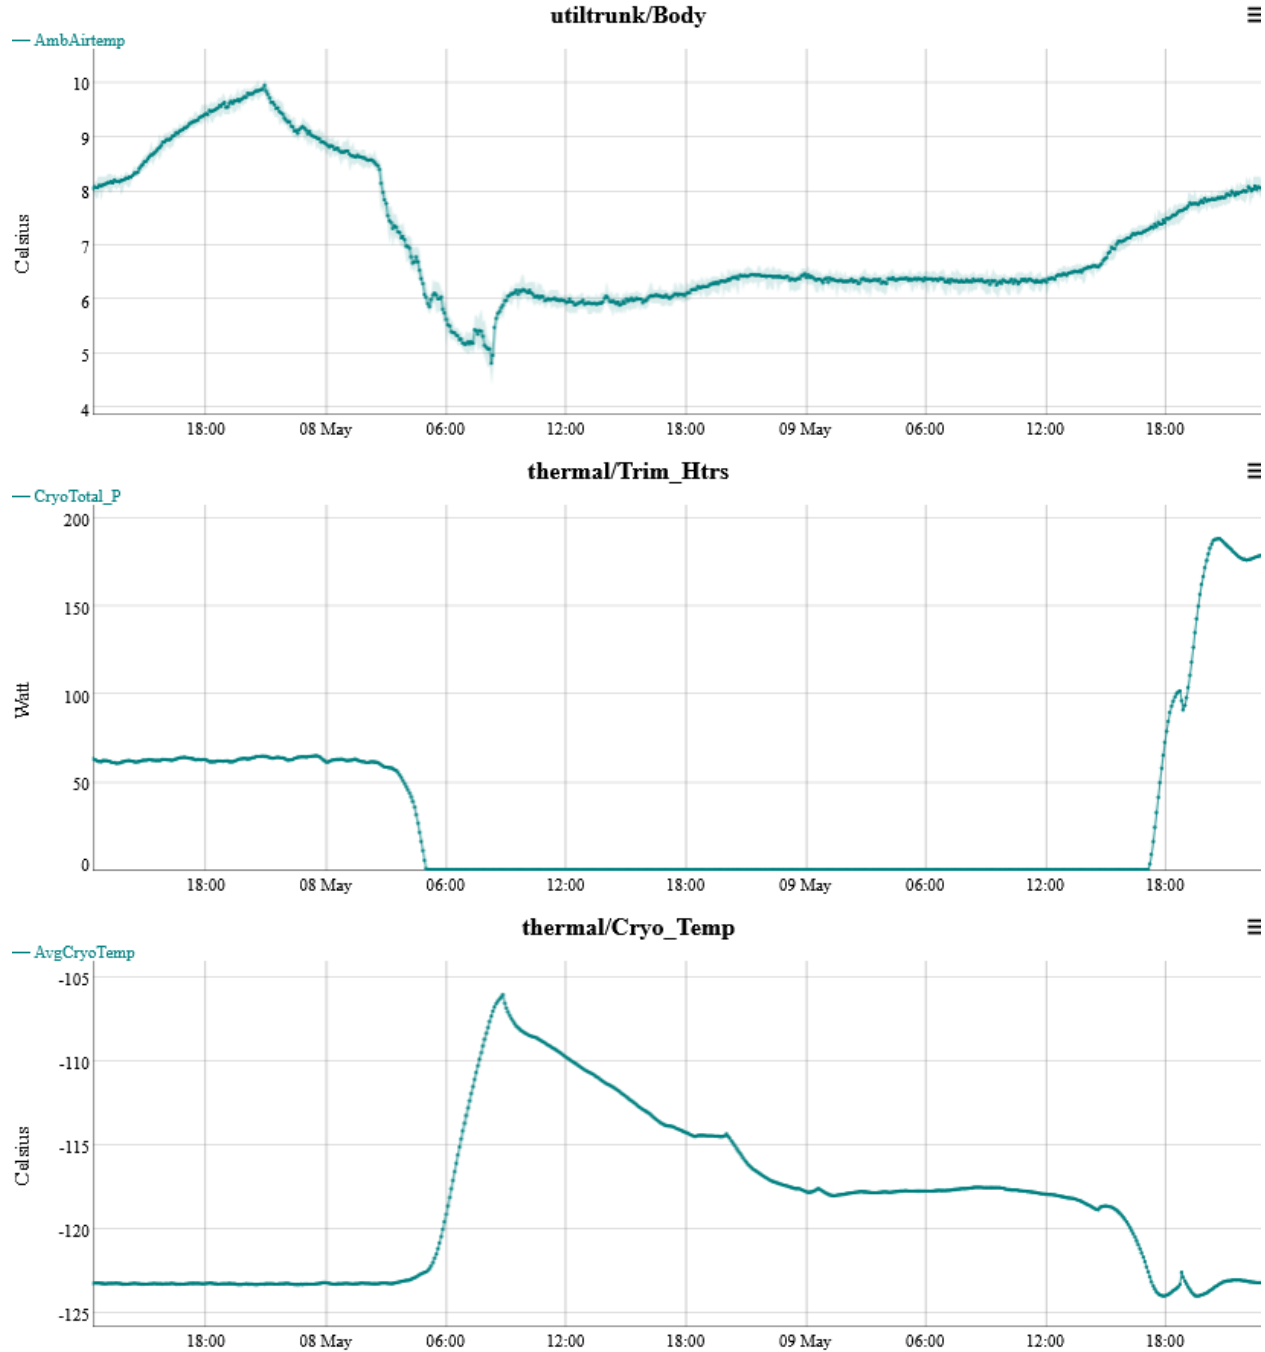
FIGURE 47: Ambient temperature, Cryo trimheat and cryoplate temperature at around 6 am UTC on May 8, 2025

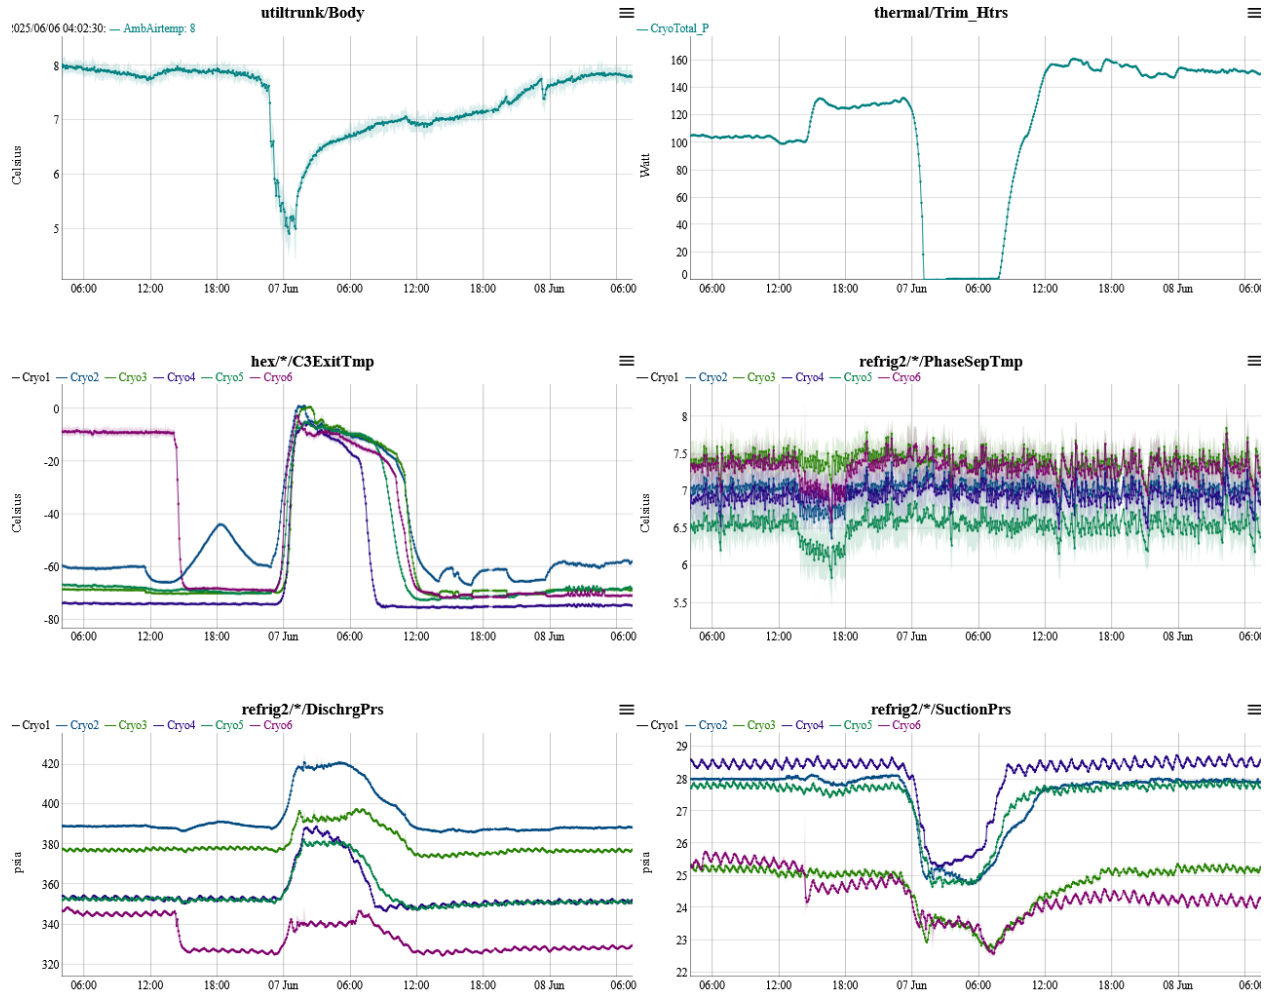
FIGURE 51: Cryo system loss cooling capacity due to low ambient temperature on June 6/June 7 in 2025

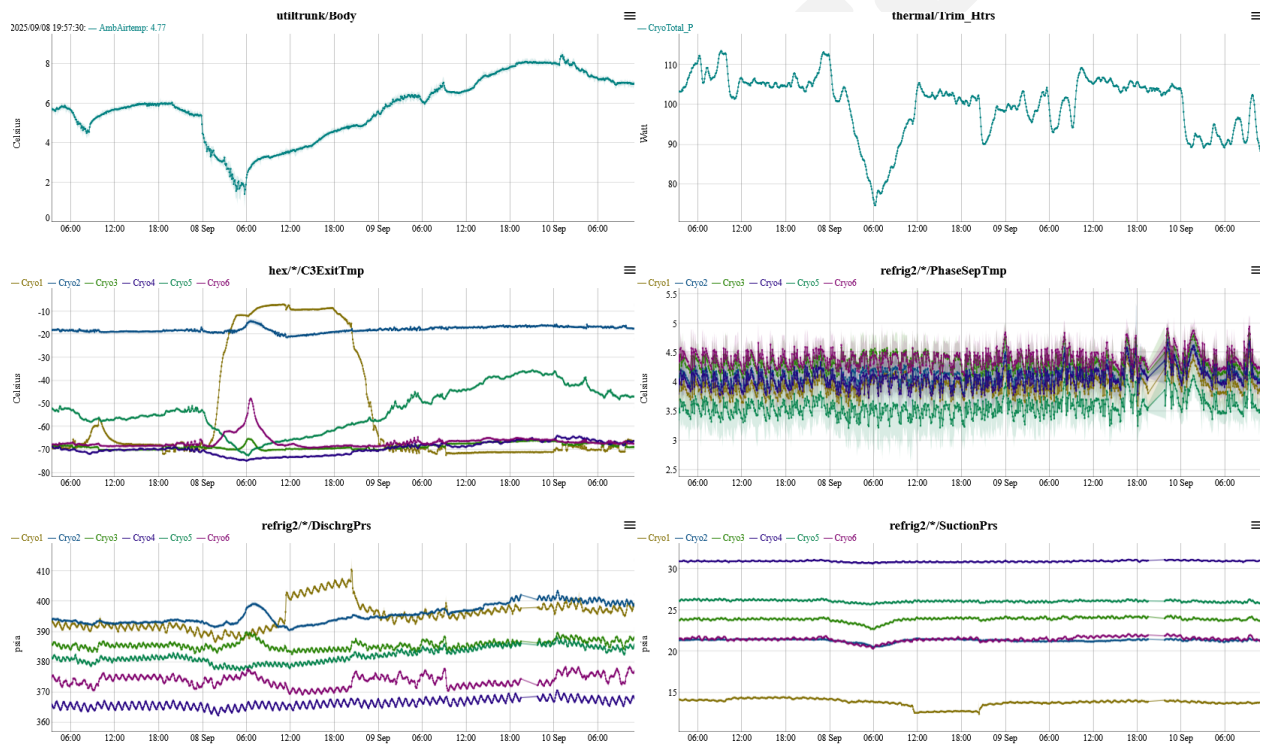
FIGURE 52: Cryo system behavior when ambient temperature reduced to 0.75 C on September 8, 2025
