# The LSST Camera commissioning

CTN-007

This technote describes what we found during the LSST Camera commissioning.

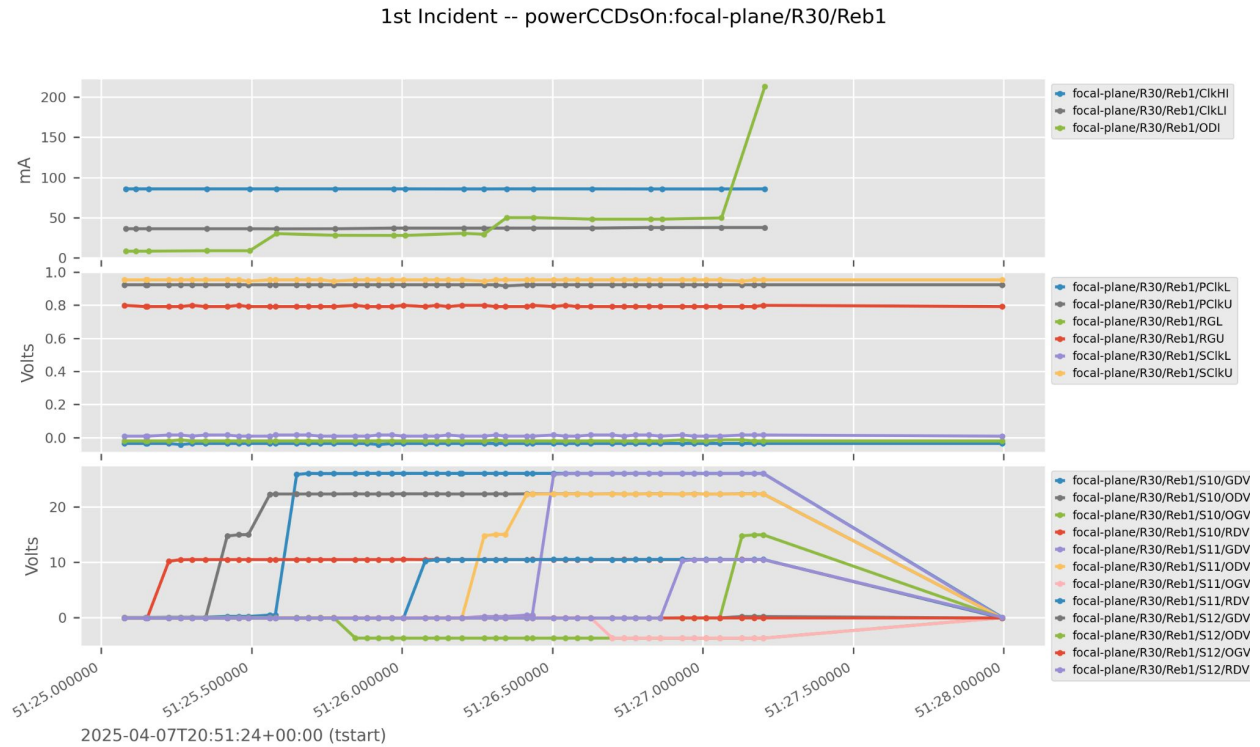
followed by `powerCCDsOn()` FAILED for R30/Reb1 and, 0.8 s later, an automatic `powerCCDsOff()`. In each case the DAC was set back to zero immediately, returning OD to 0 V within 100–140 ms of the step. Bias voltages are read every 5.3 ms and the parent currents every 33 ms, so each trip is documented by only a few samples and the voltage at which the current peaked is loosely constrained.

FIGURE 4: Trending of the first power-on attempt (Marshall, 2025b). Top: the REB parent currents, with ODI (green) leaving its baseline as the bias sequence proceeds and reaching 213 mA. Middle: the clock rails. Bottom: the CCD bias voltages; the last trace to rise, to  $\approx 15$  V, is the OD of S12, and all biases return to zero at 51:28 when the protection has fired and `powerCCDsOff` runs.

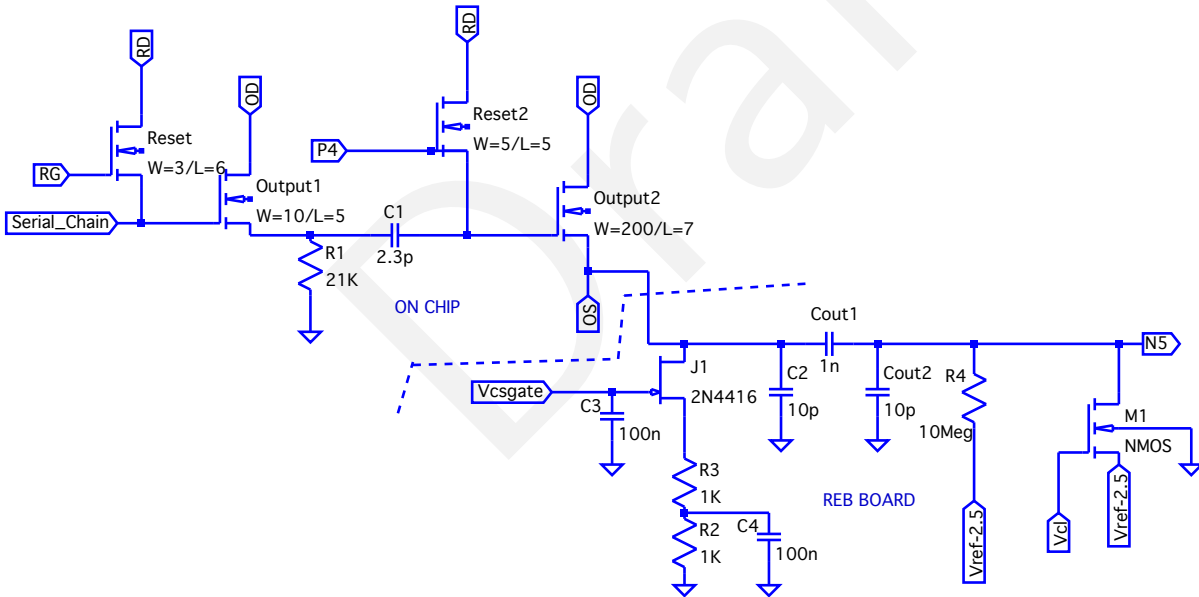
FIGURE 5: The e2v output stage and the first stage of the REB circuit, drawn by C. Lage (Lage, 2025). The two on-chip source followers (*Output1*, *Output2*) are coupled through  $C1$ , with the clamp *Reset 2* on that node driven by  $P4$ ; *Output2* drives the OS pin into the current source  $J1$  on the REB, whose return to ground through  $R3$  and  $R2$  carries the per-segment current monitor. The suspected short is from the OS node to ground.

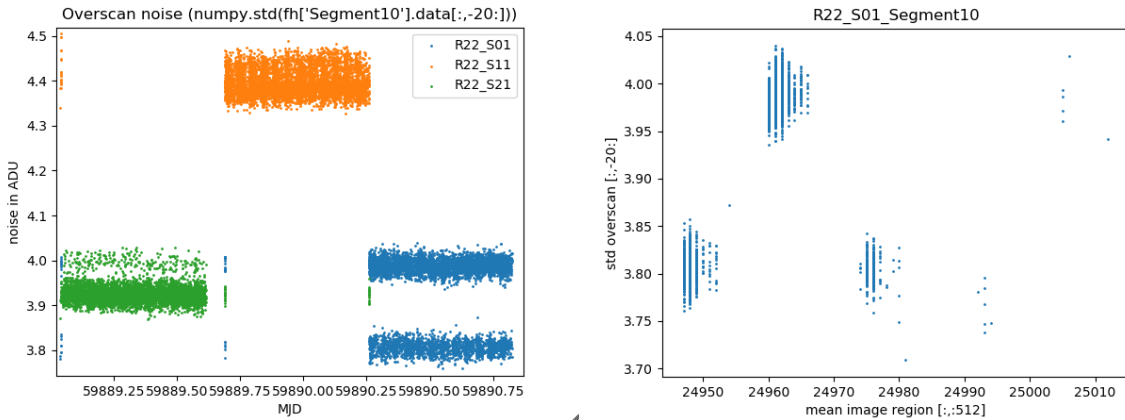
FIGURE 26: Bias multimodality before the natural frequency firmware. Left: overscan noise as a function of time for three sensors of raft R22, showing discrete bands rather than a continuous distribution. Right: overscan noise versus mean image level for R22\_S01, segment 10, where the same behaviour appears as separate clusters.

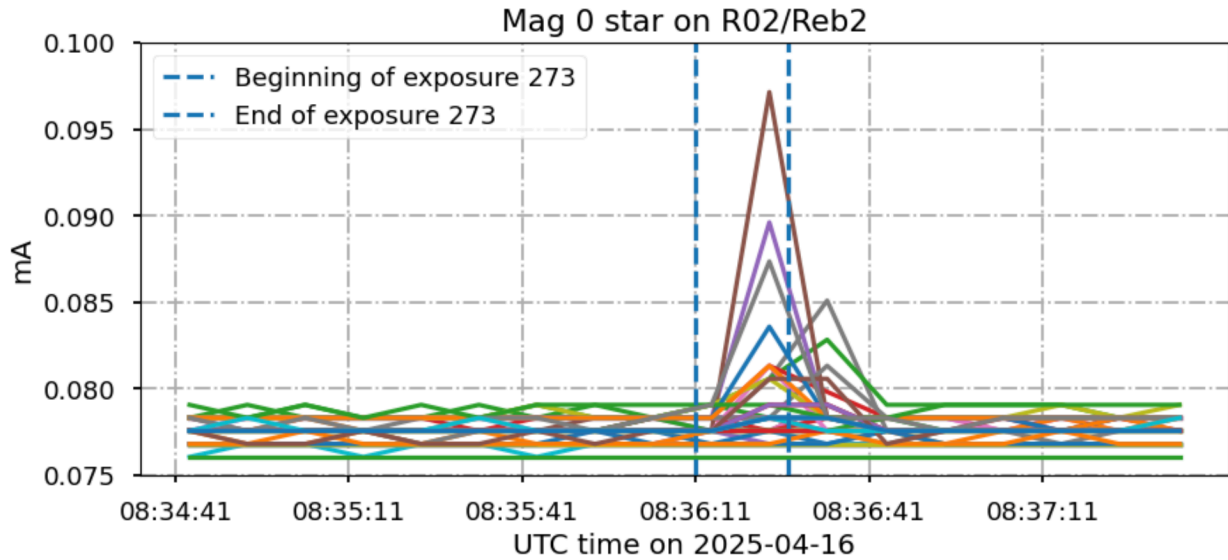
FIGURE 51: The largest bias current excursion observed during the bright star test. The vertical dashed lines indicate the start and end of the exposure. The solid lines indicate the measured current on each REB.
