Vera C. Rubin Observatory  
Rubin Observatory Operations

# The LSST Camera commissioning

CTN-007

This technote describes what we found during the LSST Camera commissioning.

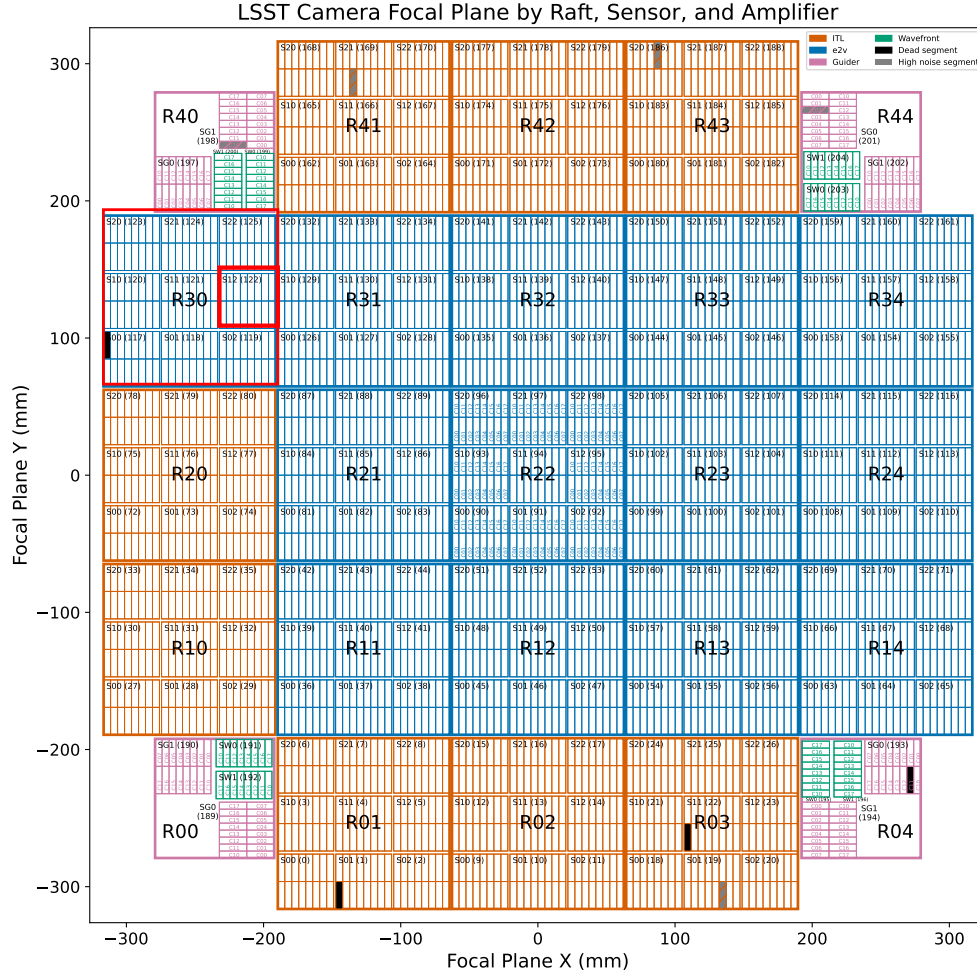
FIGURE 2: LSSTCam focal plane layout, after Plazas Malagón et al. (CTN-001, Fig. 1). The large red box marks R30 = RTM-012 and the small box indicates the sensor S12.

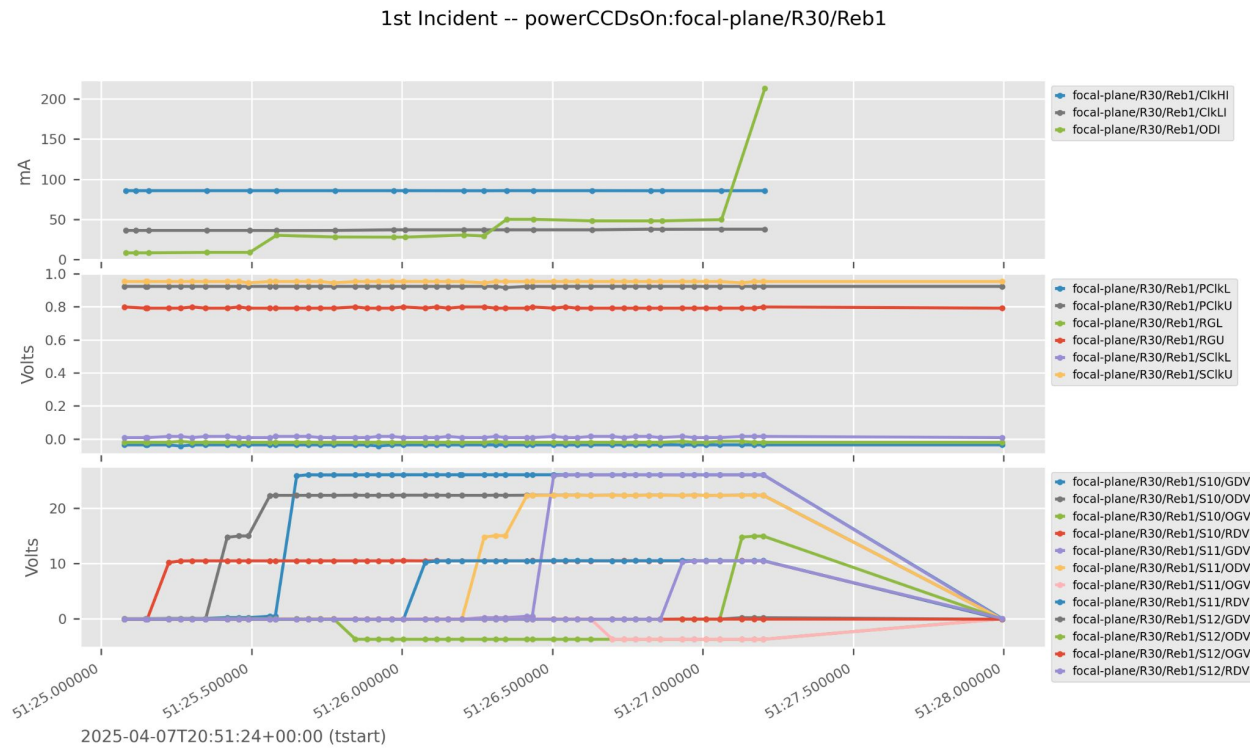
Taking the excess current of the two April events to flow through a resistive path,  $R_{\text{short}} = V/\Delta I$  gives 125 and 208  $\Omega$  (Marshall, 2025b). Each April trip is accompanied by a rise of the cryostat pressure from  $1.31 \times 10^{-7}$  to  $1.47 \times 10^{-7}$  Torr, decaying over a few minutes, and by a  $\sim 0.25$  °C

FIGURE 4: Trending of the first power-on attempt (Marshall, 2025b). Top: the REB parent currents, with ODI (green) leaving its baseline as the bias sequence proceeds and reaching 213 mA. Middle: the clock rails. Bottom: the CCD bias voltages; the last trace to rise, to  $\approx 15$  V, is the OD of S12, and all biases return to zero at 51:28 when the protection has fired and powerCCDsOff runs.

excursion of focal-plane/R30/Reb1/Temp9, indicating localised power dissipation at the fault site.

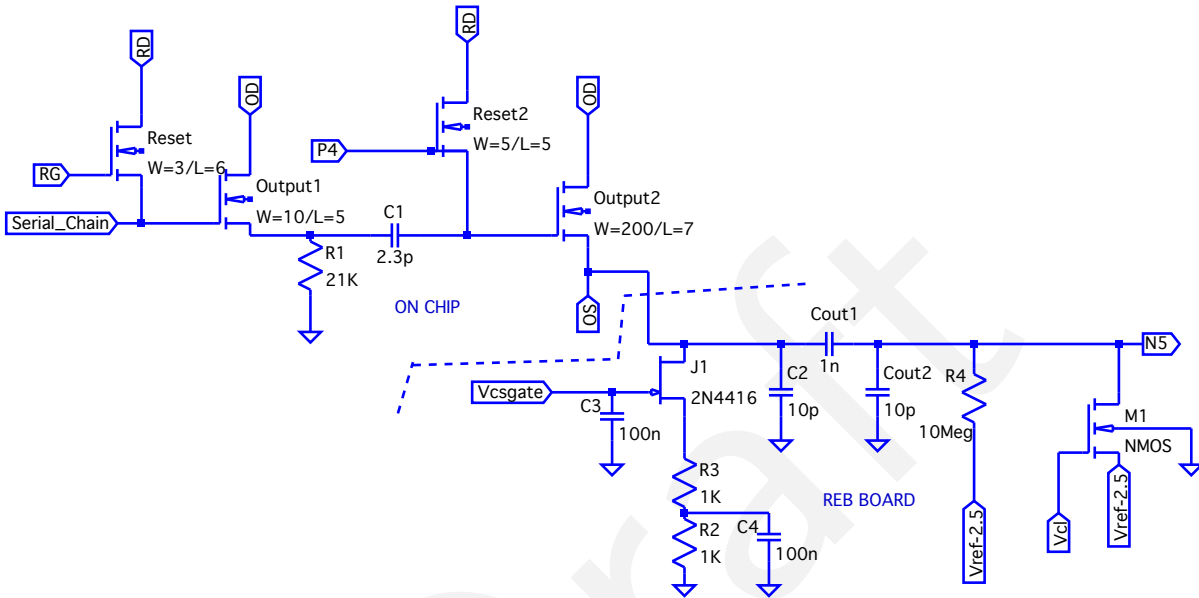
FIGURE 5: The e2v output stage and the first stage of the REB circuit, drawn by C. Lage (Lage, 2025). The two on-chip source followers (*Output1*, *Output2*) are coupled through *C1*, with the clamp *Reset 2* on that node driven by *P4*; *Output2* drives the OS pin into the current source *J1* on the REB, whose return to ground through *R3* and *R2* carries the per-segment current monitor. The suspected short is from the OS node to ground.
