Vera C. Rubin Observatory  
Rubin Observatory Operations

## The LSST Camera commissioning

CTN-007

This technote describes what we found during the LSST Camera commissioning.

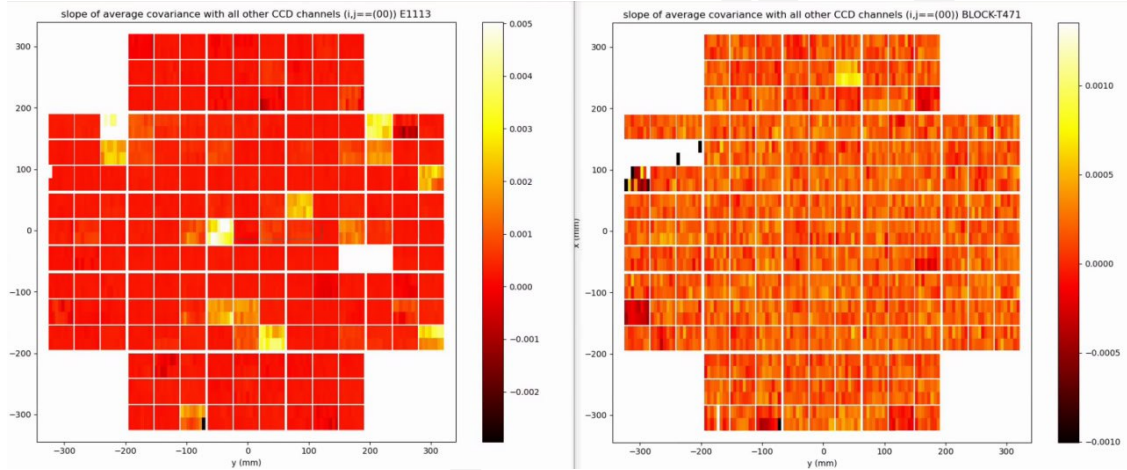
The measurement of brighter-fatter coefficients reported in LSST Camera Team et al. (SITCOMTN-148) had already shown an anomalously high value of the  $a_{00}$  coefficient for one specific e2v

sensor: R23\_S02 (see Figure 34 in that note). This measurement is derived from fits over the variance and spatial covariance curves versus the flux. The curves for the channels in that particular sensor were in fact affected by an excess of variance, which affected not only the noise measurement in bias frames, but also introduced an extra flux-dependent component in the variance. This degraded the gain measurements from the PTC (using  $C_{00}/\mu$ ). This issue also manifested as a flux-dependent covariance between amplifiers in the same sensor, and as an excess in the correlation with the next pixel in the serial direction ( $a_{10}$ ). One way to detect this issue in a systematic manner is to compute the slopes of the covariances between channels versus the flux, and average them over all channels in the sensor (as done in Figure 59). Using this metric, other sensors were found to exhibit a similar issue, but to a smaller degree (same Figure, left plot). Other related metrics (noise correlation between channels, correlations between channels) also pointed to the same sensors.

FIGURE 59: Averages of the slopes of the covariances between channels, for each sensor. Left: during test Run 7. Right: on sky, with the modified ‘RGn20’ readout sequence.

We then tested a series of modifications to the timing of the readout sequence. In a sensor that did not exhibit the extra covariance with the nominal timing, we were able to induce it by triggering the S2 clock drop 10 ns before the RG drop. Conversely, tests on sensors that exhibited the issue showed that delaying the S2 drop by an increment of 10 or 20 ns after the RG drop removed the issue (Figure 59, on the right). A 20 ns delay was selected as the safer option, and added to the e2v readout sequence (tagged as v30\_RGn20, then adopted as v31). A similar modification was tested on ITL sensors, which had no effect on sensors that exhibited correlated noise.

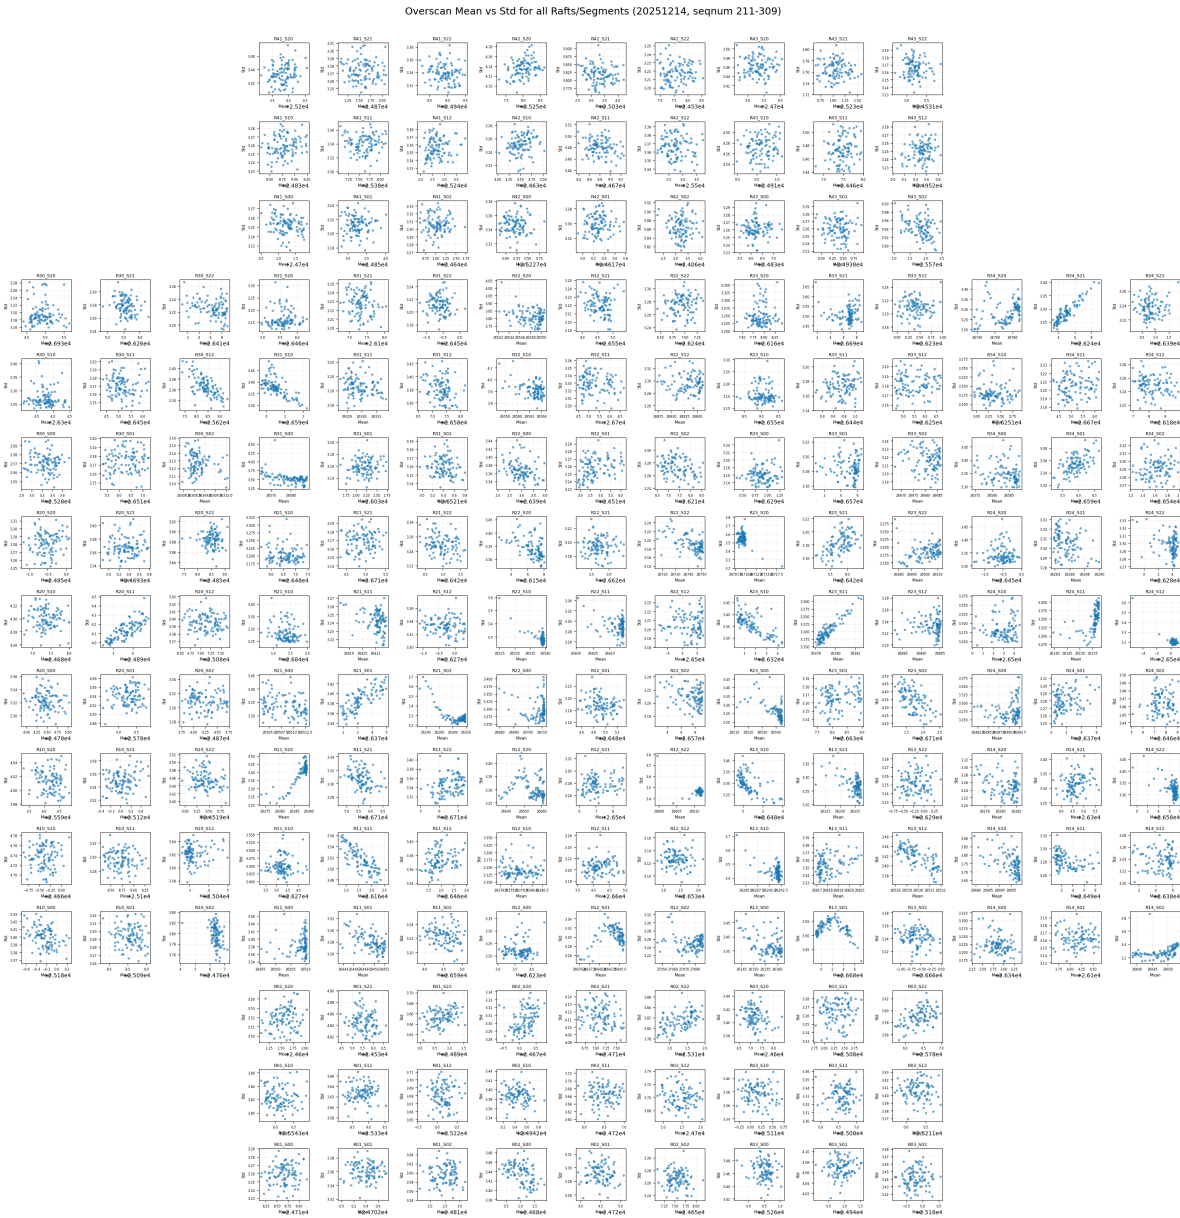
**3.1.3.3 Bias level versus noise.** Plotting the overscan noise against the overscan mean for one amplifier per sensor over the whole focal plane (Figure 65) no longer shows multiple distinct populations. The residual systematic drift within each sensor is consistent with gain and temperature changes over the duration of the acquisition rather than with discrete state changes.

FIGURE 65: Overscan mean versus overscan standard deviation for all rafts and sensors (20251214, sequence numbers 211–309), one amplifier per sensor. The distinct populations seen before the firmware change (Figure 61) are absent.

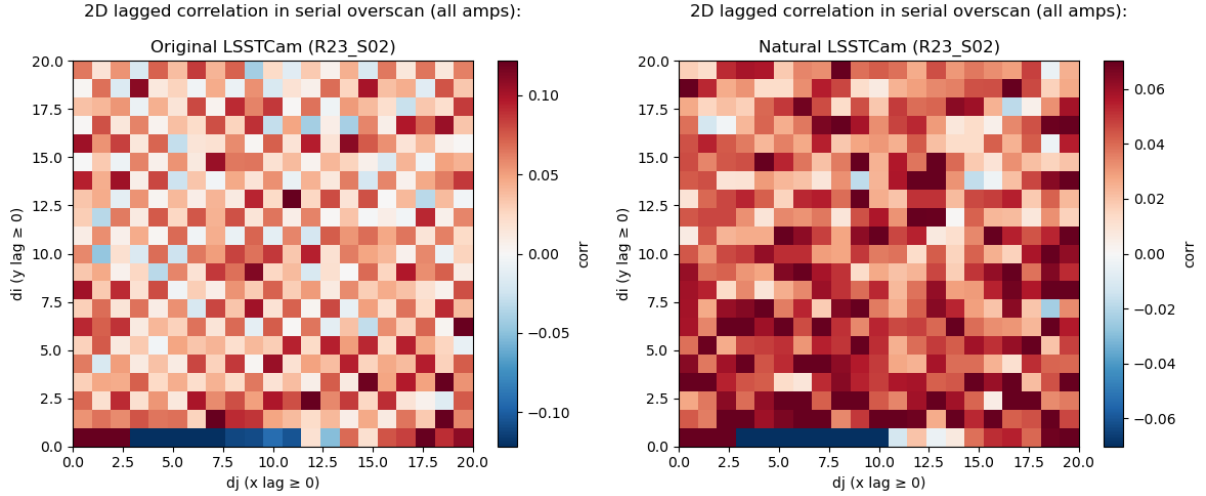
**3.1.3.7 Checkerboard in the overscan.** The two-dimensional lagged correlation of the serial overscan, averaged over all amplifiers of R23\_S02, is shown in Figure 70 for the original and for the natural frequency configuration. The checkerboard pattern is gone in the latter.

FIGURE 70: Two-dimensional lagged correlation in the serial overscan, all amplifiers of R23\_S02. Left: original configuration (20251216, sequence number 366). Right: natural frequency configuration (20251214, sequence number 211).
