Vera C. Rubin Observatory  
Rubin Observatory Operations

## The LSST Camera commissioning

CTN-007

This technote describes what we found during the LSST Camera commissioning.

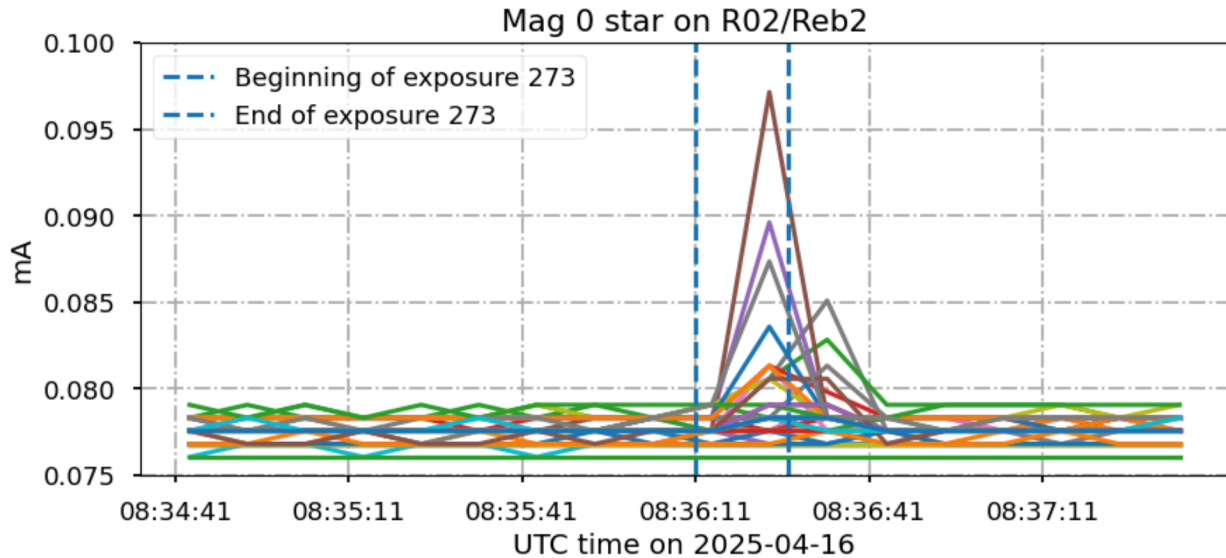
Across all examined exposures, stellar magnitudes, and REBs, the bias-current telemetry remains within the acceptable safety limit of 120 mA. No current excursions above 97mA are observed (see Figure 86). No discontinuities, or systematic trends were observed during or after the bright-star exposures. This holds across the entire set of rafts tested, indicating that bright stars does not pose a risk to REBs that have shown previous sensitivity to high flux.

FIGURE 86: The largest bias current excursion observed during the bright star test. The vertical dashed lines indicate the start and end of the exposure. The solid lines indicate the measured current on each REB.

Telemetry inspection shows that any small-scale fluctuations in the currents are comparable to those seen outside of the exposure windows and are consistent with nominal electronic noise rather than illumination-induced effects.
