# The LSST Camera commissioning

CTN-007

This technote describes what we found during the LSST Camera commissioning.

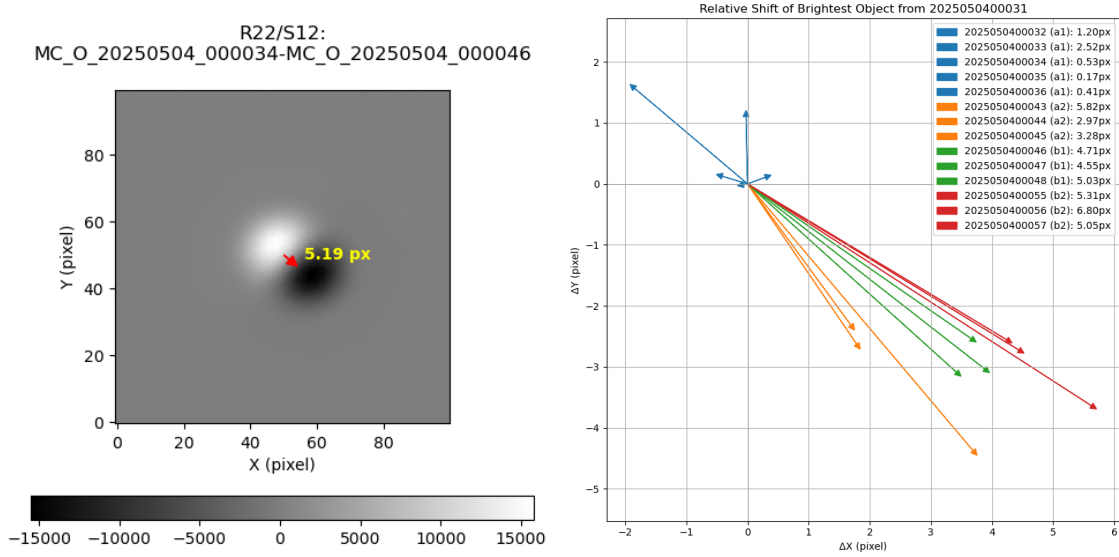
FIGURE 52: Caption

The left-hand panel of Figure 52 shows a difference image between the first exposure before the filter change and the fourth exposure after the filter change, revealing small but systematic shifts in the pinhole positions. The right-hand panel displays the measured positional offsets relative to the first exposure for images that are taken when the rotator angle was  $0^\circ$ . Scatter within a single condition (e.g., all points from a1) is on the order of a few pixels, indicating that the CBP itself is stable but non-negligible motion could be present.

Systematic offsets are evident when comparing conditions: the average shift between a1 and b1 is  $\approx 2$  px in X and  $\approx 3$ –4 px in Y. The four distinct groups (a1, a2, b1, b2) are distributed rea-
