# The LSST Camera commissioning

CTN-007

This technote describes what we found during the LSST Camera commissioning.

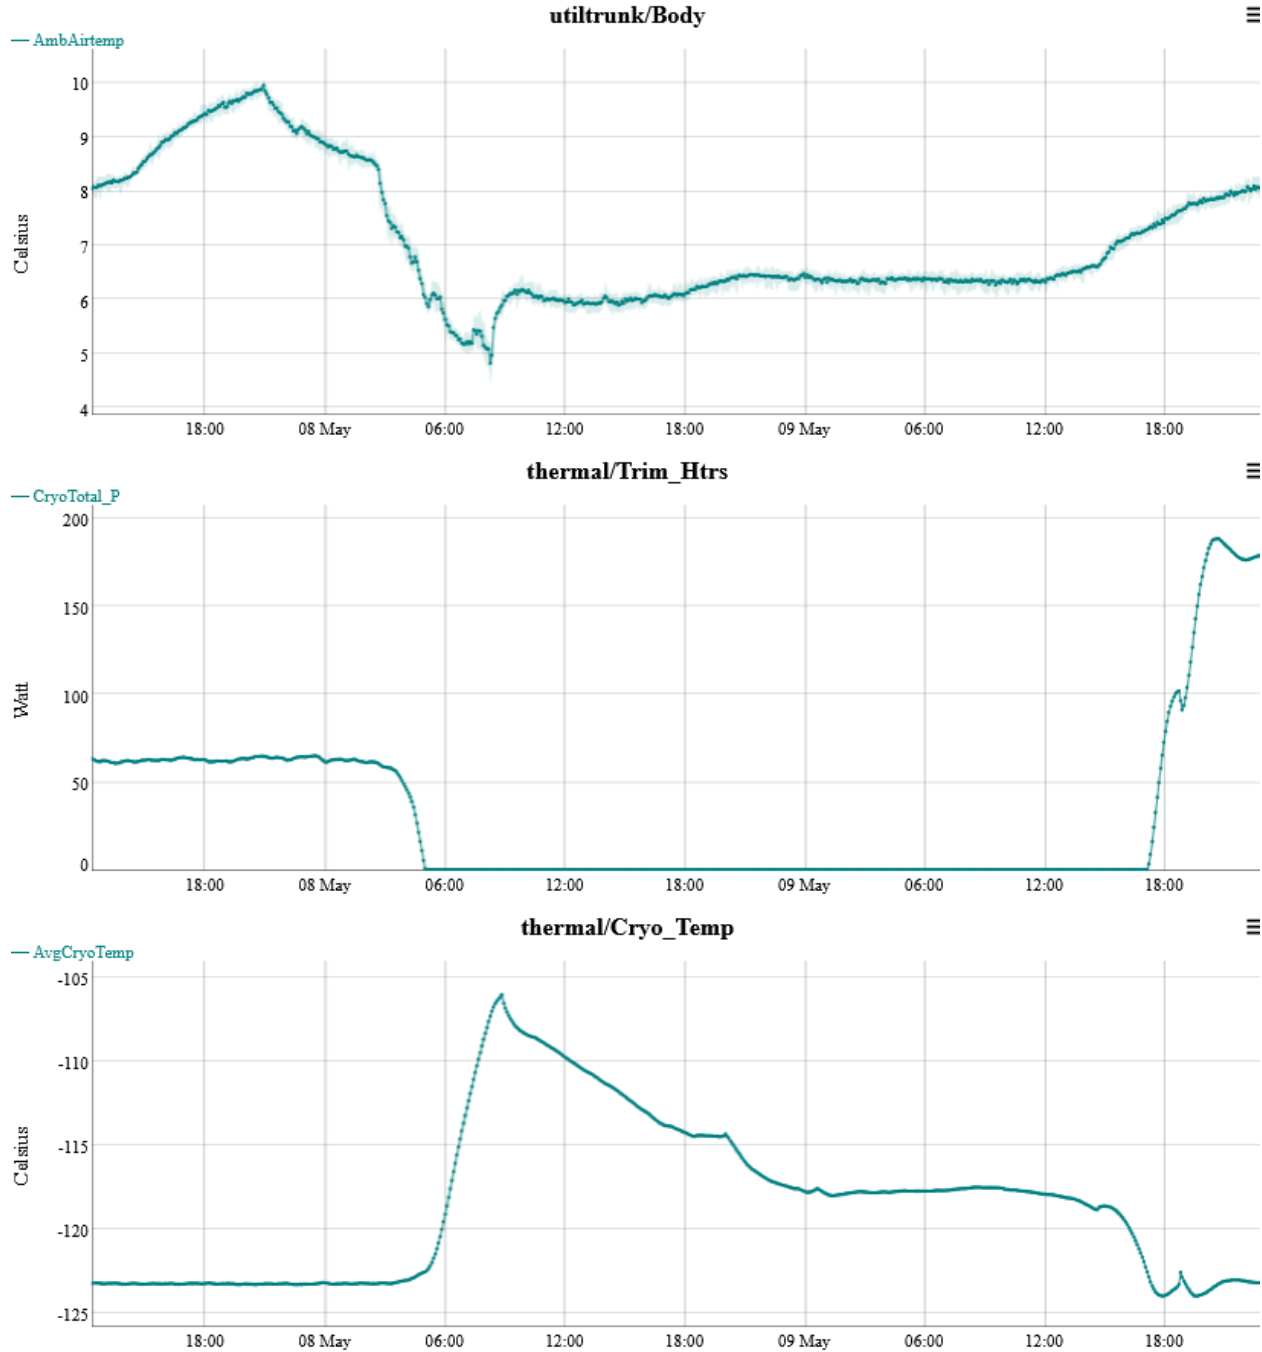
The first instance of the Cryo ambient temperature sensitivity issue occurred on May 8, 2025. The camera ambient temperature was below 7 C and reached 4.43 C at 8:18:39 UTC. The Cryo trim reduced to zero and the cryoplate temperature warmed up, as shown in Figure 12

FIGURE 12: Ambient temperature, Cryo trimheat and cryoplate temperature at around 6 am UTC on May 8, 2025

We have lowered the glycol/water temperature from 7 C to 4 C. This has reduced the phase separator temperature from 7 C to 4 C.

We have installed the self regulating heating cable on the vapor supply line and liquid supply

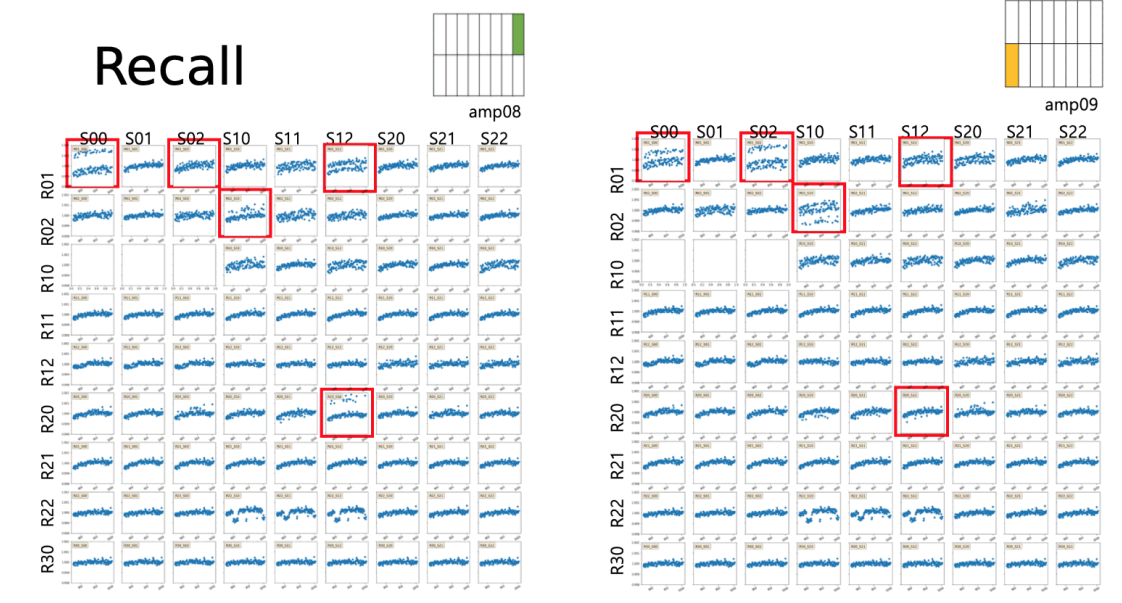
Gain jumps had been known since 2020, when Hyeyun Park found that the measured gain of a given amplifier could move between discrete values from one acquisition to the next, at the sub-percent level (Figure 25). This triggered the RTM-004 optimization runs,<sup>2</sup> and the effect was partially mitigated at the time by a change of the output drain (OD) voltage.

FIGURE 25: Gain measurements per sensor across the focal plane for two amplifiers (amp08, left; amp09, right). Red boxes mark sensors in which the gain moves between discrete states from one acquisition to the next; the difference between states is at the sub-percent level.

If the discrete states of the gain and of the bias arise from these phase shifts, then running the REB at its natural frequency, that is, taking the sequencer timing directly from the 6.4 ns clock instead of the converted 10 ns clock, should remove them.

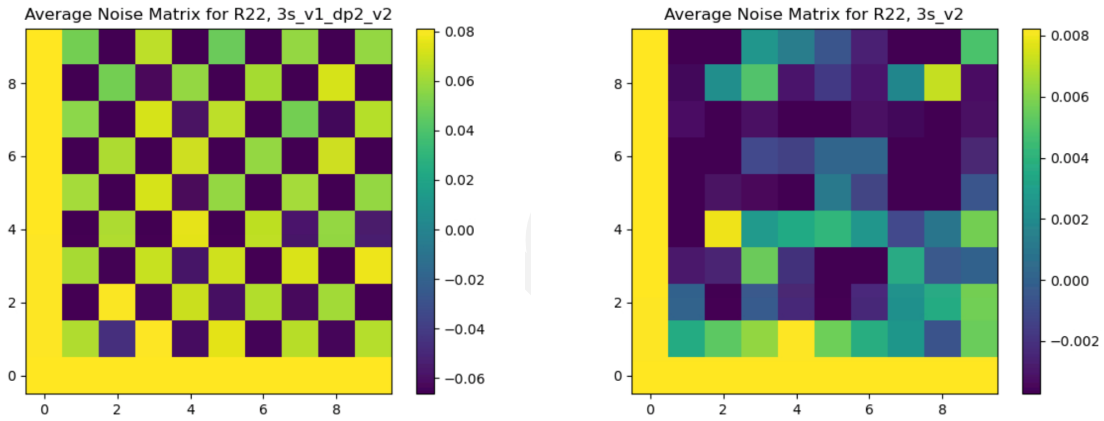
**3.1.3.8 Checkerboard in the PTC.** The PTC products confirm the same result on the flats, through a completely different measurement. Averaged over raft R22, the e2v noise matrix carries an unmistakable checkerboard in  $3s\_v1\_dp2\_v2$ ; with  $3s\_v2$  the pattern disappears and the colour scale shrinks by an order of magnitude, from  $\pm 0.08$  to  $\pm 0.008$  (Figure 38). The  $A$  matrix behaves the same way: the alternating structure that was superimposed on the smooth brighter-fatter falloff is absent in the new data (Figure 39), which means the  $a_{ij}$  measurement is no longer polluted. ITL, averaged over R02, shows the same improvement in the noise matrix at lower amplitude (Figure 40); the ITL  $A$  matrix was already free of the pattern and is essentially unchanged, consistent with the checkerboard having been an e2v effect from the start.

FIGURE 38: Average PTC noise matrix over raft R22 (e2v). Left:  $3s\_v1\_dp2\_v2$ . Right:  $3s\_v2$ . Note that the colour scale differs by a factor of ten between the two panels (E. Rykoff).

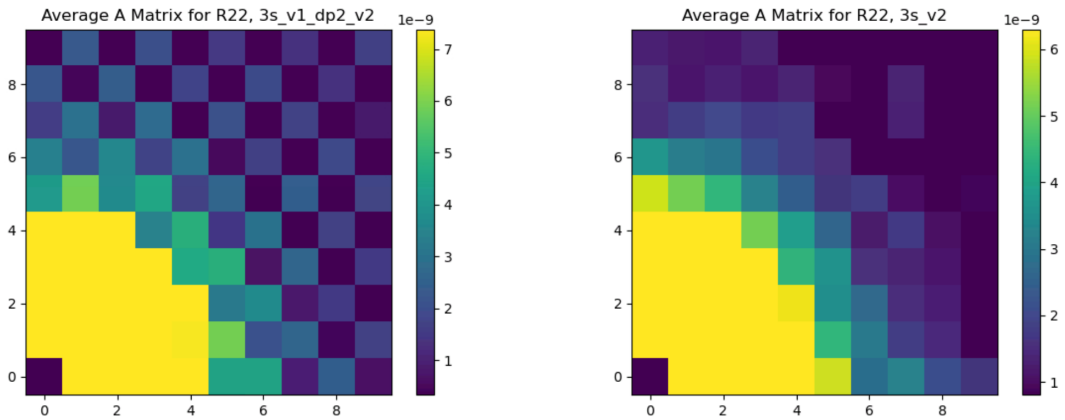
FIGURE 39: Average  $A$  matrix over raft R22 (e2v). Left:  $3s\_v1\_dp2\_v2$ . Right:  $3s\_v2$ . The checkerboard superimposed on the brighter-fatter falloff is gone (E. Rykoff).

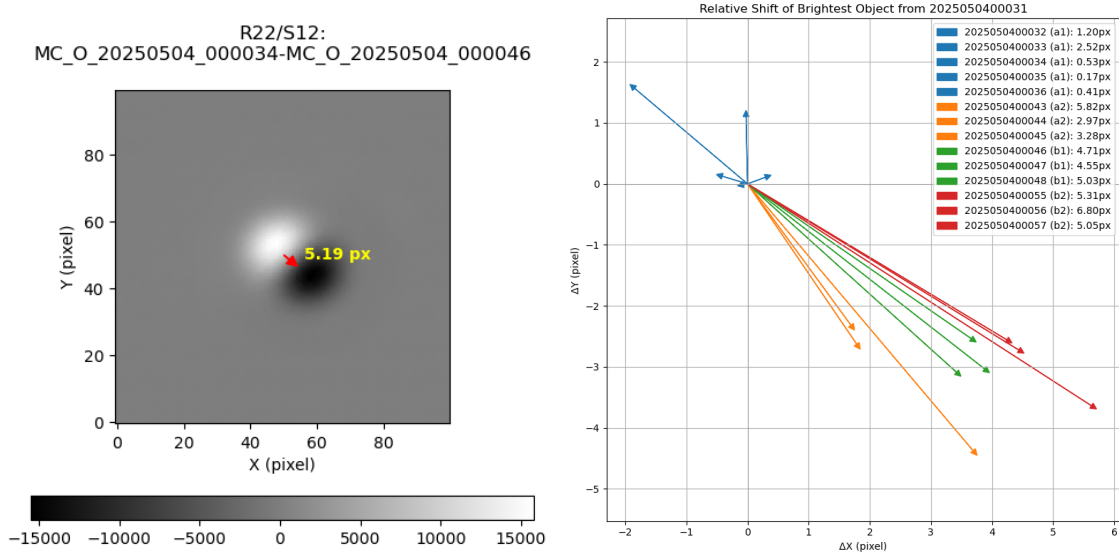
FIGURE 52: Caption

The left-hand panel of Figure 52 shows a difference image between the first exposure before the filter change and the fourth exposure after the filter change, revealing small but systematic shifts in the pinhole positions. The right-hand panel displays the measured positional offsets relative to the first exposure for images that are taken when the rotator angle was  $0^\circ$ . Scatter within a single condition (e.g., all points from a1) is on the order of a few pixels, indicating that the CBP itself is stable but non-negligible motion could be present.

Systematic offsets are evident when comparing conditions: the average shift between a1 and b1 is  $\approx 2$  px in X and  $\approx 3$ –4 px in Y. The four distinct groups (a1, a2, b1, b2) are distributed rea-

sonably consistent but distinguishable distributions. Because the total displacements are well below the 10-pixel (100  $\mu\text{m}$ ) repeatability requirement, we conclude that the filter placement is within specification. Nevertheless, the observed systematic trends suggest that both filter positioning and rotator repeatability contribute to the measured offsets, making it difficult to isolate the dominant source without further controlled experiments.
