# The LSST Camera commissioning

CTN-007

This technote describes what we found during the LSST Camera commissioning.

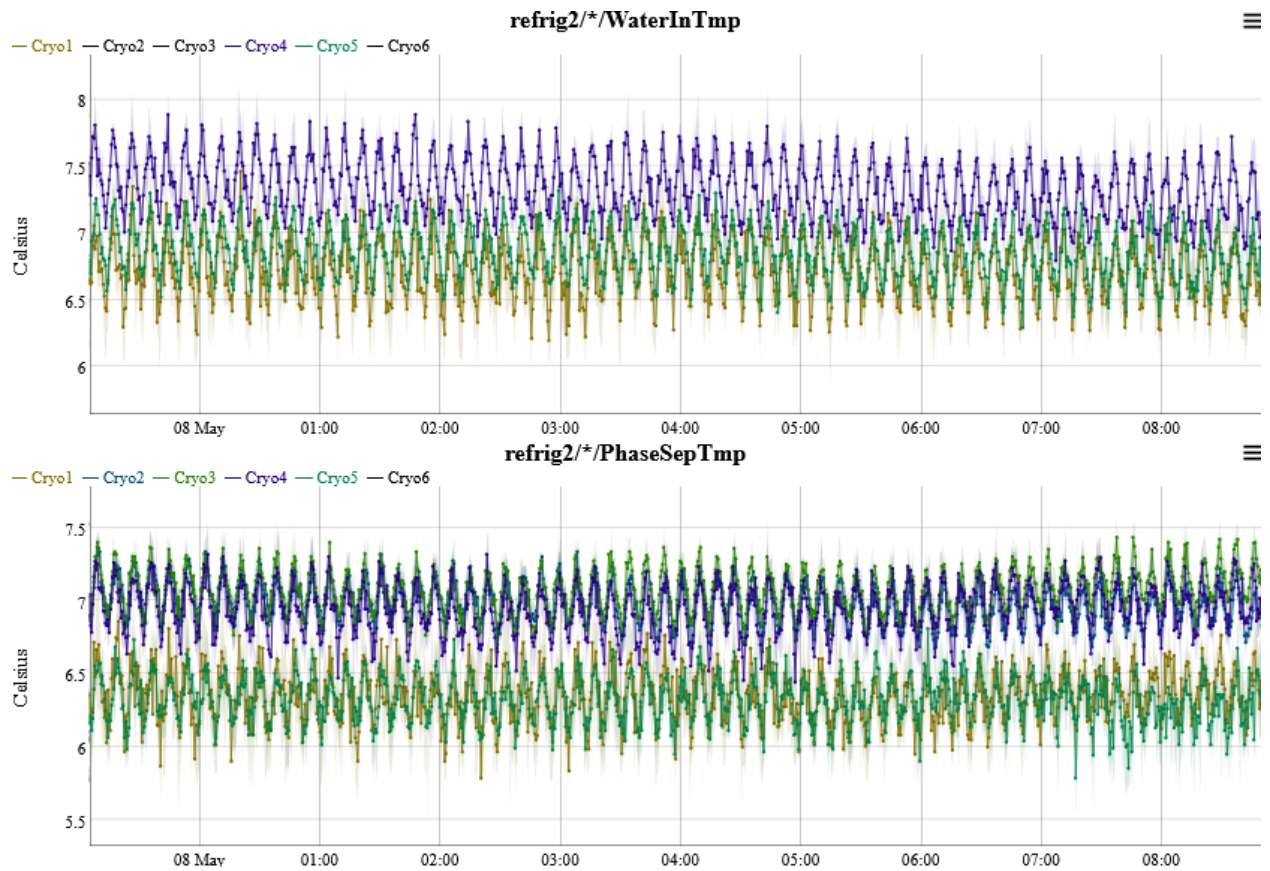
FIGURE 15: Glycol/Water Inlet temperature and phase separator temperature of each Cryo circuit at around 6 am on May 8, 2025

The glycol/water supply temperature was 7 C and the phase separator was at around 7 C at the time being, as shown in Figure 15.

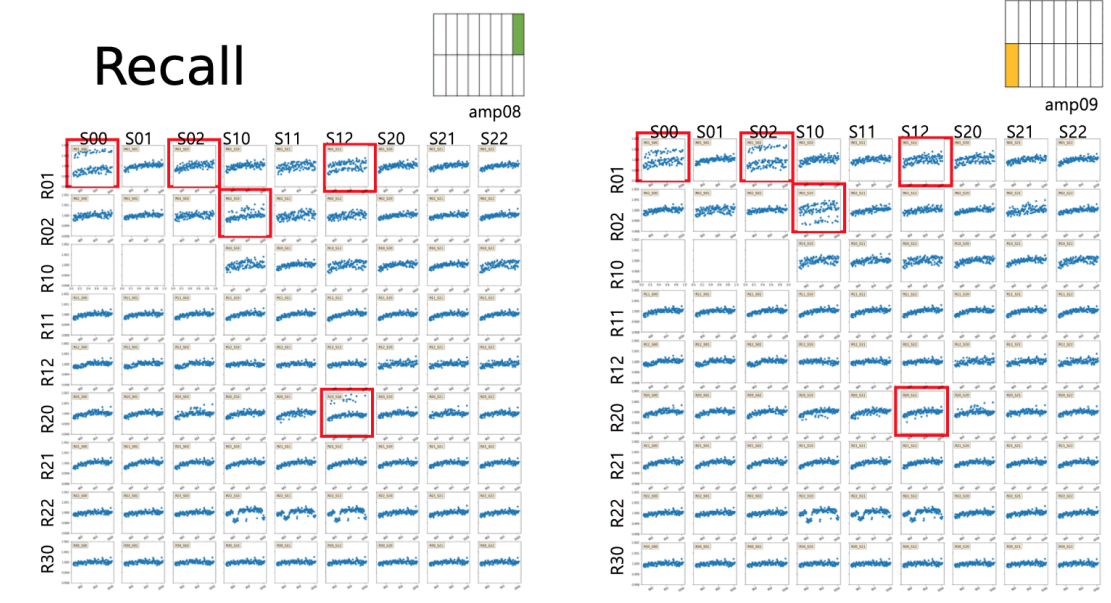
Gain jumps had been known since 2020, when Hyeyun Park found that the measured gain of a given amplifier could move between discrete values from one acquisition to the next, at the sub-percent level (Figure 25). This triggered the RTM-004 optimization runs,<sup>2</sup> and the effect was partially mitigated at the time by a change of the output drain (OD) voltage.

FIGURE 25: Gain measurements per sensor across the focal plane for two amplifiers (amp08, left; amp09, right). Red boxes mark sensors in which the gain moves between discrete states from one acquisition to the next; the difference between states is at the sub-percent level.

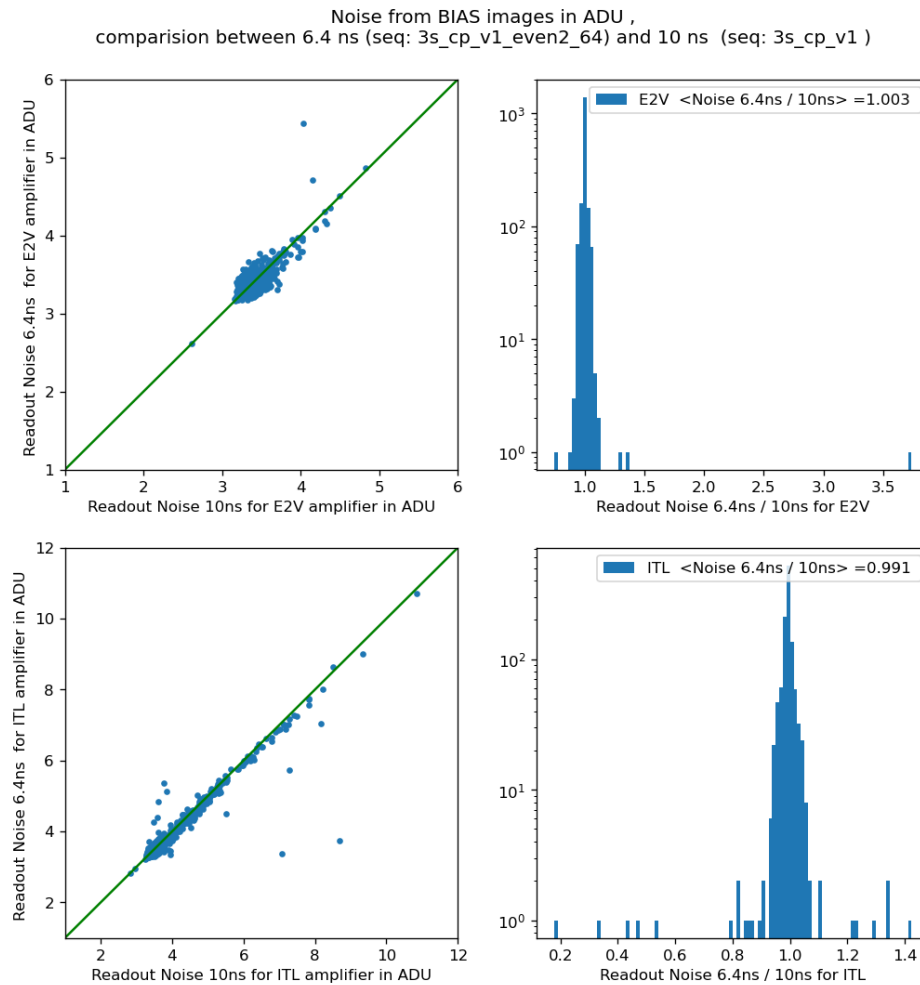
**3.1.3.2 Noise and gain consistency between configurations.** The readout noise measured with the 6.4 ns sequencer (3s\_cp\_v1\_even2\_64) and with the 10 ns sequencer (3s\_cp\_v1) agrees closely, with mean ratios of 1.003 for e2v and 0.991 for ITL (Figure 28). A small rounding in the sequencer timing makes the gains inconsistent between vendors at the 1% level. The outliers are half-dead or high-noise sensors (R10\_S01, R43\_S20, R41\_S21). No geometrically systematic correlation across the focal plane was observed, which addresses the concern that the WREB might inject noise into neighbouring rafts.

FIGURE 28: Readout noise from bias images, comparing the 6.4 ns sequencer (3s\_cp\_v1\_even2\_64) with the 10 ns sequencer (3s\_cp\_v1), for e2v (top) and ITL (bottom). Left: amplifier by amplifier. Right: distribution of the ratio between the two (P. Antilogus).

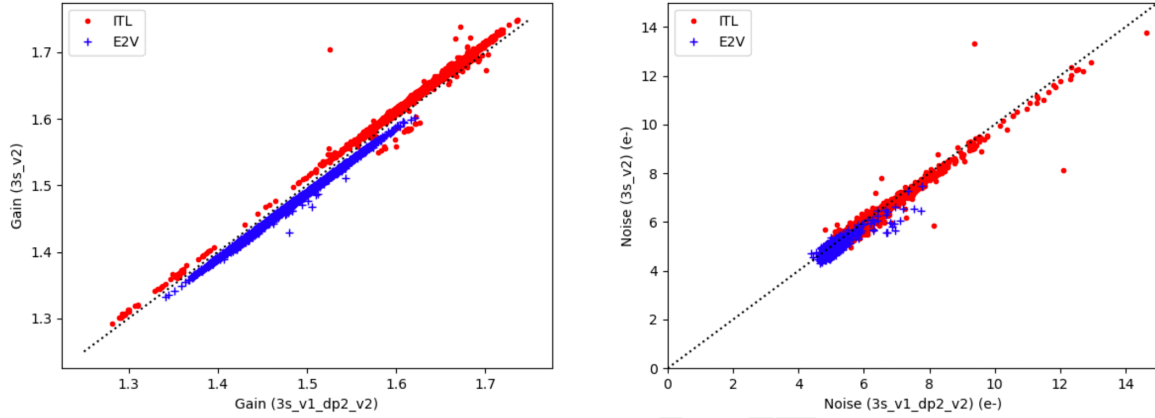
The PTC products give the same result from the flats, amplifier by amplifier across the whole focal plane (Figure 29). The gains move slightly and in opposite directions for the two vendors,

e2v down a little and ITL up a little, which is the vendor- dependent rounding above seen in the gain itself rather than in the noise. The read noise generally decreases for all amplifiers, and for a subset of e2v amplifiers it decreases substantially — presumably the channels that were carrying the excess variance associated with the checkerboard discussed below.

FIGURE 29: Per-amplifier comparison between 3s\_v1\_dp2\_v2 and 3s\_v2 from the PTC. Left: gain. Right: read noise in electrons. The dotted line is equality (E. Rykoff).

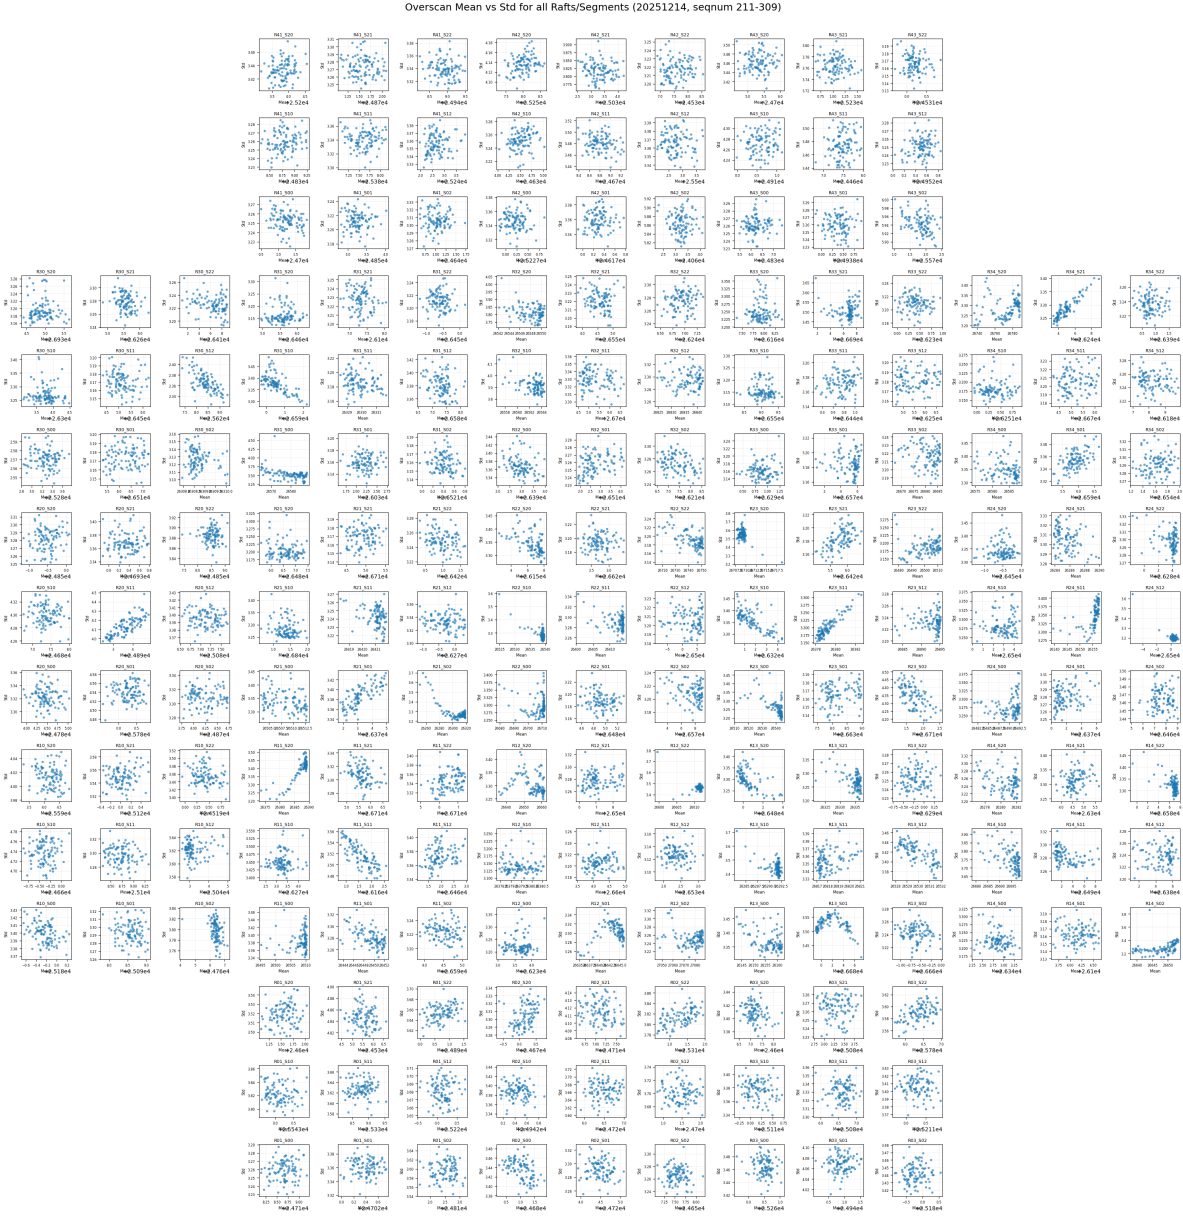
**3.1.3.3 Bias level versus noise.** Plotting the overscan noise against the overscan mean for one amplifier per sensor over the whole focal plane (Figure 30) no longer shows multiple distinct populations. The residual systematic drift within each sensor is consistent with gain and temperature changes over the duration of the acquisition rather than with discrete state changes.

FIGURE 30: Overscan mean versus overscan standard deviation for all rafts and sensors (20251214, sequence numbers 211–309), one amplifier per sensor. The distinct populations seen before the firmware change (Figure 26) are absent.

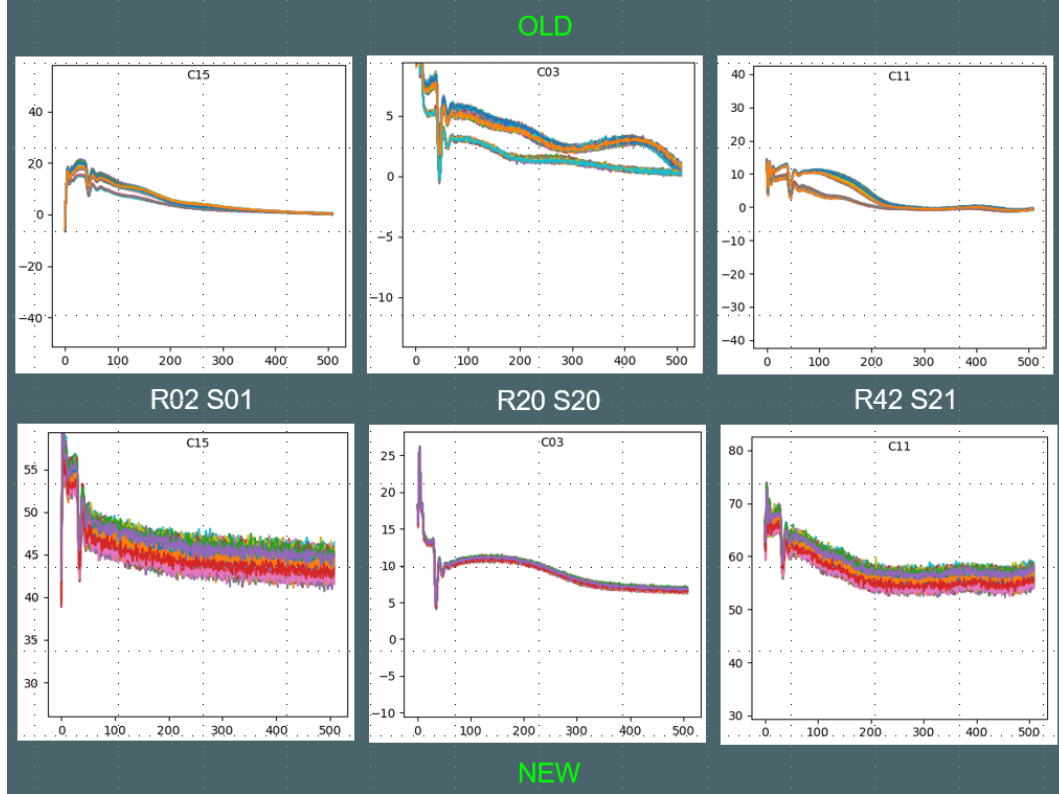
**3.1.3.4 Bias row profiles.** The row profiles measured before and after the change are compared in Figure 31. With the original firmware the profile of a given amplifier differed between exposures; with the natural frequency firmware the profiles from repeated exposures fall on top of each other.

FIGURE 31: Bias row profiles for three amplifiers (R02\_S01 C15, R20\_S20 C03, R42\_S21 C11) with the original firmware (top) and with the natural frequency firmware (bottom, run E1110, 9 December 2025). The profiles become consistent from exposure to exposure (T. Guillemin).

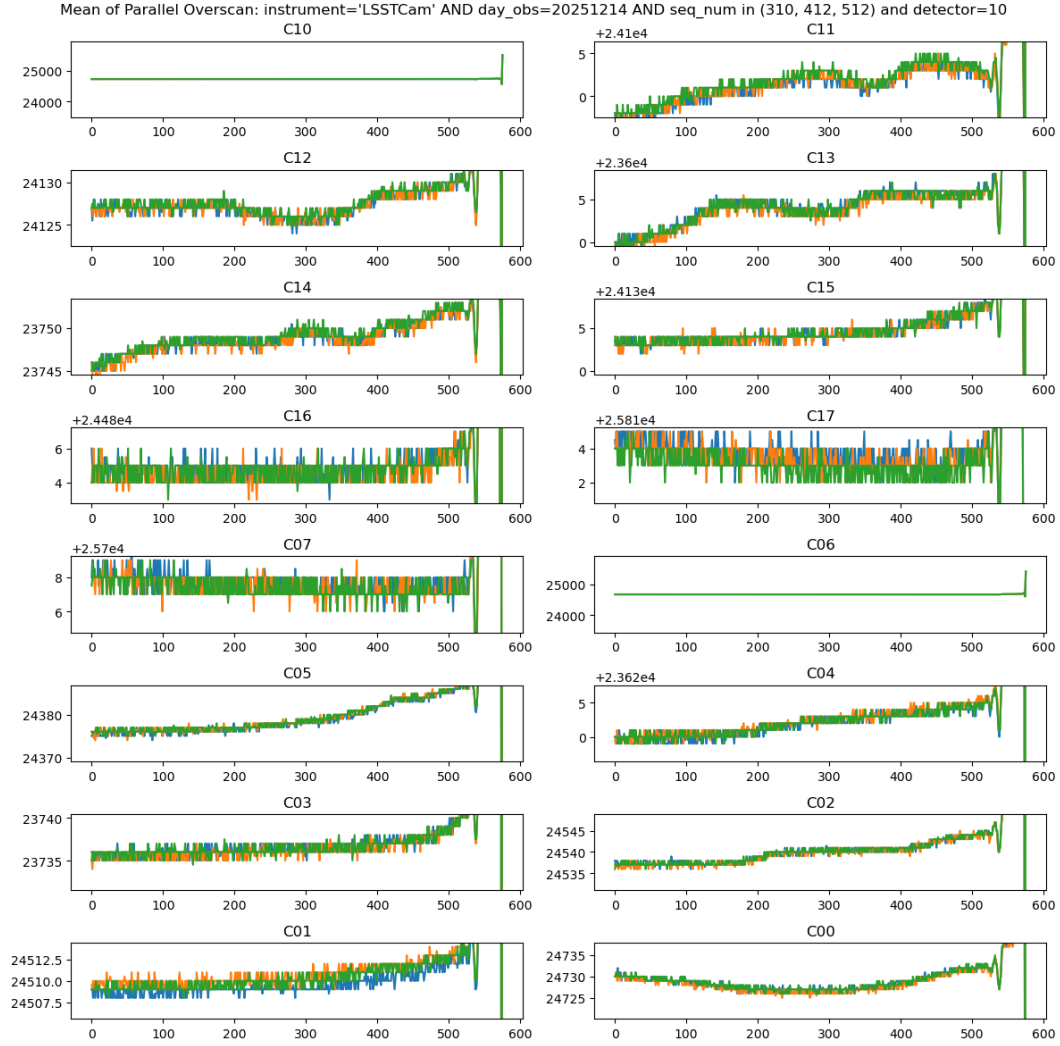
**3.1.3.5 Consistency across resets.** Since the phase shift introduced at REB synchronization persists until a link reset, the acquisitions of 14 December 2025 were split into three runs separated by an RCE reset. The mean parallel overscan profiles of the three runs agree amplifier by amplifier (Figure 32); no change was observed between before and after a reset. Together with the noise agreement above, this points at the 6.4 ns to 10 ns conversion rather than at the REB synchronization as the origin of the multimodality.

FIGURE 32: Mean of the parallel overscan for each amplifier of detector 10, for the three runs of 20251214 separated by an RCE reset (sequence numbers 310, 412 and 512). The three curves overlap in every channel.

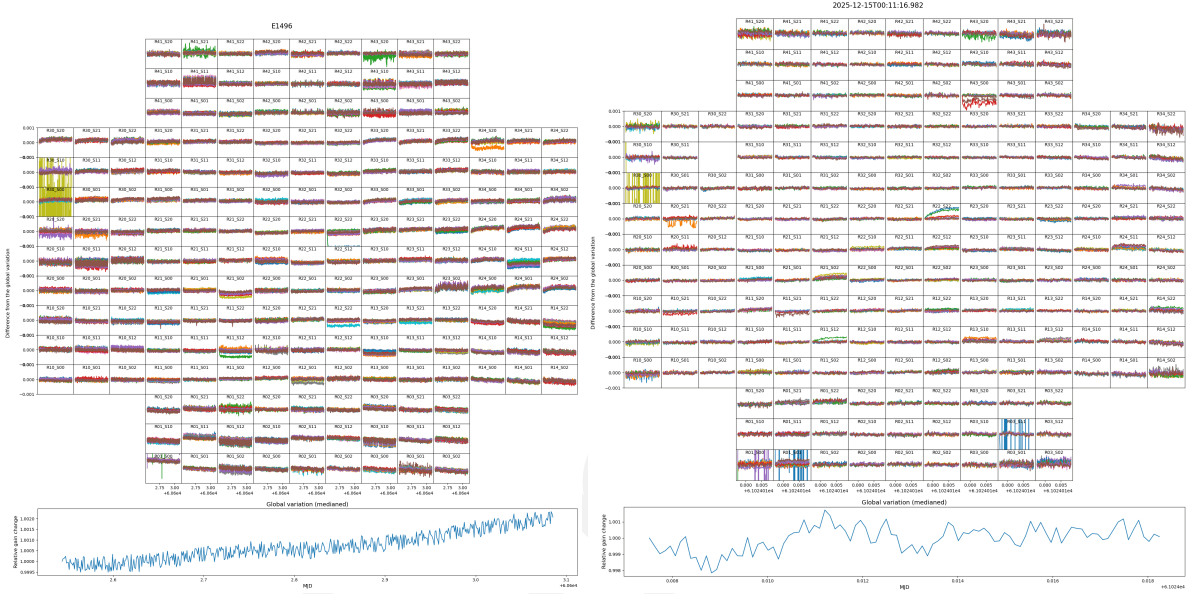
**3.1.3.6 Gain stability.** The relative gain change of every amplifier, measured against the focal-plane median, is shown in Figure 33 without and with the natural frequency firmware. Without it the median gain drifts by more than  $2 \times 10^{-3}$  over the run; with it the drift is removed and the residual per-amplifier scatter is at the level of the measurement noise. The amplifiers that remain noisy in the right-hand panel are noisy intrinsically.

FIGURE 33: Difference of the per-amplifier relative gain from the focal-plane median, and the median itself (bottom panel of each plot). Left: without the natural frequency firmware (run E1496). Right: with the natural frequency firmware (2025-12-15).

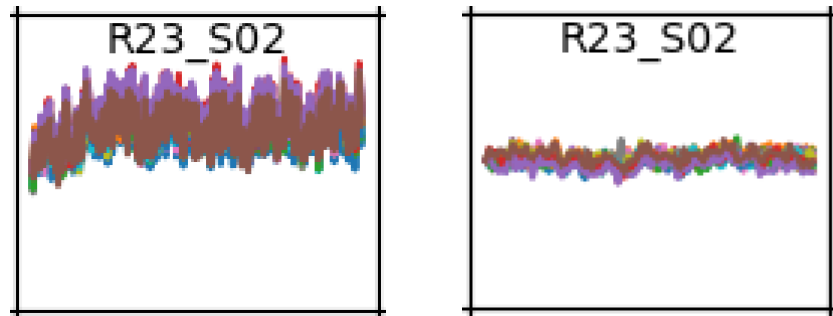
Figure 36 shows the covariances  $\langle \text{cov}_{ij} \rangle$  for all channel pairs of R23\_S02, excluding the self-correlations, before and after the change. The average over pairs, shown as an inset, carries a clear checkerboard in the original data and is flat with the natural frequency firmware. P. Astier interpreted the decaying signal at  $\Delta y = 0$  as a gain variation, which the natural frequency partially cures: the spread of the relative gain of R23\_S02 narrows from roughly  $\pm 10^{-3}$  to a considerably smaller range (Figure 37).

FIGURE 37: Relative gain of R23\_S02 over the course of a run, on a vertical scale of  $\pm 0.001$ . Left: original configuration. Right: with the natural frequency firmware.

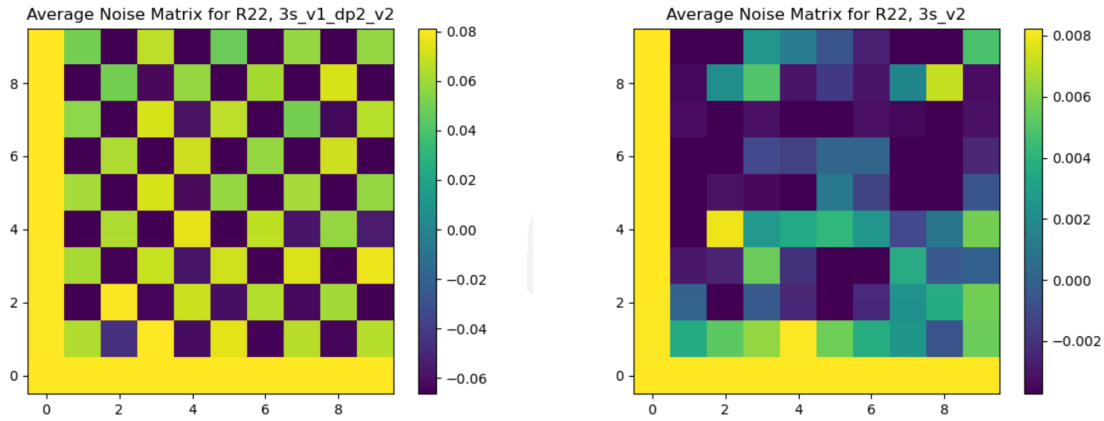
**3.1.3.8 Checkerboard in the PTC.** The PTC products confirm the same result on the flats, through a completely different measurement. Averaged over raft R22, the e2v noise matrix carries an unmistakable checkerboard in  $3s\_v1\_dp2\_v2$ ; with  $3s\_v2$  the pattern disappears and the colour scale shrinks by an order of magnitude, from  $\pm 0.08$  to  $\pm 0.008$  (Figure 38). The  $A$  matrix behaves the same way: the alternating structure that was superimposed on the smooth brighter-fatter falloff is absent in the new data (Figure 39), which means the  $a_{ij}$  measurement is no longer polluted. ITL, averaged over R02, shows the same improvement in the noise matrix at lower amplitude (Figure 40); the ITL  $A$  matrix was already free of the pattern and is essentially unchanged, consistent with the checkerboard having been an e2v effect from the start.

FIGURE 38: Average PTC noise matrix over raft R22 (e2v). Left:  $3s\_v1\_dp2\_v2$ . Right:  $3s\_v2$ . Note that the colour scale differs by a factor of ten between the two panels (E. Rykoff).

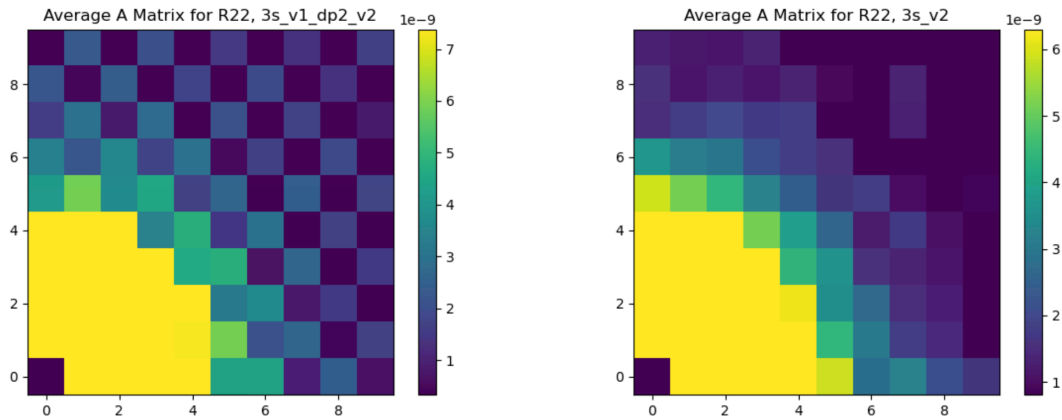
FIGURE 39: Average  $A$  matrix over raft R22 (e2v). Left:  $3s\_v1\_dp2\_v2$ . Right:  $3s\_v2$ . The checkerboard superimposed on the brighter-fatter falloff is gone (E. Rykoff).

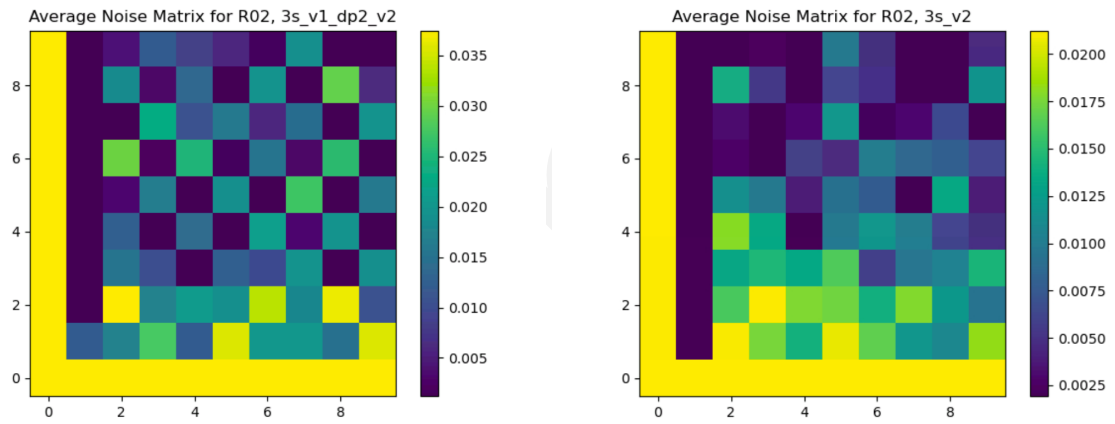
FIGURE 40: Average PTC noise matrix over raft R02 (ITL). Left: 3s\_v1\_dp2\_v2. Right: 3s\_v2 (E. Rykoff).

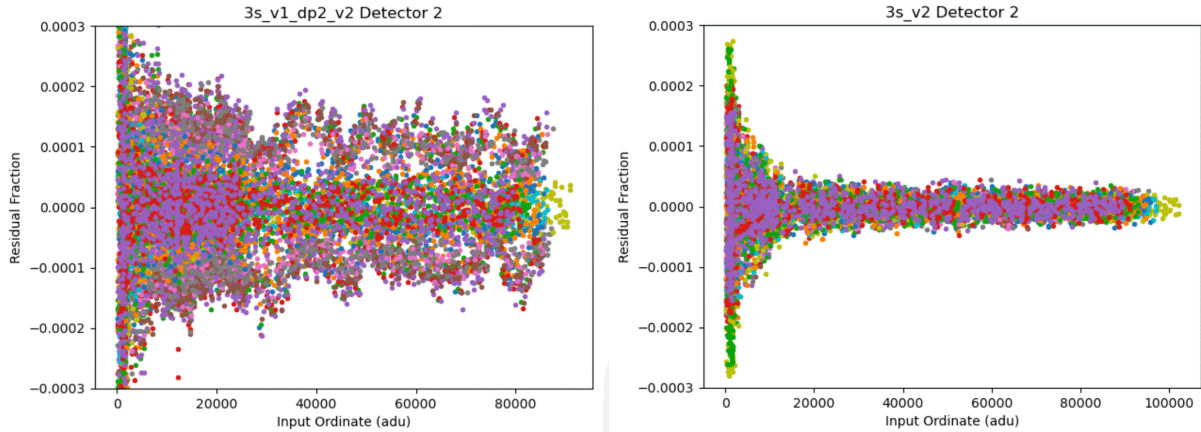
**3.1.3.9 Linearity.** The linearity solution improves as well, most visibly on the ITL detectors, where the structure that the old solution left in the residuals is largely gone (Figure 41). With  $3s\_v1\_dp2\_v2$  the residual fraction is spread over roughly  $\pm 1.5 \times 10^{-4}$  with visible wave-like structure across the full signal range; with  $3s\_v2$  it collapses to a narrow band that tightens with signal, and the usable range extends past  $10^5$  adu. Some ITL detectors improve only slightly (for example detector 15), and the e2v detectors, which started in better shape, improve more modestly but consistently (Figure 42).

FIGURE 41: Linearizer residual fraction against input ordinate for every amplifier of ITL detector 2. Left:  $3s\_v1\_dp2\_v2$ . Right:  $3s\_v2$ . The structure spread over  $\pm 1.5 \times 10^{-4}$  in the old solution collapses to a narrow band (E. Rykoff).

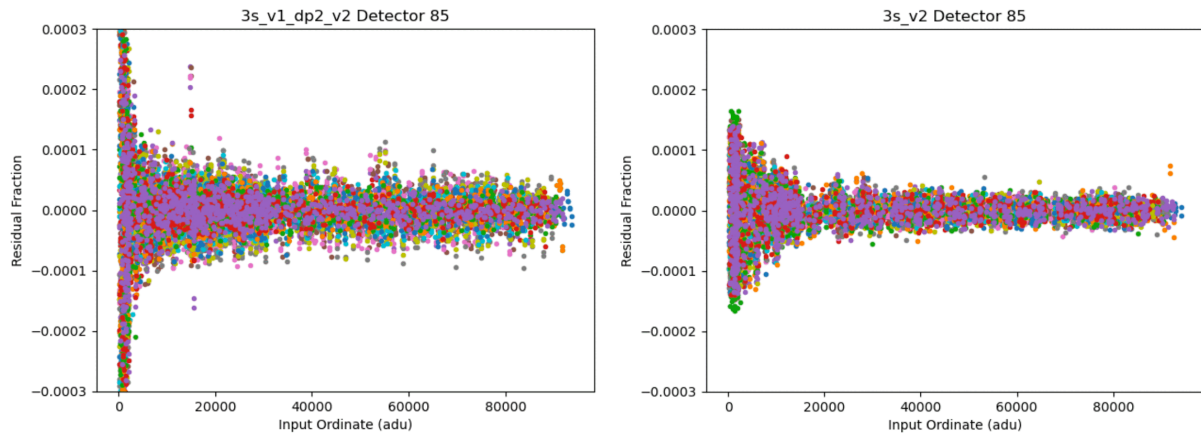
FIGURE 42: The same comparison for e2v detector 85, which was already in better shape. Left:  $3s\_v1\_dp2\_v2$ . Right:  $3s\_v2$ .

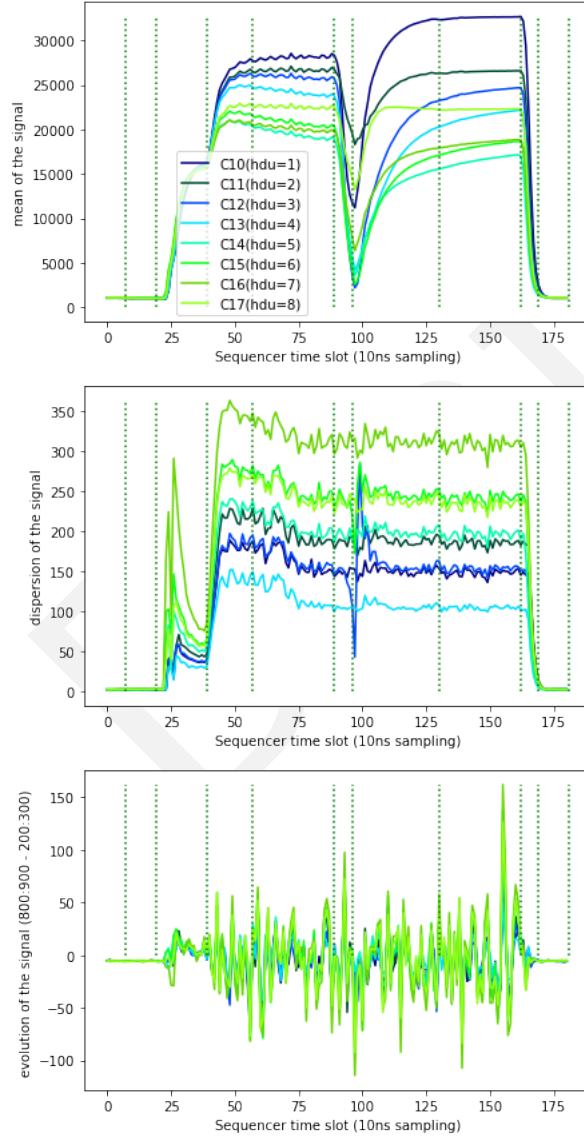
**3.1.3.13 Understanding the wavefront sensors.** Scan mode is the natural tool for understanding the underlying issue, since it resolves the signal within the sequencer time slots. The scan-mode data taken on R00\_SW0 in run 13108 (Figure 50) show a wild signal after the RST/CL toggling, wiggles in the first ramp, and an increase of the noise for a longer ramp time. These acquisitions have not been repeated since November 2023. Progress requires getting TS8 running and testing there, and then stepping to LATISS and LSSTCam.

FIGURE 50: Scan-mode data for R00\_SW0, run 13108, sampled every 10 ns of the sequencer. Top: mean of the signal for the eight channels. Middle: dispersion of the signal. Bottom: evolution of the signal between scans 800–900 and 200–300. Dotted lines mark the sequencer transitions.

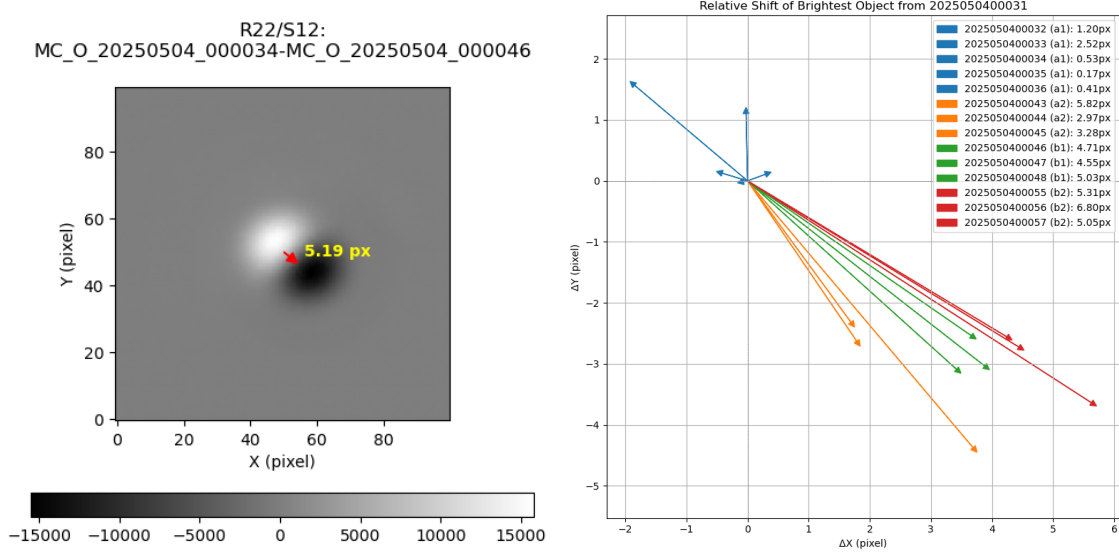
FIGURE 52: Caption

The left-hand panel of Figure 52 shows a difference image between the first exposure before the filter change and the fourth exposure after the filter change, revealing small but systematic shifts in the pinhole positions. The right-hand panel displays the measured positional offsets relative to the first exposure for images that are taken when the rotator angle was  $0^\circ$ . Scatter within a single condition (e.g., all points from a1) is on the order of a few pixels, indicating that the CBP itself is stable but non-negligible motion could be present.

Systematic offsets are evident when comparing conditions: the average shift between a1 and b1 is  $\approx 2$  px in X and  $\approx 3$ –4 px in Y. The four distinct groups (a1, a2, b1, b2) are distributed rea-

sonably consistent but distinguishable distributions. Because the total displacements are well below the 10-pixel (100  $\mu\text{m}$ ) repeatability requirement, we conclude that the filter placement is within specification. Nevertheless, the observed systematic trends suggest that both filter positioning and rotator repeatability contribute to the measured offsets, making it difficult to isolate the dominant source without further controlled experiments.
