# The LSST Camera commissioning

CTN-007

This technote describes what we found during the LSST Camera commissioning.

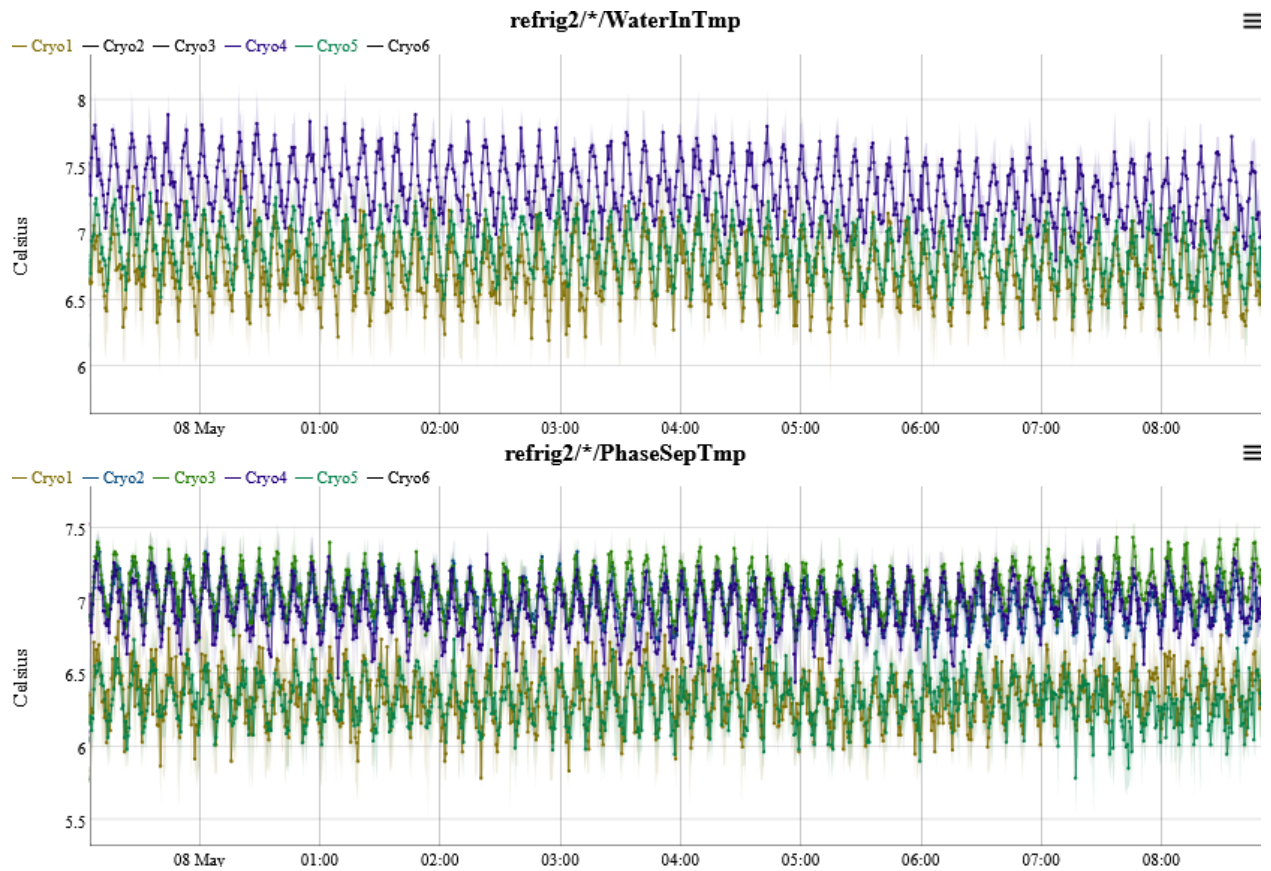
The glycol/water supply temperature was 7 C and the phase separator was at around 7 C at the time being, as shown in Figure 15.

FIGURE 15: Glycol/Water Inlet temperature and phase separator temperature of each Cryo circuit at around 6 am on May 8, 2025

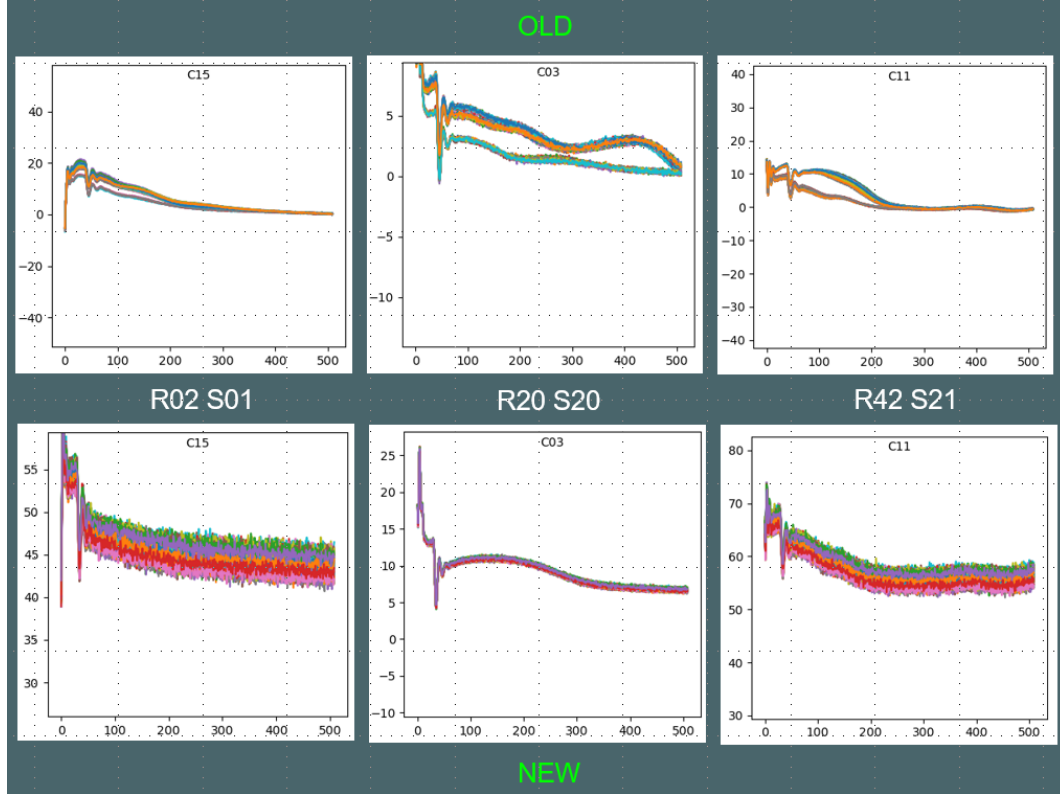
**3.1.3.4 Bias row profiles.** The row profiles measured before and after the change are compared in Figure 31. With the original firmware the profile of a given amplifier differed between exposures; with the natural frequency firmware the profiles from repeated exposures fall on top of each other.

FIGURE 31: Bias row profiles for three amplifiers (R02\_S01 C15, R20\_S20 C03, R42\_S21 C11) with the original firmware (top) and with the natural frequency firmware (bottom, run E1110, 9 December 2025). The profiles become consistent from exposure to exposure (T. Guillemin).
