Vera C. Rubin Observatory  
Rubin Observatory Operations

# The LSST Camera commissioning

CTN-007

This technote describes what we found during the LSST Camera commissioning.

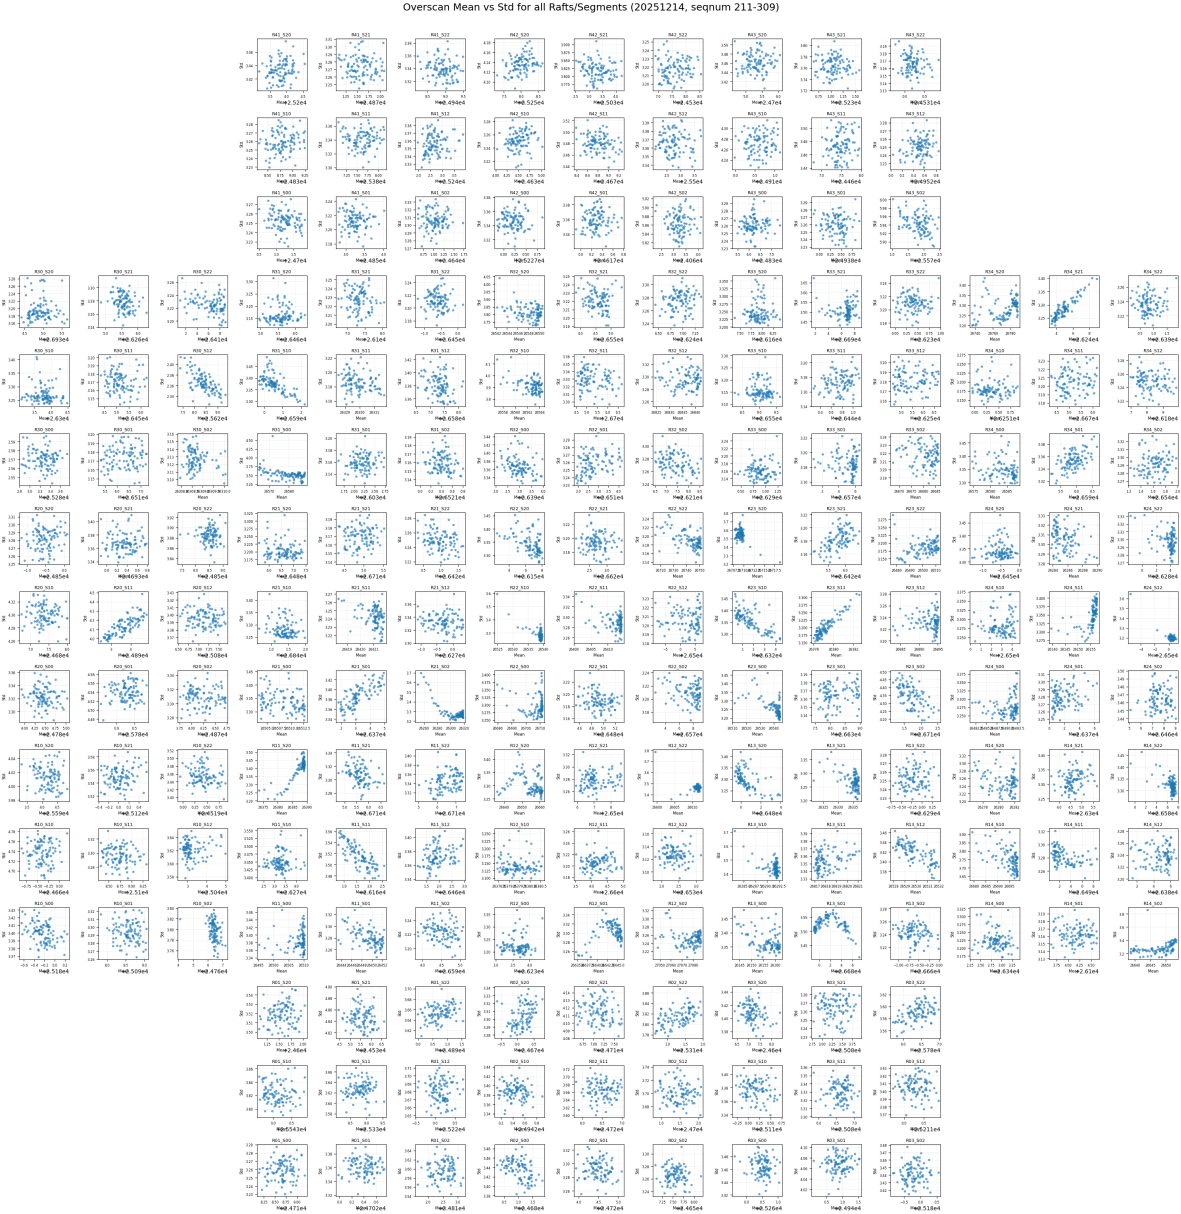
**3.1.3.3 Bias level versus noise.** Plotting the overscan noise against the overscan mean for one amplifier per sensor over the whole focal plane (Figure 30) no longer shows multiple distinct populations. The residual systematic drift within each sensor is consistent with gain and temperature changes over the duration of the acquisition rather than with discrete state changes.

FIGURE 30: Overscan mean versus overscan standard deviation for all rafts and sensors (20251214, sequence numbers 211–309), one amplifier per sensor. The distinct populations seen before the firmware change (Figure 26) are absent.

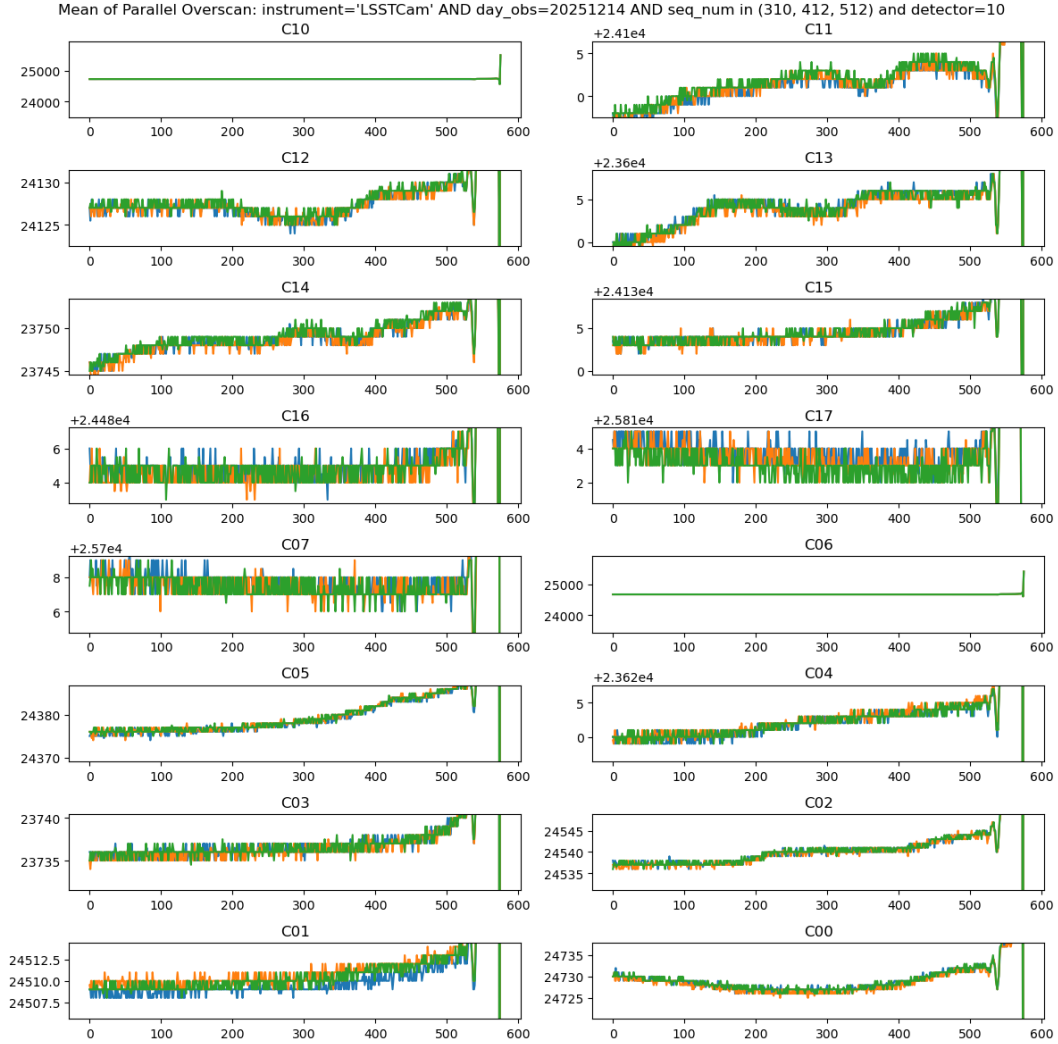
**3.1.3.5 Consistency across resets.** Since the phase shift introduced at REB synchronization persists until a link reset, the acquisitions of 14 December 2025 were split into three runs separated by an RCE reset. The mean parallel overscan profiles of the three runs agree amplifier by amplifier (Figure 32); no change was observed between before and after a reset. Together with the noise agreement above, this points at the 6.4 ns to 10 ns conversion rather than at the REB synchronization as the origin of the multimodality.

FIGURE 32: Mean of the parallel overscan for each amplifier of detector 10, for the three runs of 20251214 separated by an RCE reset (sequence numbers 310, 412 and 512). The three curves overlap in every channel.

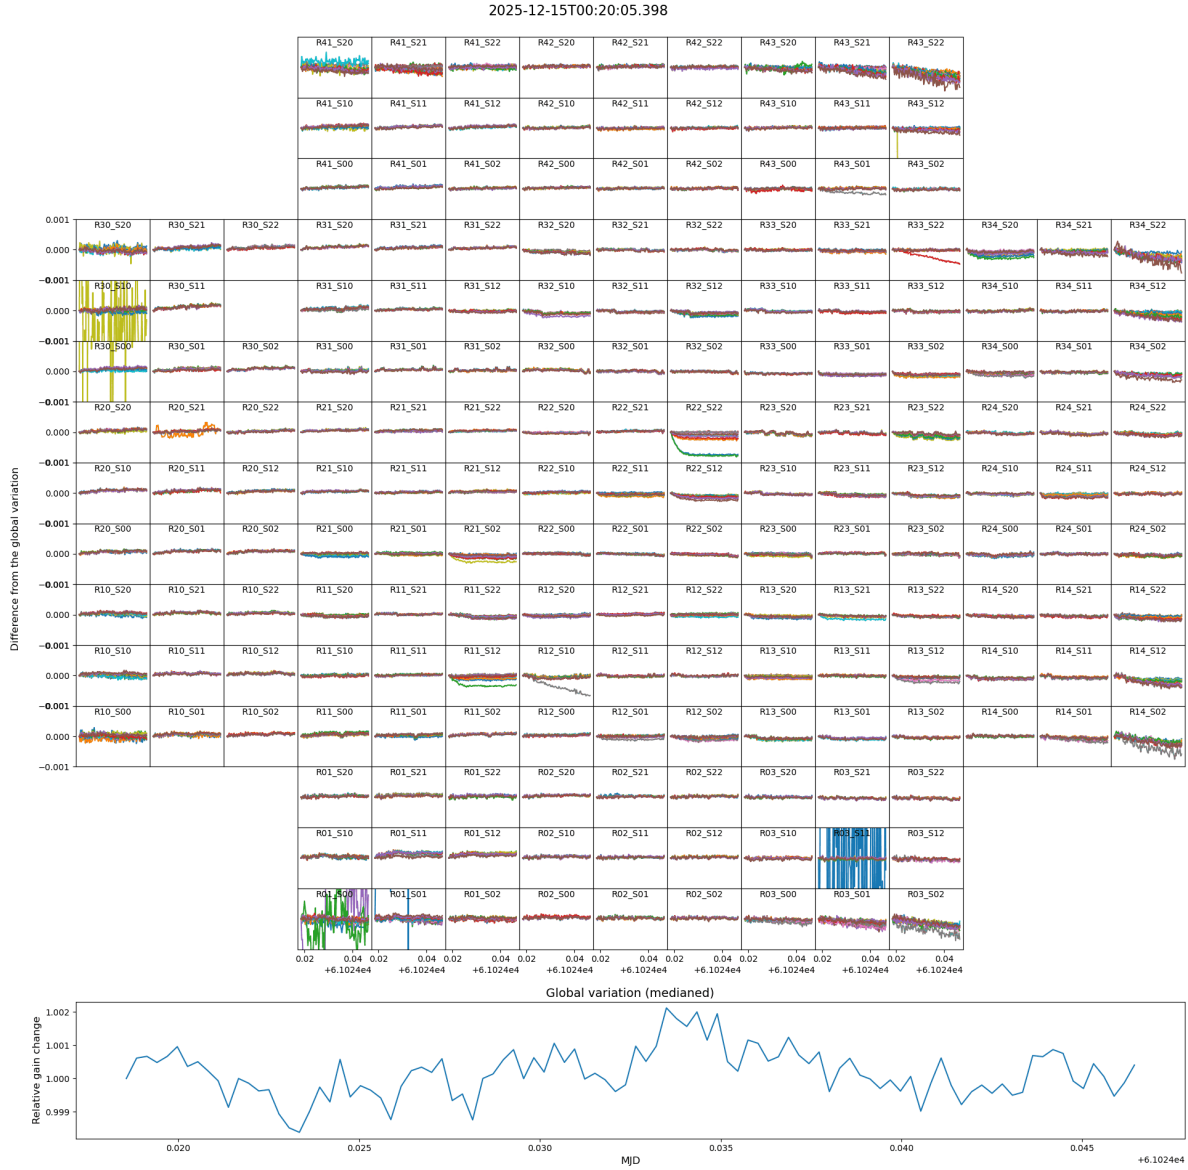
The same measurement performed on the high-flux flats (Figure 34) is to be compared with the specification of 0.1% RMS over 1 h and 1% RMS over 12 h. The majority of the amplifiers are better than  $\mathcal{O}(10^{-4})$ . Three classes of outlier remain: non-stable illumination at the edge of the focal plane, sensor-intrinsic behaviour, and a gain-temperature correlation that is not yet understood. The linearity analysis below finds residual patterns of exactly these two kinds — smooth variation over the night on the vignetted edge detectors, and a time and temperature correlation on isolated amplifiers — which suggests the two campaigns are seeing the same residual effects through different measurements.

FIGURE 34: Relative gain change per amplifier for the high-flux flats acquired with the natural frequency firmware (2025-12-15), in the same format as Figure 33.

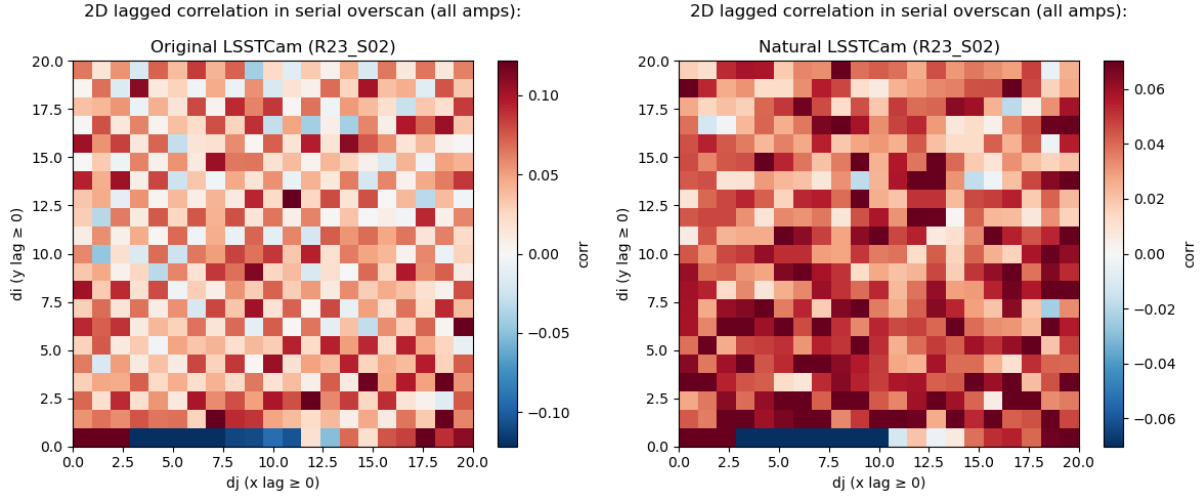
**3.1.3.7 Checkerboard in the overscan.** The two-dimensional lagged correlation of the serial overscan, averaged over all amplifiers of R23\_S02, is shown in Figure 35 for the original and for the natural frequency configuration. The checkerboard pattern is gone in the latter.

FIGURE 35: Two-dimensional lagged correlation in the serial overscan, all amplifiers of R23\_S02. Left: original configuration (20251216, sequence number 366). Right: natural frequency configuration (20251214, sequence number 211).

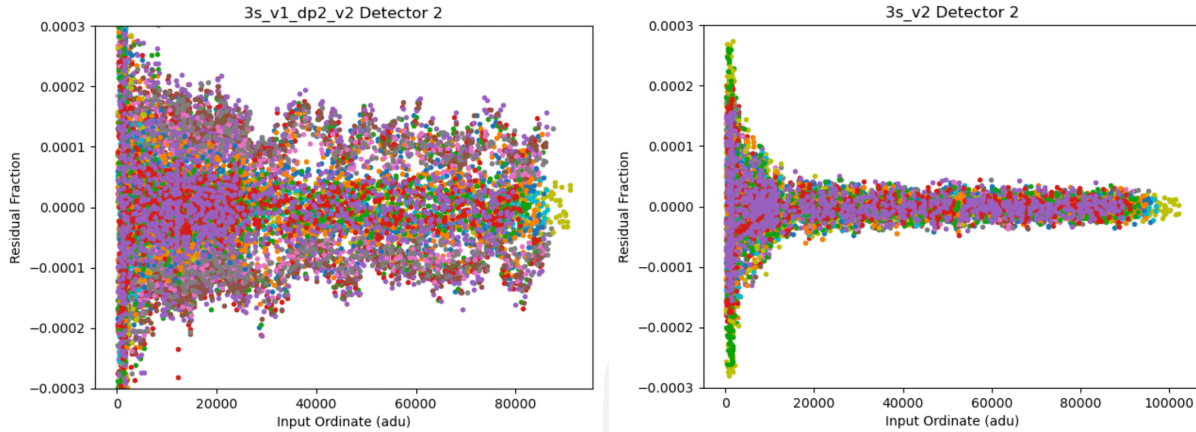
**3.1.3.9 Linearity.** The linearity solution improves as well, most visibly on the ITL detectors, where the structure that the old solution left in the residuals is largely gone (Figure 41). With  $3s\_v1\_dp2\_v2$  the residual fraction is spread over roughly  $\pm 1.5 \times 10^{-4}$  with visible wave-like structure across the full signal range; with  $3s\_v2$  it collapses to a narrow band that tightens with signal, and the usable range extends past  $10^5$  adu. Some ITL detectors improve only slightly (for example detector 15), and the e2v detectors, which started in better shape, improve more modestly but consistently (Figure 42).

FIGURE 41: Linearizer residual fraction against input ordinate for every amplifier of ITL detector 2. Left:  $3s\_v1\_dp2\_v2$ . Right:  $3s\_v2$ . The structure spread over  $\pm 1.5 \times 10^{-4}$  in the old solution collapses to a narrow band (E. Rykoff).

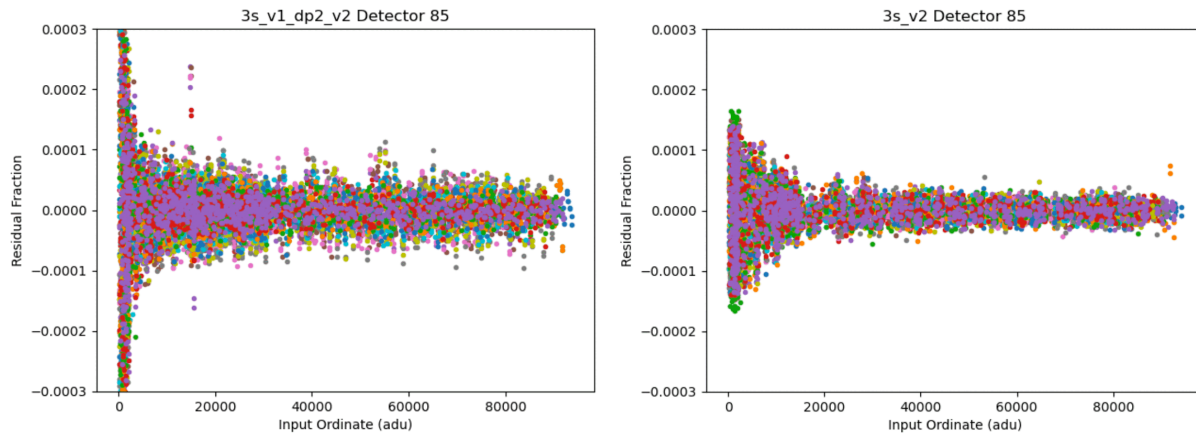
FIGURE 42: The same comparison for e2v detector 85, which was already in better shape. Left:  $3s\_v1\_dp2\_v2$ . Right:  $3s\_v2$ .

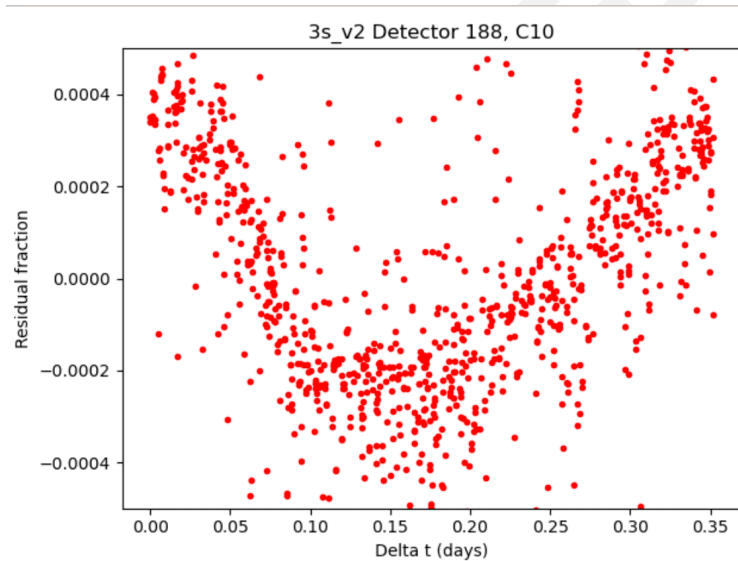
The amplifiers at the edge of the focal plane show a residual that varies smoothly over the night (Figure 43). The same or similar patterns appear on all partly vignettted and nearly-partly-vignettted detectors, for example detector 178 (R42\_S21), while the inner amplifiers and detectors show nothing of the kind. Variable illumination at the edges is the natural explanation, and it accounts for the edge outliers in the flat-field gain stability above.

FIGURE 43: Absolute linearizer residual fraction against elapsed time for detector 188 (R43\_S22), amplifier C10, with the 3s\_v2 data. The smooth variation over the night is seen on the partly vignettted detectors only (E. Rykoff).
