Vera C. Rubin Observatory  
Rubin Observatory Operations

# The LSST Camera commissioning

CTN-007

This technote describes what we found during the LSST Camera commissioning.

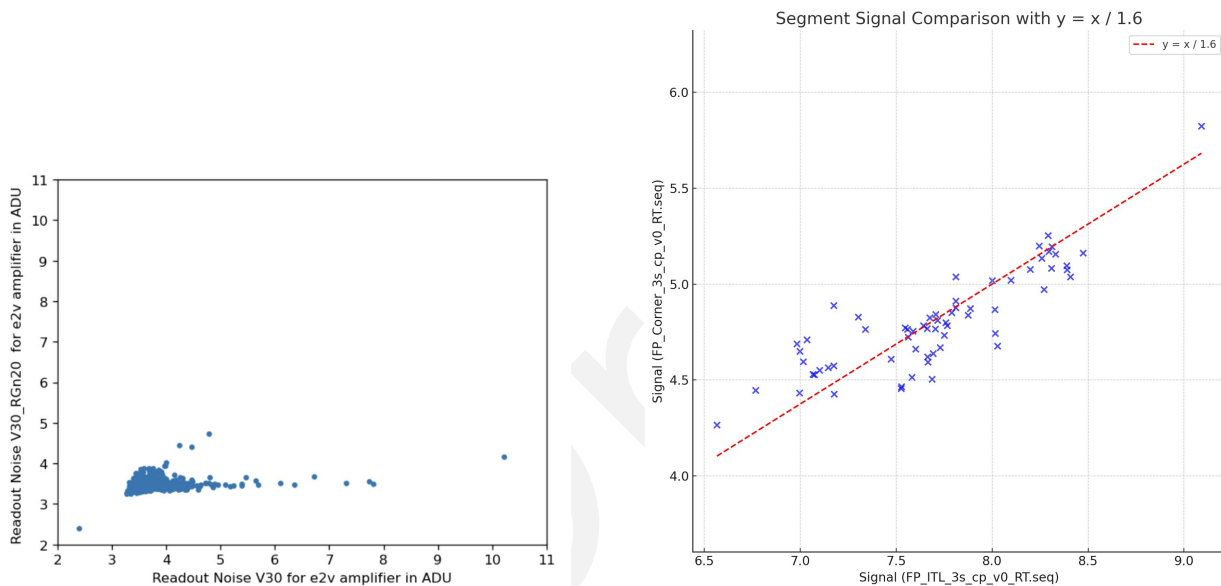
mention 2025-04-26 to 2025-12-29; status **Resolved**. A year-long programme rather than a fault: new sequencer files to address e2v noise and covariance anomalies (clear improvement on e2v, little change on ITL), the 3 s readout sequencers, and finally the retuning of the sequencer clock to 6.4 ns. The natural-frequency firmware was tested on the summit in December in three campaigns and used for a holiday calibration run, but was not promoted to the default slot; the dense photon-transfer curve that these changes require was repeatedly deferred through the year. The programme was closed in early January 2026, after the period covered here.

FIGURE 21: **FW-04**. Left: read noise per e2v amplifier with the new sequencer against the old one — most amplifiers unchanged, the worst improved (2025-04-28). Right: segment signal with the 3 s corner-raft sequencer against the ITL one, compared with the expected ratio (2025-06-25).

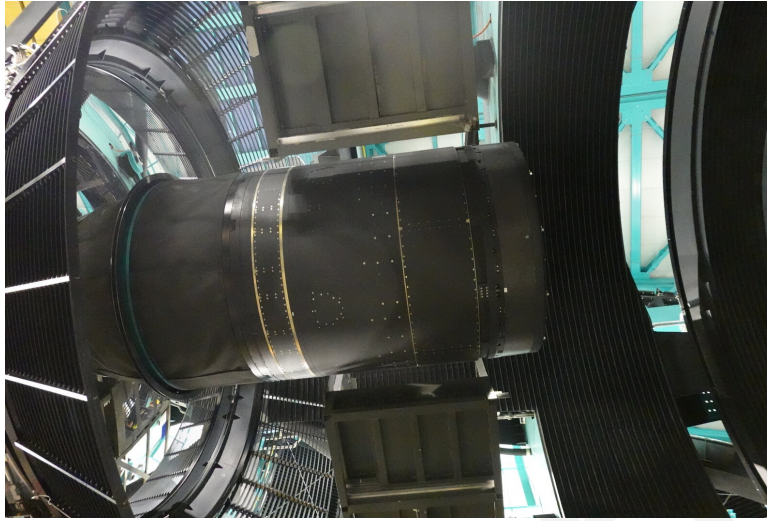
The dominant filter-exchange failure mode: a carousel clamp fails to open or lock within the allowed time, faulting the changer and costing observing time. It was attacked from three sides — automated unclamping recovery in July (essentially 100 % success once deployed, error rate below 1 in 400 over 1000 exchanges), mechanical servicing and greasing of the socket clamps during the October shutdown (the grease not having been renewed since 2021), and a warm-up brake sequence in November — yet socket-specific faults were still occurring in December. A filter had to be removed from the camera in July when socket 3 could not be trusted.

FIGURE 33: **FES-01.** The camera on the telescope with the filter-exchange region in view, on the night the final science-filter complement was in place (2025-10-30, #cam-summit-ops).

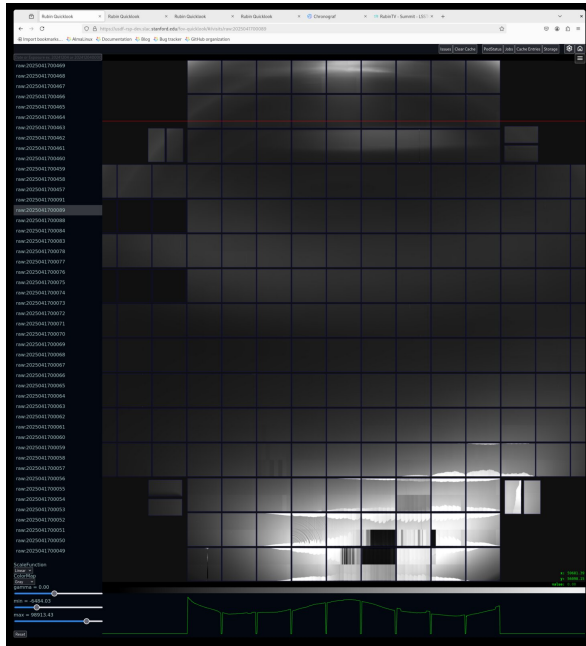
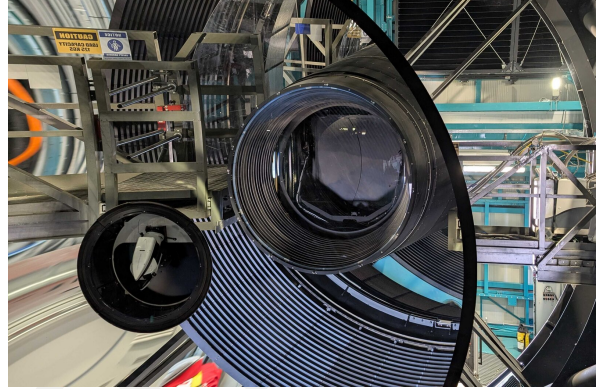
Light reaching the focal plane with the shutter closed repeatedly tripped the HV bias: sunlight through an open P-flow door with the mirror covers open, head lamps and light past the filter-loader door during FES work, a laser tracker left running all day, dome floodlights during a public demonstration, dome lights switched on by accident (about 20 channels tripped, all ITL rafts), and specular reflection of the moon within roughly 20 degrees. Each case produced a procedural rule — mirror covers closed when the P-flow is open, a minimum moon-avoidance angle, HV off during dome-shutter and filter operations — and the trips became less frequent, but the mechanism is unchanged.

FIGURE 35: **OPT-01.** Left: a focal-plane image taken while light was reaching the sensors with the shutter closed (2025-04-17). Right: the camera and the open P-flow area on the day light through that route tripped the HV bias (2025-05-06).

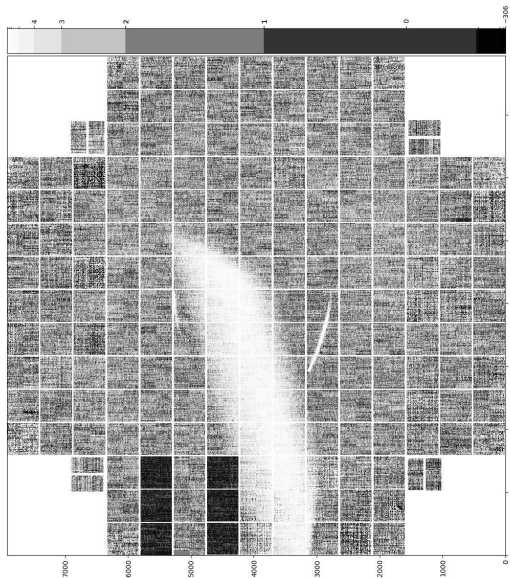
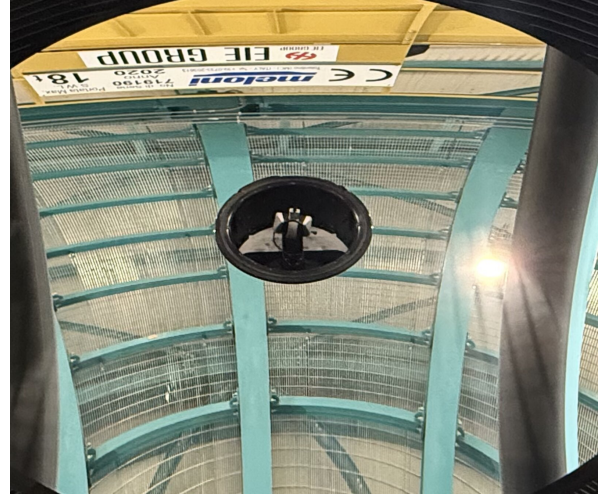
**OPT-02 “Banana” stray-light feature in darks and flats.** *First to last mention 2025-04-19 to 2025-04-20; status **Transferred**.* A banana-shaped feature appeared in dark and flat images, partly rotating with telescope azimuth and partly fixed, with equipment near M1M3 such as a laser tracker suspected as the source; reinstalling the pinhole filter was proposed as a partial mitigation for extended stray light. No follow-up appears in either channel: the investigation was handed over to the stray-light group and is tracked there.

FIGURE 36: **OPT-02.** Left: the banana-shaped feature in the focal plane that gave the issue its name. Right: the dome interior photographed the same evening while looking for its source (2025-04-19, #cam-operator).

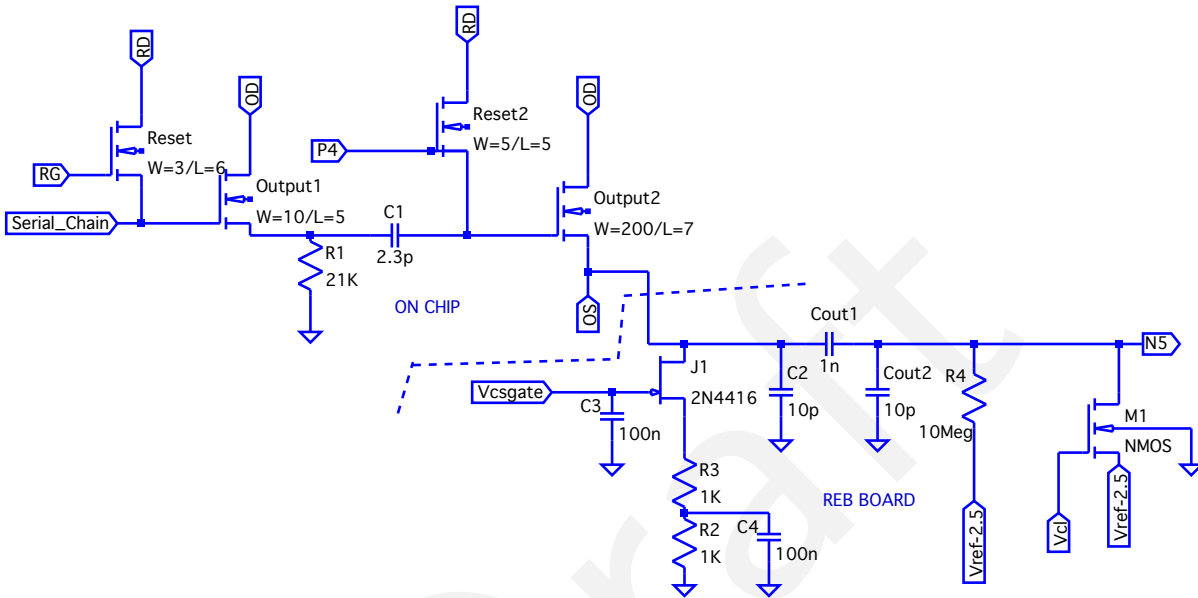
Taking the excess current of the two April events to flow through a resistive path,  $R_{\text{short}} = V/\Delta I$  gives 125 and 208  $\Omega$  (Marshall, 2025b). Each April trip is accompanied by a rise of the cryostat pressure from  $1.31 \times 10^{-7}$  to  $1.47 \times 10^{-7}$  Torr, decaying over a few minutes, and by a  $\sim 0.25$   $^{\circ}\text{C}$

excursion of focal-plane/R30/Reb1/Temp9, indicating localised power dissipation at the fault site.

FIGURE 45: The e2v output stage and the first stage of the REB circuit, drawn by C. Lage (Lage, 2025). The two on-chip source followers (*Output1*, *Output2*) are coupled through *C1*, with the clamp *Reset 2* on that node driven by *P4*; *Output2* drives the OS pin into the current source *J1* on the REB, whose return to ground through *R3* and *R2* carries the per-segment current monitor. The suspected short is from the OS node to ground.

**2.1.1.3 Interpretation.** A shorted segment reading zero current follows from where the currents are measured (Fig. 45). Each segment current is monitored on the low side of that segment's current source, its return to ground, whereas the OD current is measured only as a total, for the CCD's OD supply as a whole. If the output node of a segment is held at 0 V by a short to ground, the current source cannot force its current and the segment monitor reads 0 mA. An open connection reads the same, since a current source cannot impose a current into an unterminated node either.

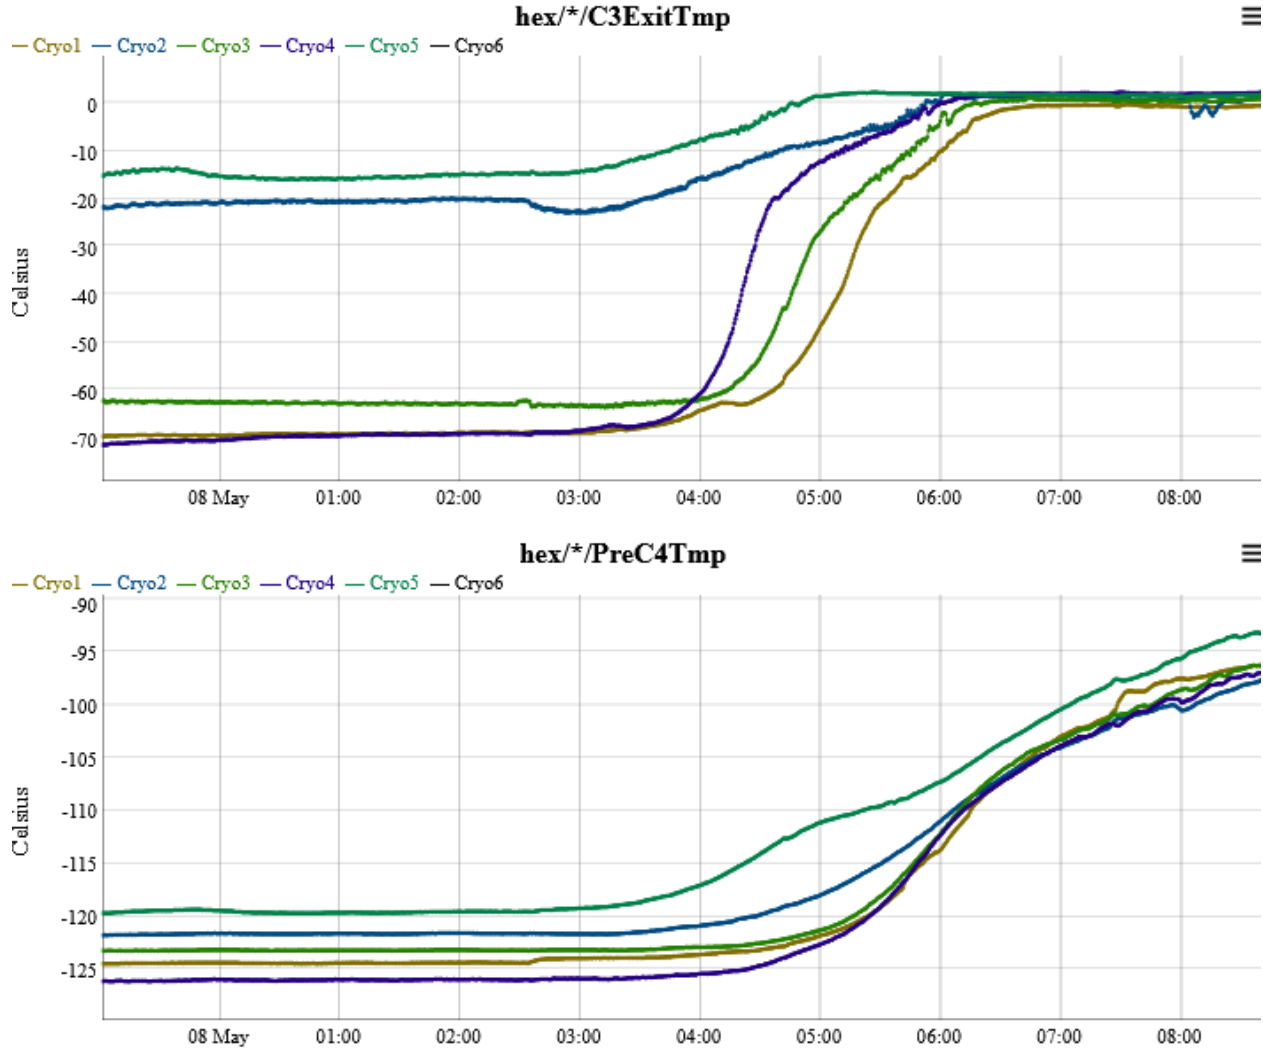
All five running circuits have the C3ExitTmp warm up closer to 0 C, indicating that the refrigerant C3 flow was reduced. This is shown in Figure 53

All five running circuits showed an increase in PreC4Tmp, indicating that the C4 flow was reduced. This is shown in Figure 53

FIGURE 53: C3ExitTmp and PreC4Tmp of each Cryo circuit at around 6 am on May 8, 2025

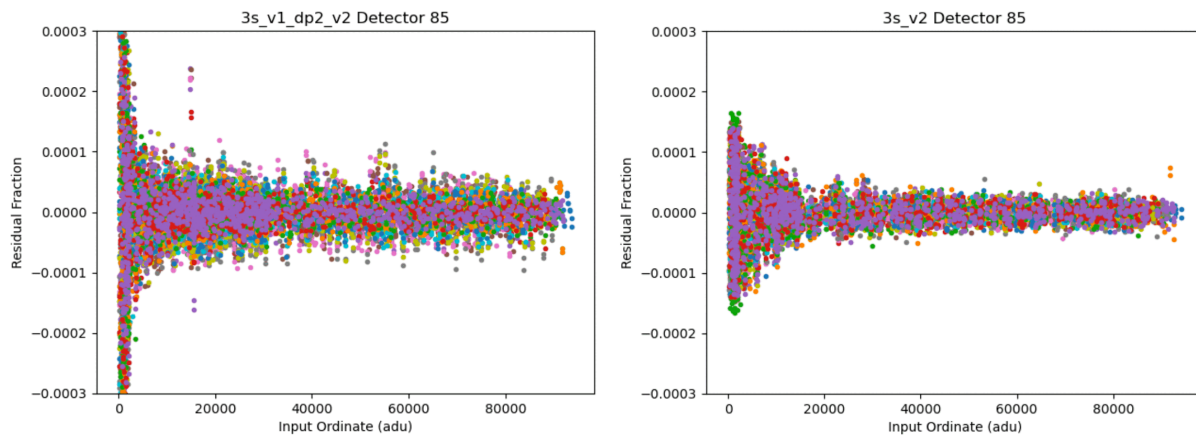
FIGURE 82: The same comparison for e2v detector 85, which was already in better shape. Left:  $3s\_v1\_dp2\_v2$ . Right:  $3s\_v2$ .

A handful of inner amplifiers still show structure in the  $3s\_v2$  residuals, and the patterns differ from one another. On detector 41 (R22\_S12\_C14) the residuals appear correlated with the overscan level, which is not typical of the focal plane. On detector 48 (R12\_S10\_C07) they cor-

relate with time and possibly with the REB temperature, and on detector 152 (R33\_S22\_C03) with time alone, in both cases for a single amplifier on an otherwise well-behaved detector. These are the linearity counterpart of the gain-temperature outliers noted above.
