## The LSST Camera commissioning

CTN-007

This technote describes what we found during the LSST Camera commissioning.

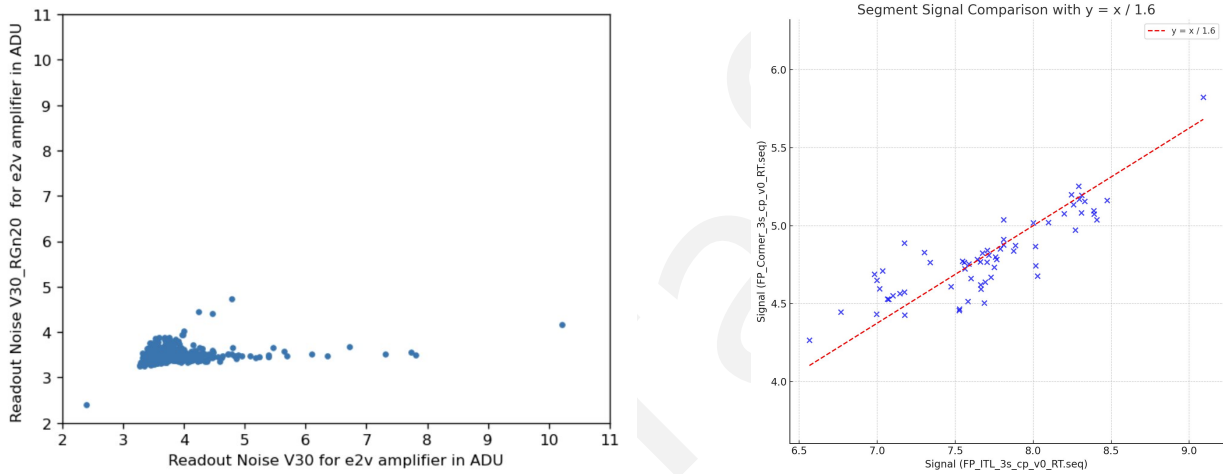
mention 2025-04-26 to 2025-12-29; status **Resolved**. A year-long programme rather than a fault: new sequencer files to address e2v noise and covariance anomalies (clear improvement on e2v, little change on ITL), the 3 s readout sequencers, and finally the retuning of the sequencer clock to 6.4 ns. The natural-frequency firmware was tested on the summit in December in three campaigns and used for a holiday calibration run, but was not promoted to the default slot; the dense photon-transfer curve that these changes require was repeatedly deferred through the year. The programme was closed in early January 2026, after the period covered here.

FIGURE 17: **FW-04**. Left: read noise per e2v amplifier with the new sequencer against the old one — most amplifiers unchanged, the worst improved (2025-04-28). Right: segment signal with the 3 s corner-raft sequencer against the ITL one, compared with the expected ratio (2025-06-25).

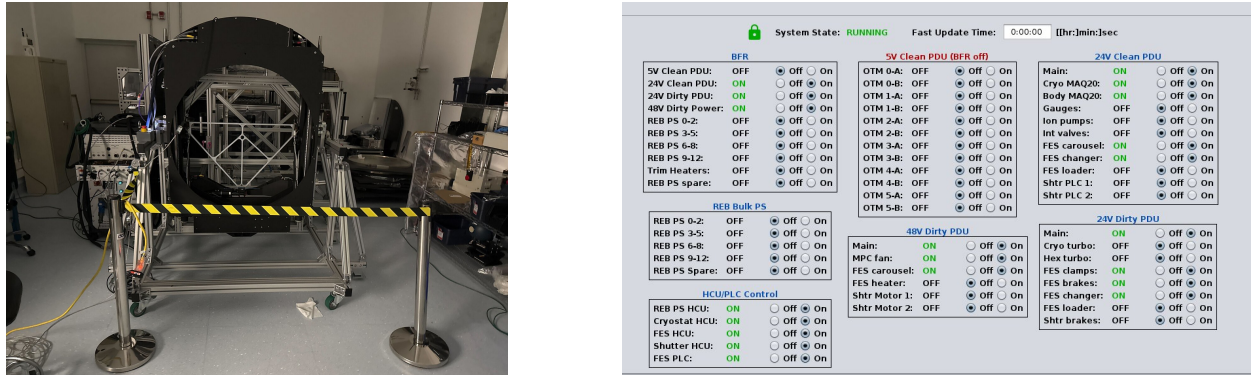
### FES-03 Autochanger trucks, homing and the damaged X+ clamp motor. *First to last mention 2025-02-13 to 2025-12-13; status **Open**?* The autochanger truck controllers fault with undervoltage errors after losing homing, a problem that first blocked filter exchange in February and reappeared in December (OBS-1454); a new automated homing procedure

was qualified in hardware in March but the old method was kept for first photon. Separately the X+ online clamp motor, damaged in summer 2023, faulted repeatedly during April exchanges and was never repaired. Alignment test campaigns ran in September; what they concluded is not recorded in these channels.

FIGURE 29: **FES-03**. Left: an autochanger on its stand in the clean room, where the homing procedure was qualified (2025-04-07). Right: the quadbox power panel, whose FES carousel, clamp, loader and brake channels are the supplies behind the truck undervoltage faults (2025-02-13).

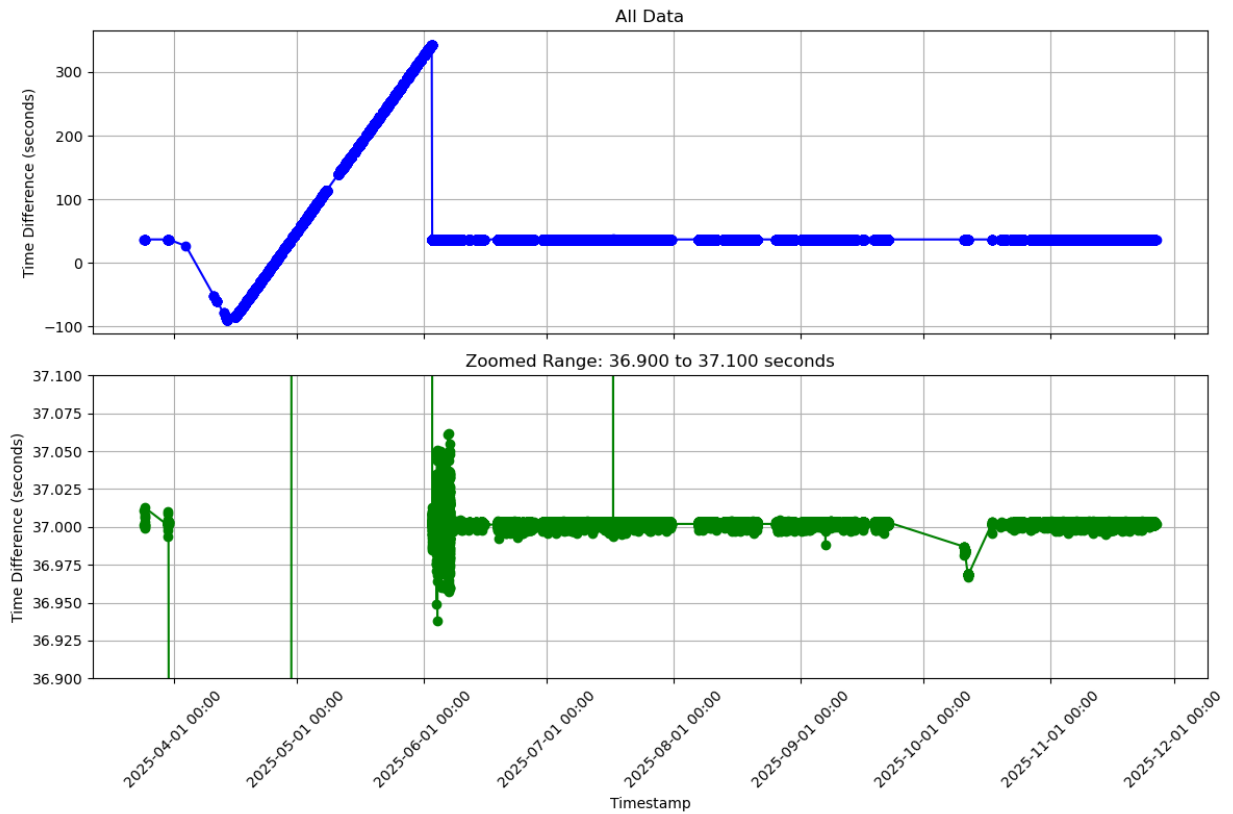
FIGURE 57: Timing between the CCS time when takeExposure was recorded and the time when the motion profile records the startTime. This does not reflect the actual shutter motion timing.

in the MCM log (“sent takeExposure to shutter1”) were paired with TAI timestamps from motion profiles (“startTime.tai.isot”). Because TAI leads UTC by 37 seconds, the expected difference is approximately: *37 seconds + system/network jitter*. Plotting these deltas reveals three operational periods during 2025 in Figure 57:

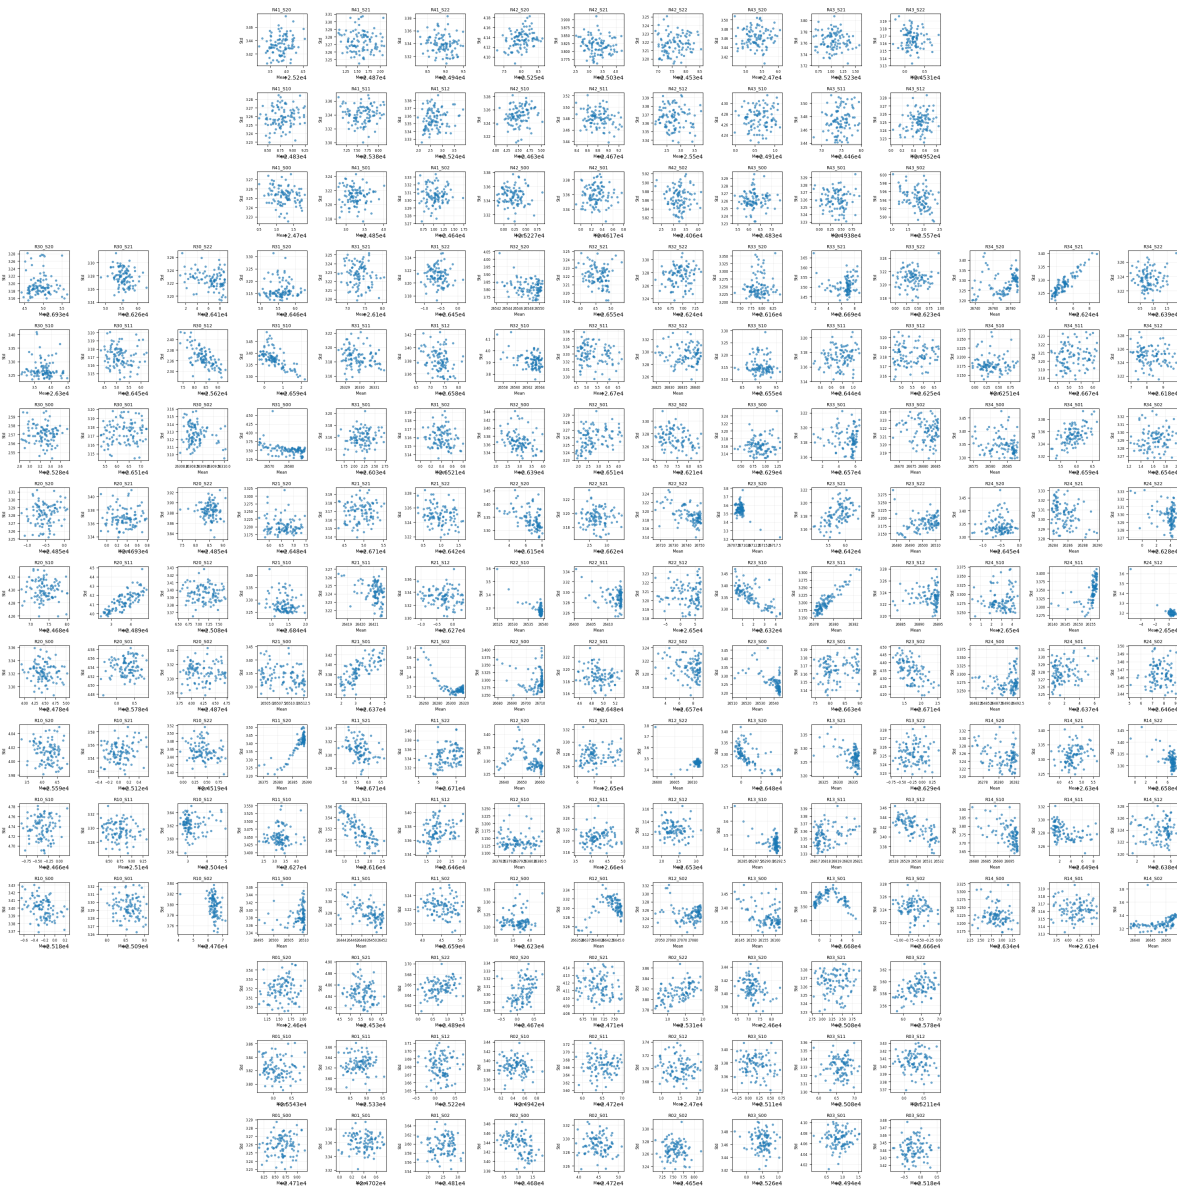
Overscan Mean vs Std for all Rafts/Segments (20251214, seqnum 211-309)

FIGURE 65: Overscan mean versus overscan standard deviation for all rafts and sensors (20251214, sequence numbers 211–309), one amplifier per sensor. The distinct populations seen before the firmware change (Figure 61) are absent.

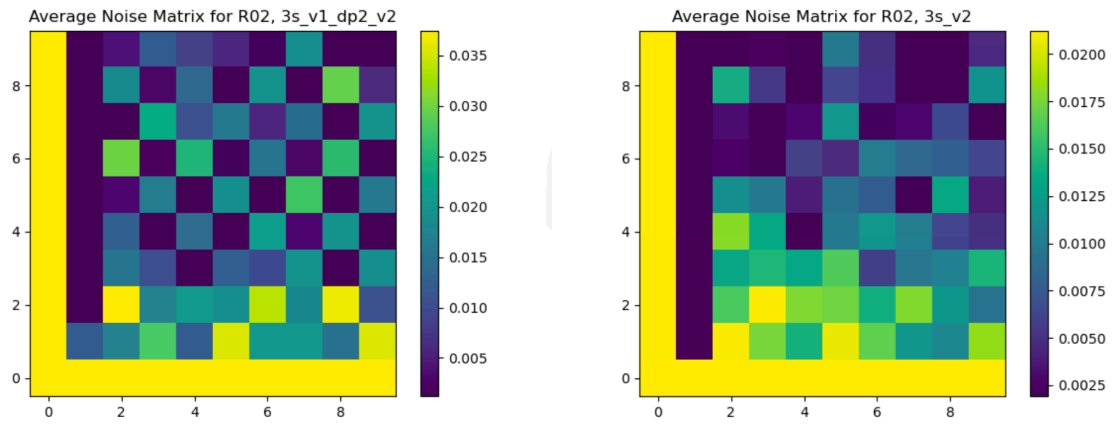
FIGURE 75: Average PTC noise matrix over raft R02 (ITL). Left: 3s\_v1\_dp2\_v2. Right: 3s\_v2 (E. Rykoff).

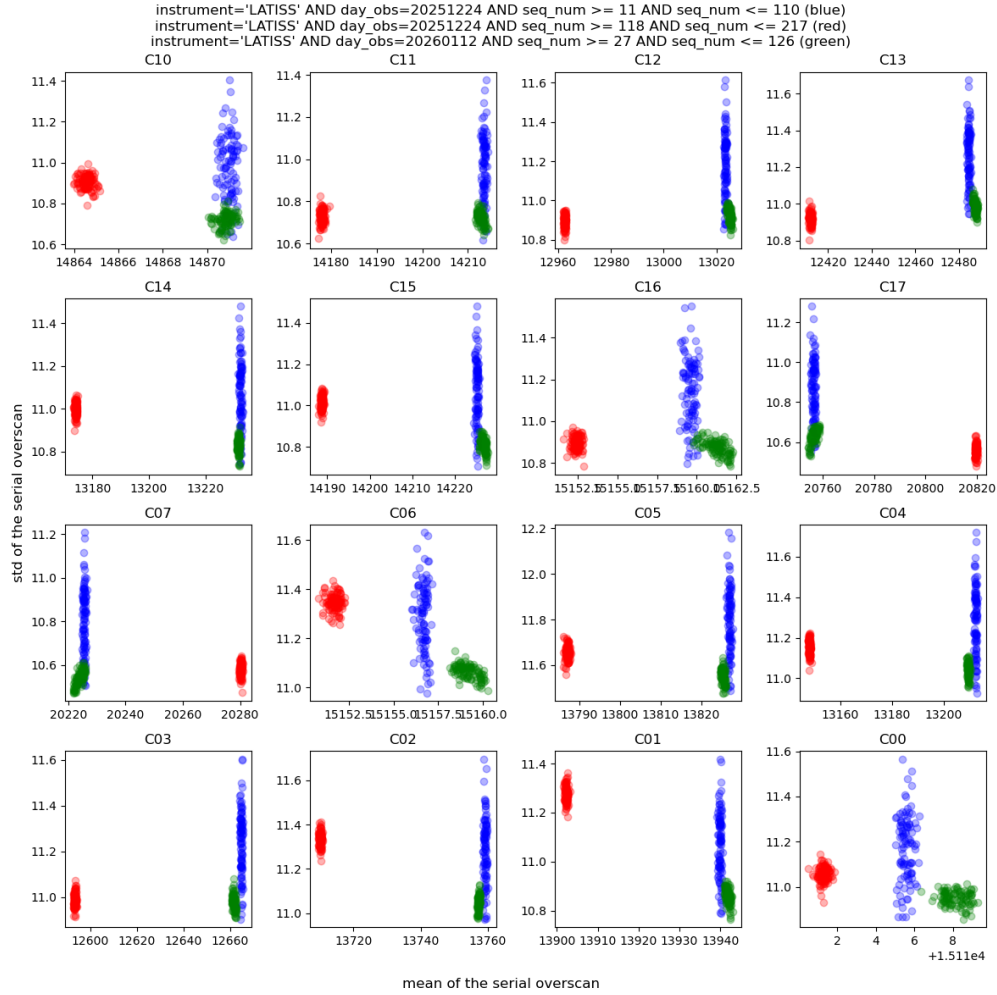
**3.1.3.12 LATISS testing (WREB).** The WREB behaves differently. The noise measurement in the noise-bias plane is noisier than for the science rafts (Figure 81), and print-through was identified as the cause: a section of the serial overscan shows the print-through structure directly (Figure 82). Disabling the ASPIC temperature read made the print-through go away. The pattern in the covariance, however, still exists in a different form, and is present whether or not the science rafts are running the natural frequency firmware (Figure 83).

FIGURE 81: Standard deviation versus mean of the serial overscan for each amplifier of LATISS, for three acquisitions: 20251224 sequence numbers 11–110 (blue), 20251224 sequence numbers 118–217 (red) and 20260112 sequence numbers 27–126 (green).

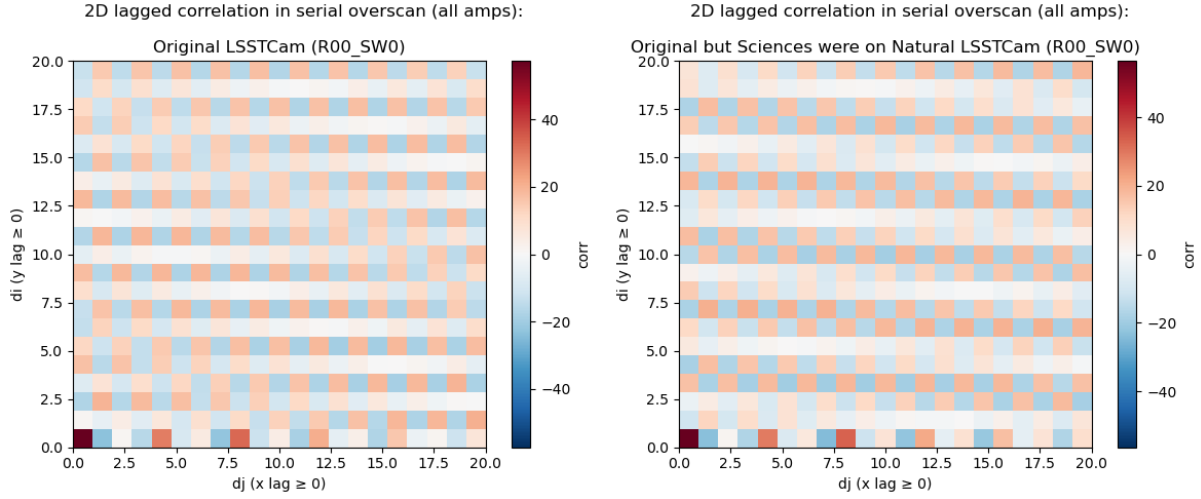
FIGURE 83: Two-dimensional lagged correlation in the serial overscan for R00\_SW0. Left: original configuration. Right: original WREB configuration while the science rafts were running the natural frequency firmware. The pattern persists in both.

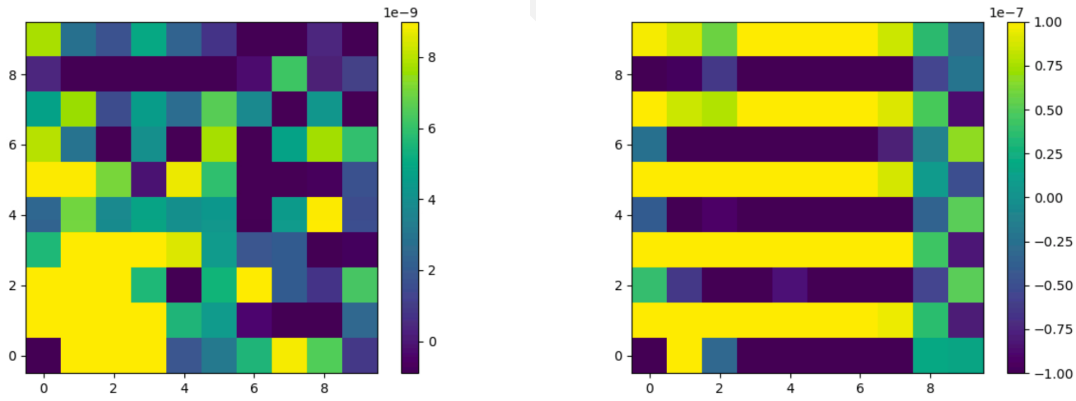
The PTC products flag a wavefront problem of their own: one amplifier, R40\_SW1\_C13, produces an  $A$  matrix in the new run that is clearly wrong, showing alternating rows that saturate both ends of a colour scale two orders of magnitude larger than expected, where the old run gave the smooth brighter-fatter structure (Figure 84). Whether this is the same underlying

FIGURE 84: A matrix for R40\_SW1\_C13. Left: old run, as expected. Right: new run, with alternating rows and a colour scale two orders of magnitude larger (E. Rykoff).
