Vera C. Rubin Observatory  
Rubin Observatory Operations

## The LSST Camera commissioning

CTN-007

This technote describes what we found during the LSST Camera commissioning.

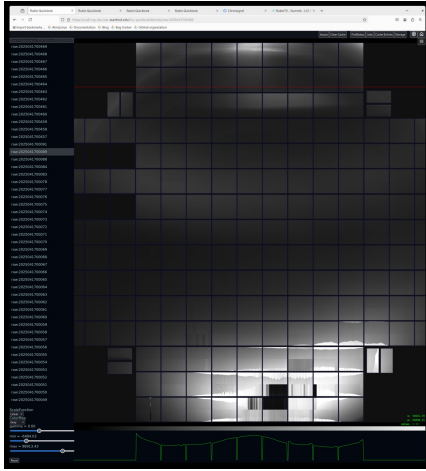
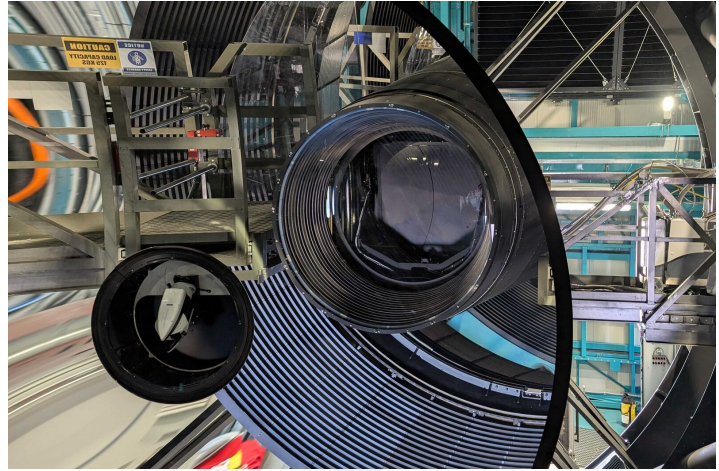
**OPT-01 Stray-light HV bias trips.** *First to last mention 2025-04-17 to 2025-10-22; status **Workaround**.*

FIGURE 30: **OPT-01**. Left: a focal-plane image taken while light was reaching the sensors with the shutter closed (2025-04-17). Right: the camera and the open P-flow area on the day light through that route tripped the HV bias (2025-05-06).

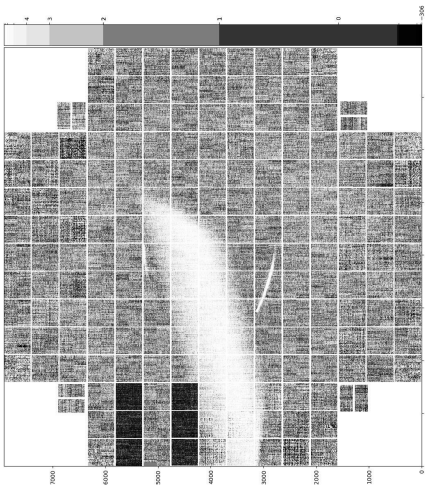
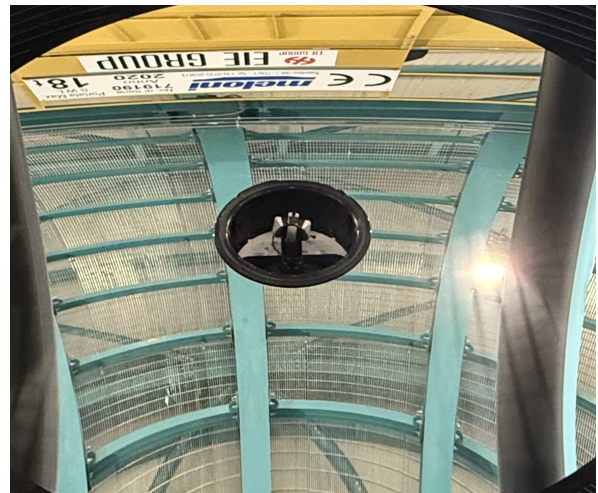
**OPT-02 “Banana” stray-light feature in darks and flats.** *First to last mention 2025-04-19 to 2025-04-20; status **Transferred**.* A banana-shaped feature appeared in dark and flat images, partly rotating with telescope azimuth and partly fixed, with equipment near M1M3 such as a laser tracker suspected as the source; reinstalling the pinhole filter was proposed as a partial mitigation for extended stray light. No follow-up appears in either channel: the investigation was handed over to the stray-light group and is tracked there.

FIGURE 31: **OPT-02**. Left: the banana-shaped feature in the focal plane that gave the issue its name. Right: the dome interior photographed the same evening while looking for its source (2025-04-19, #cam-operator).

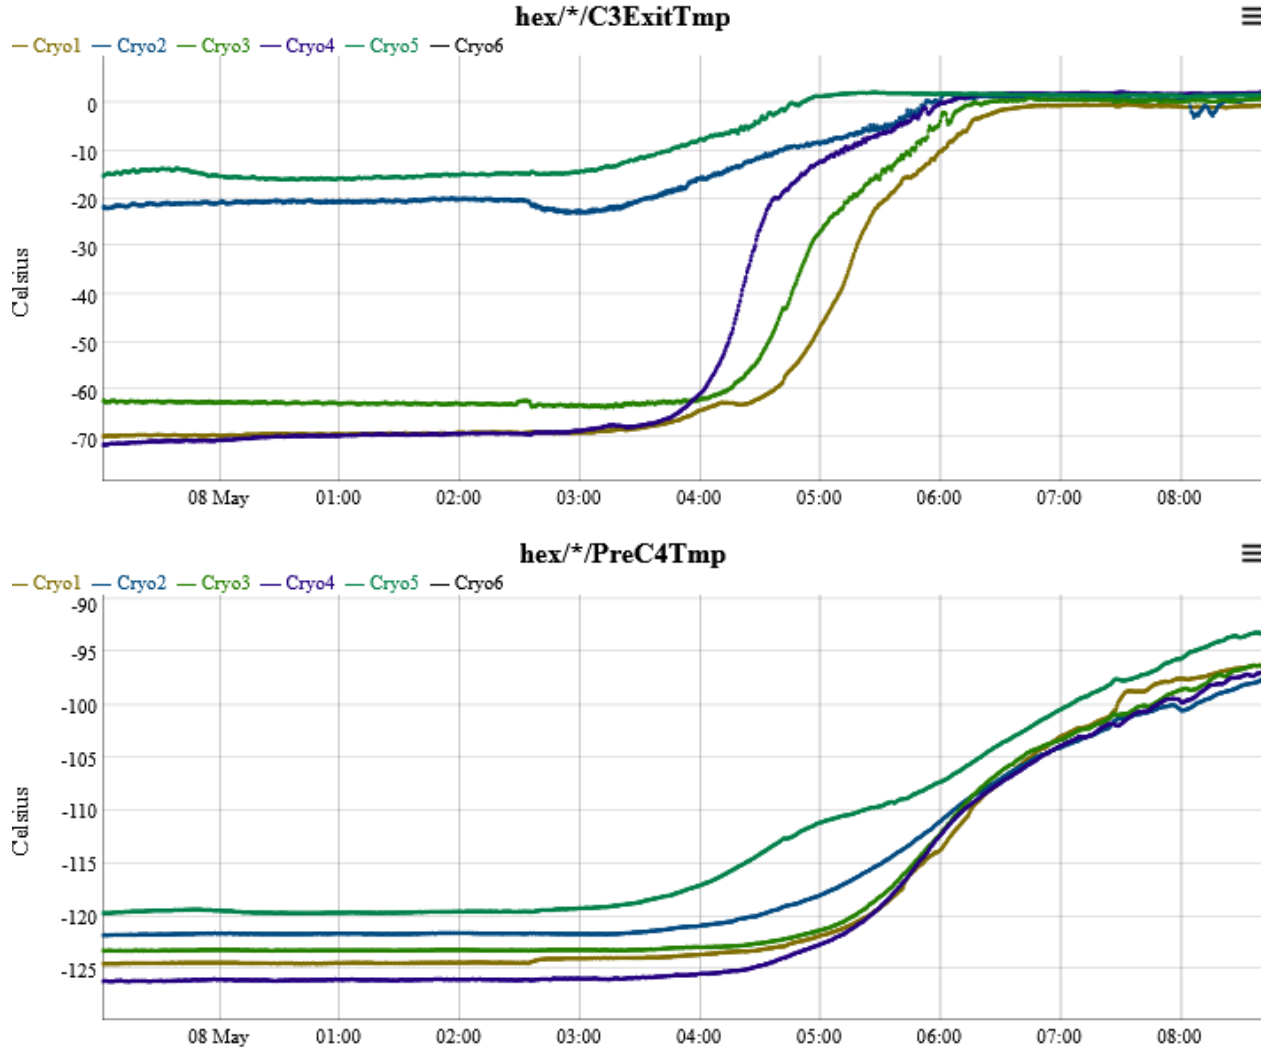
All five running circuits have the C3ExitTmp warm up closer to 0 C, indicating that the refrigerant C3 flow was reduced. This is shown in Figure 48

All five running circuits showed an increase in PreC4Tmp, indicating that the C4 flow was reduced. This is shown in Figure 48

FIGURE 48: C3ExitTmp and PreC4Tmp of each Cryo circuit at around 6 am on May 8, 2025

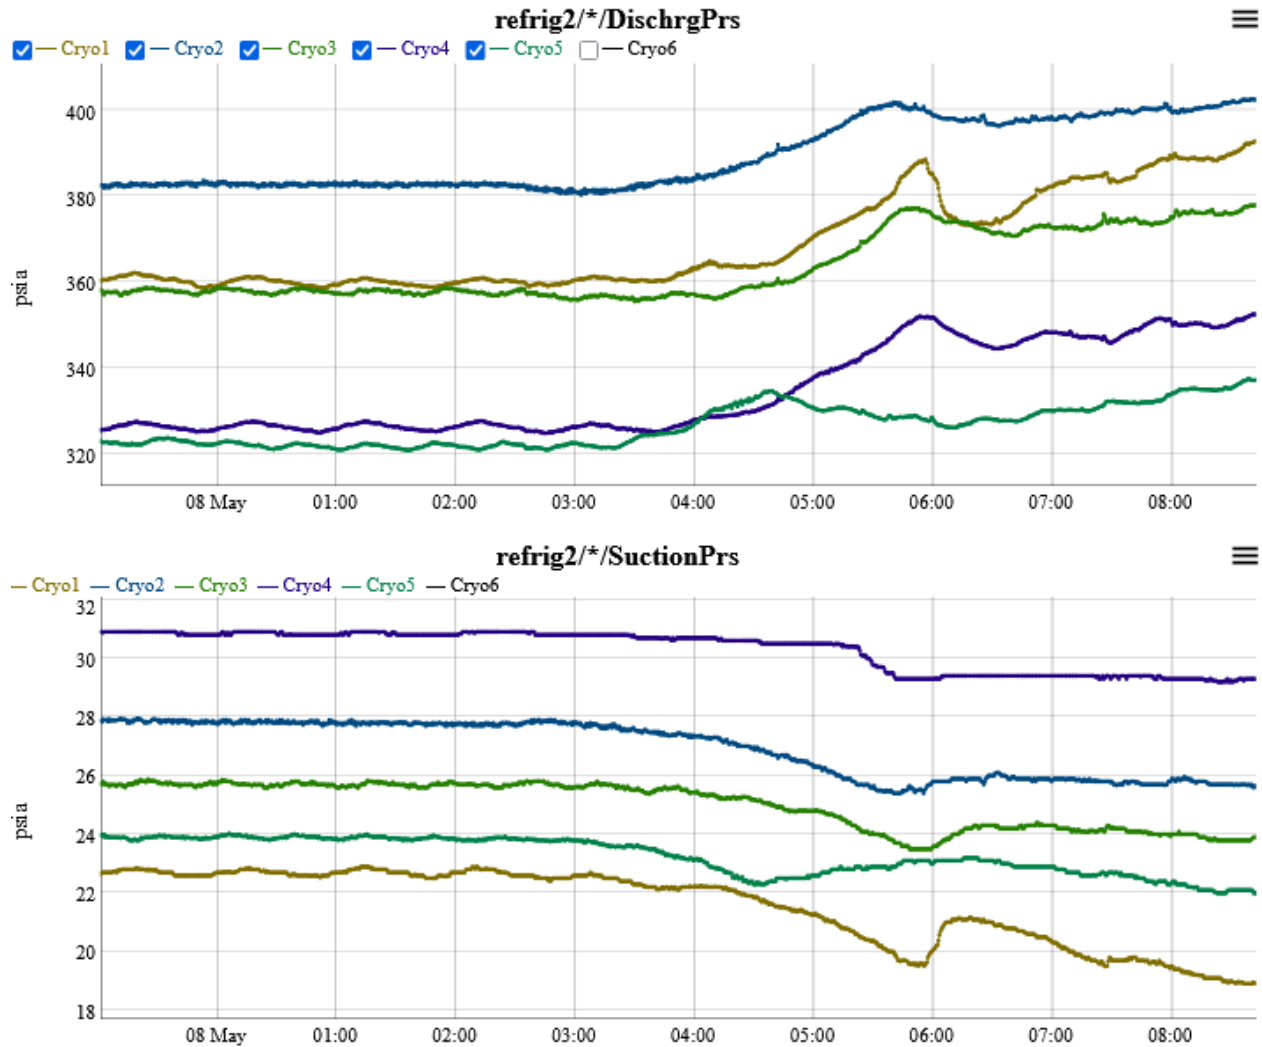
All five running circuits showed increase in discharge pressure and reduction in suction pressure, indicating that there was an increase in flow impedance. This is shown in Figure 49

FIGURE 49: Discharge and suction pressure of each Cryo circuit at around 6 am on May 8, 2025

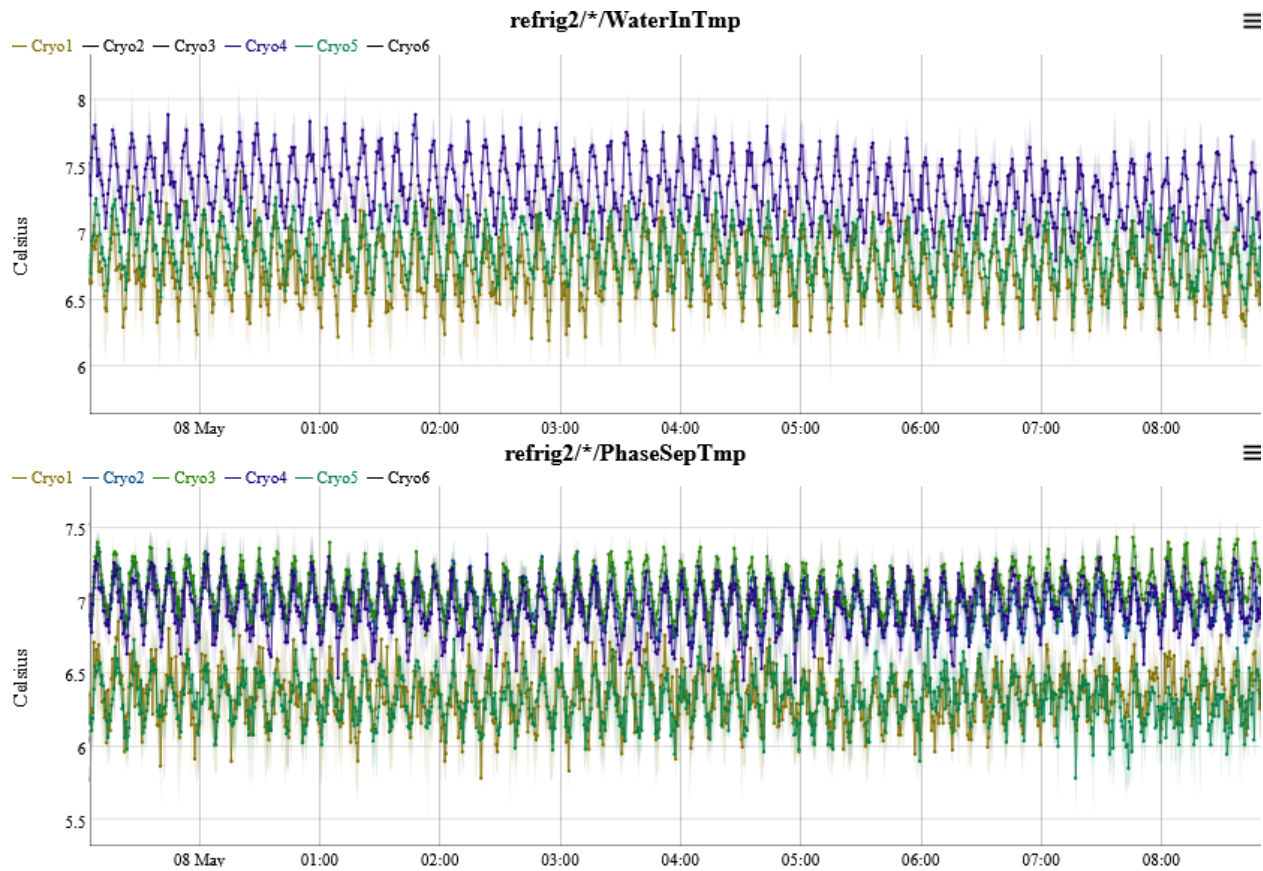
The glycol/water supply temperature was 7 C and the phase separator was at around 7 C at the time being, as shown in Figure 50.

FIGURE 50: Glycol/Water Inlet temperature and phase separator temperature of each Cryo circuit at around 6 am on May 8, 2025

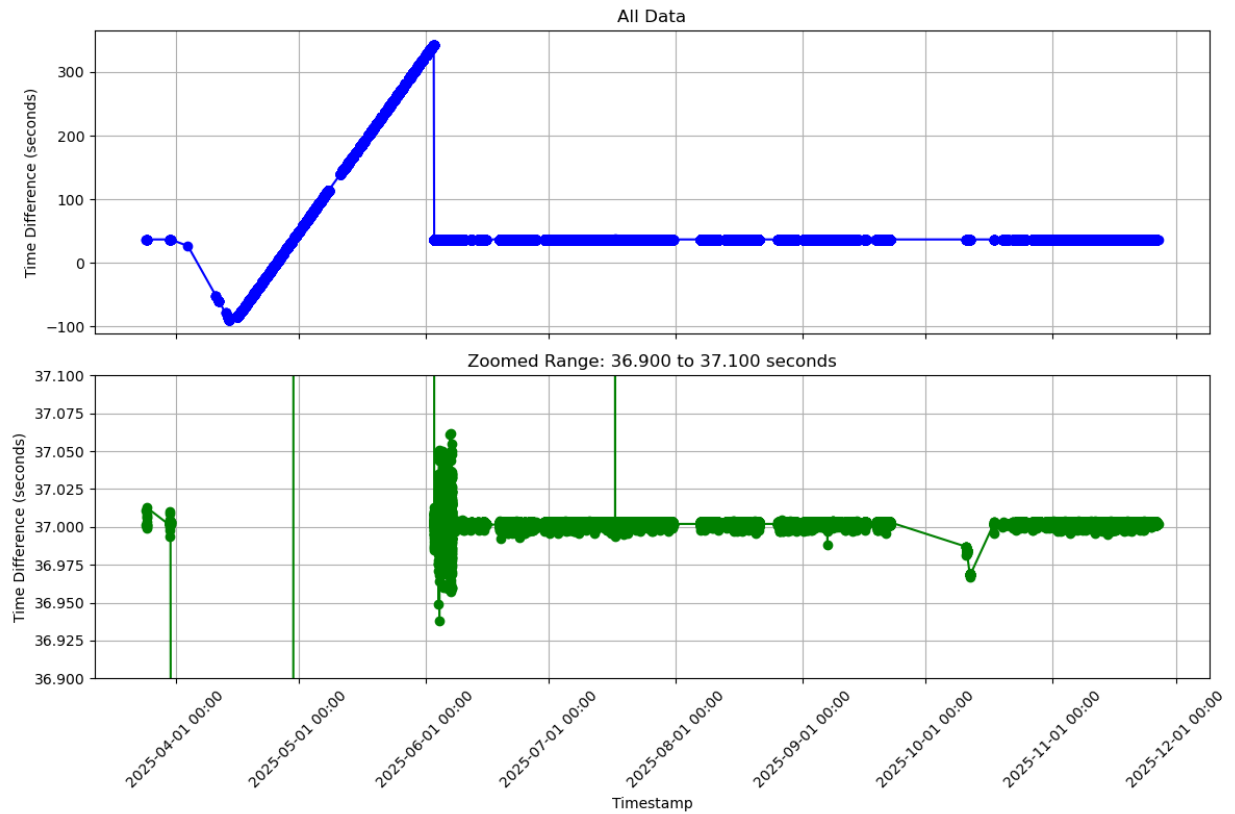
FIGURE 57: Timing between the CCS time when takeExposure was recorded and the time when the motion profile records the startTime. This does not reflect the actual shutter motion timing.

in the MCM log (“sent takeExposure to shutter1”) were paired with TAI timestamps from motion profiles (“startTime.tai.isot”). Because TAI leads UTC by 37 seconds, the expected difference is approximately: *37 seconds + system/network jitter*. Plotting these deltas reveals three operational periods during 2025 in Figure 57:

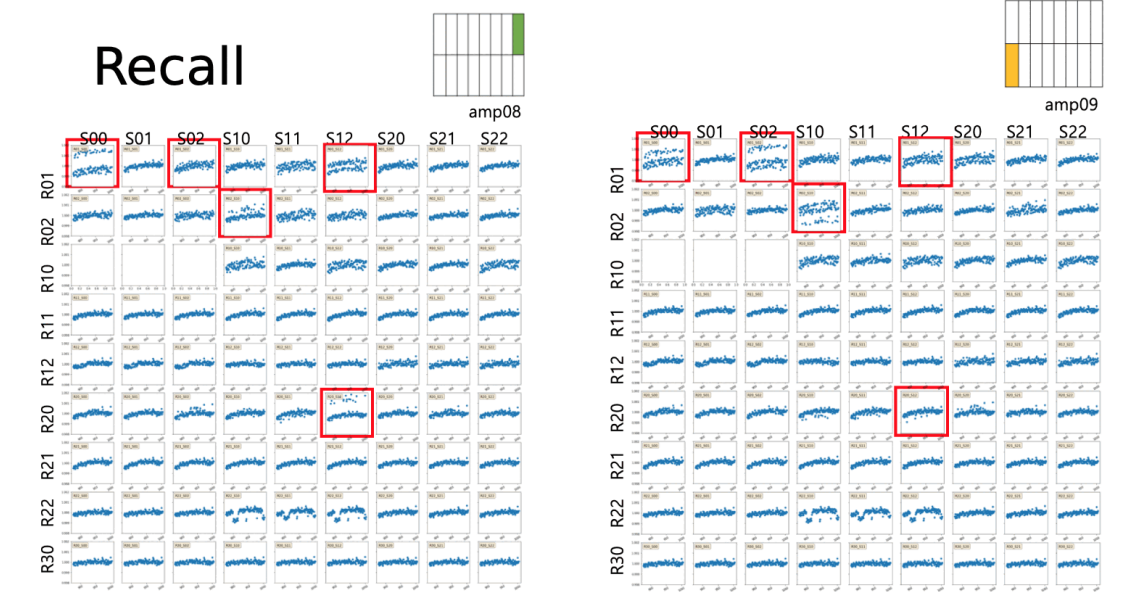
Gain jumps had been known since 2020, when Hyeyun Park found that the measured gain of a given amplifier could move between discrete values from one acquisition to the next, at the sub-percent level (Figure 60). This triggered the RTM-004 optimization runs,<sup>2</sup> and the effect was partially mitigated at the time by a change of the output drain (OD) voltage.

FIGURE 60: Gain measurements per sensor across the focal plane for two amplifiers (amp08, left; amp09, right). Red boxes mark sensors in which the gain moves between discrete states from one acquisition to the next; the difference between states is at the sub-percent level.

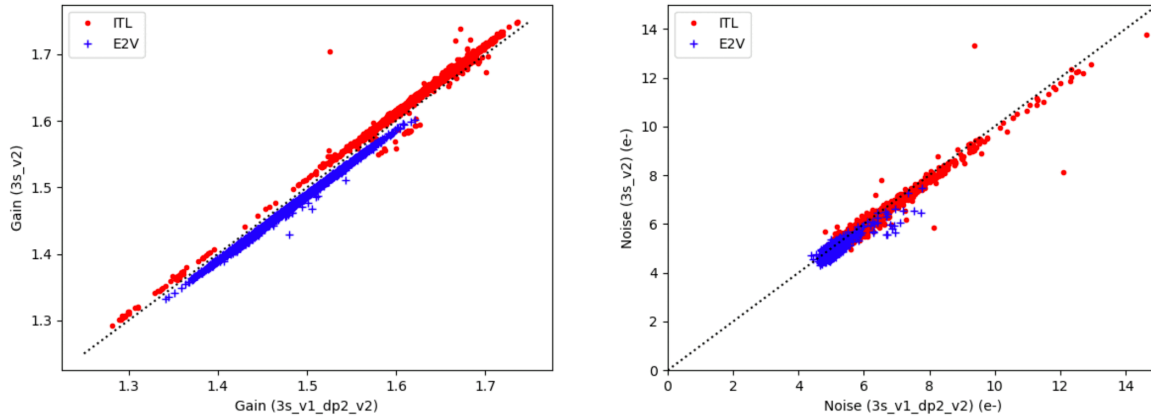
The PTC products give the same result from the flats, amplifier by amplifier across the whole focal plane (Figure 64). The gains move slightly and in opposite directions for the two vendors,

e2v down a little and ITL up a little, which is the vendor- dependent rounding above seen in the gain itself rather than in the noise. The read noise generally decreases for all amplifiers, and for a subset of e2v amplifiers it decreases substantially — presumably the channels that were carrying the excess variance associated with the checkerboard discussed below.

FIGURE 64: Per-amplifier comparison between 3s\_v1\_dp2\_v2 and 3s\_v2 from the PTC. Left: gain. Right: read noise in electrons. The dotted line is equality (E. Rykoff).

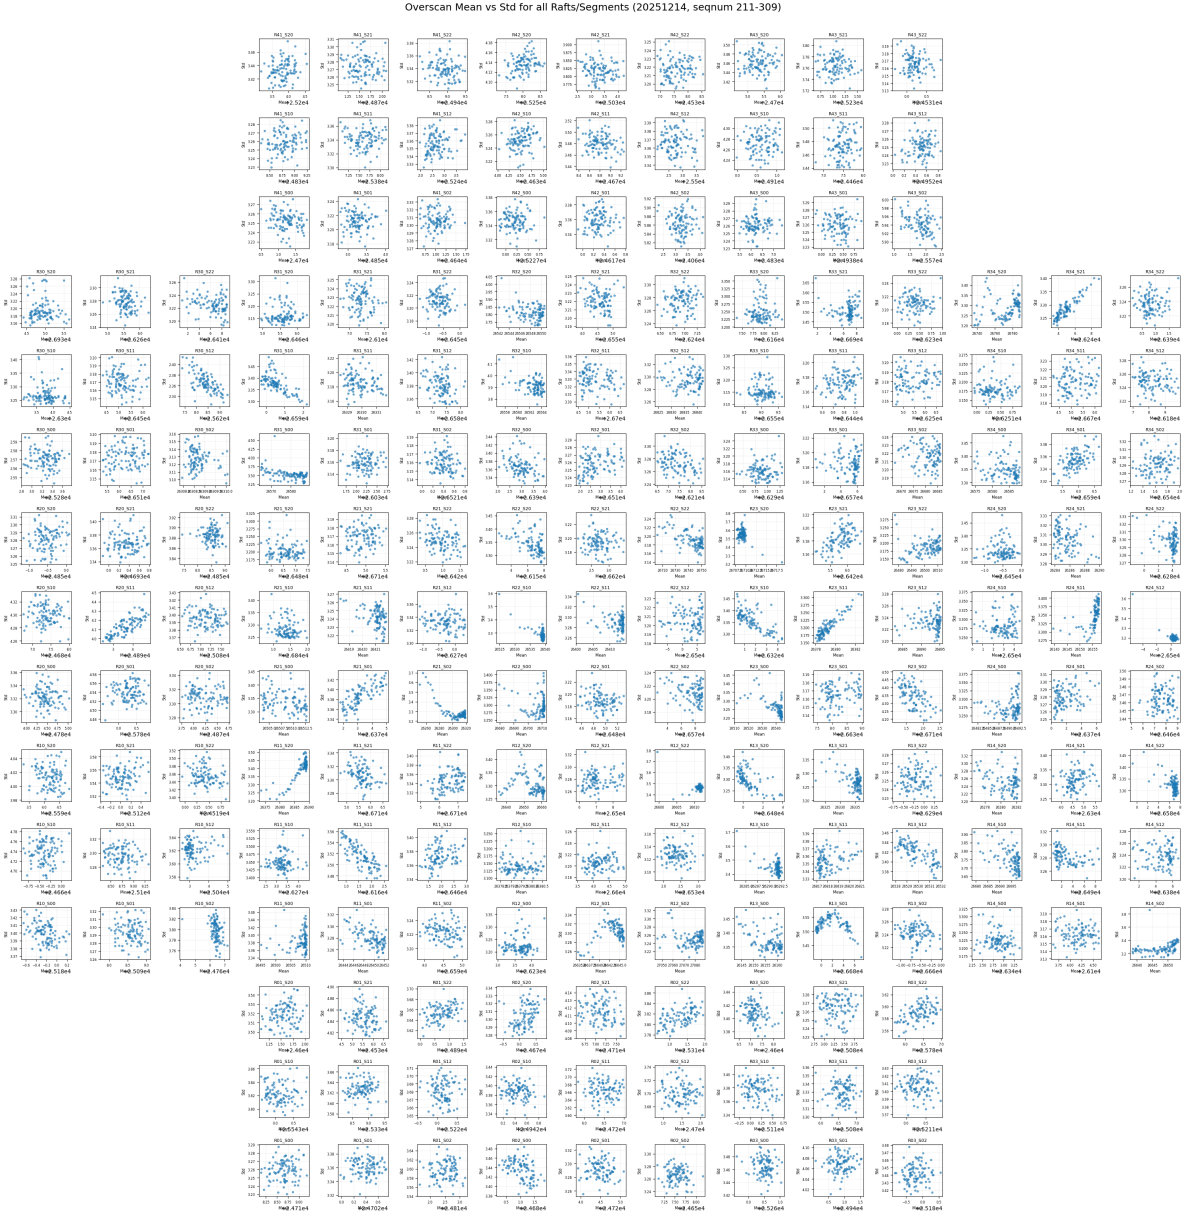
**3.1.3.3 Bias level versus noise.** Plotting the overscan noise against the overscan mean for one amplifier per sensor over the whole focal plane (Figure 65) no longer shows multiple distinct populations. The residual systematic drift within each sensor is consistent with gain and temperature changes over the duration of the acquisition rather than with discrete state changes.

FIGURE 65: Overscan mean versus overscan standard deviation for all rafts and sensors (20251214, sequence numbers 211–309), one amplifier per sensor. The distinct populations seen before the firmware change (Figure 61) are absent.

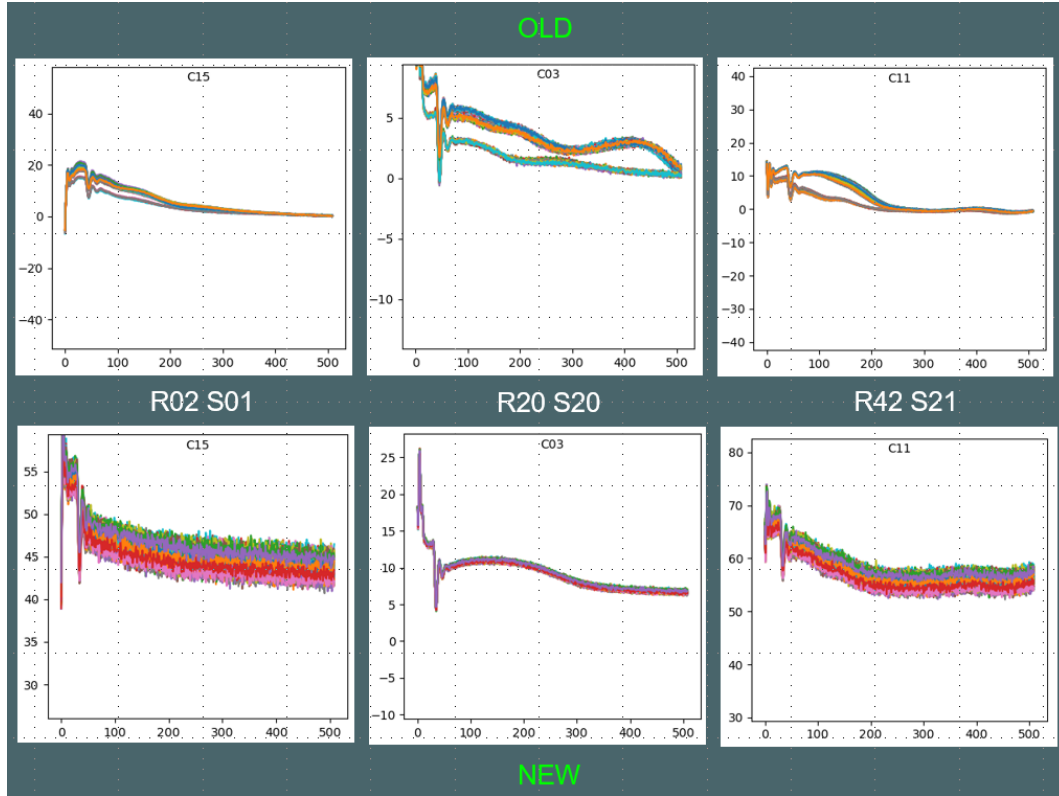
**3.1.3.4 Bias row profiles.** The row profiles measured before and after the change are compared in Figure 66. With the original firmware the profile of a given amplifier differed between exposures; with the natural frequency firmware the profiles from repeated exposures fall on top of each other.

FIGURE 66: Bias row profiles for three amplifiers (R02\_S01 C15, R20\_S20 C03, R42\_S21 C11) with the original firmware (top) and with the natural frequency firmware (bottom, run E1110, 9 December 2025). The profiles become consistent from exposure to exposure (T. Guillemin).

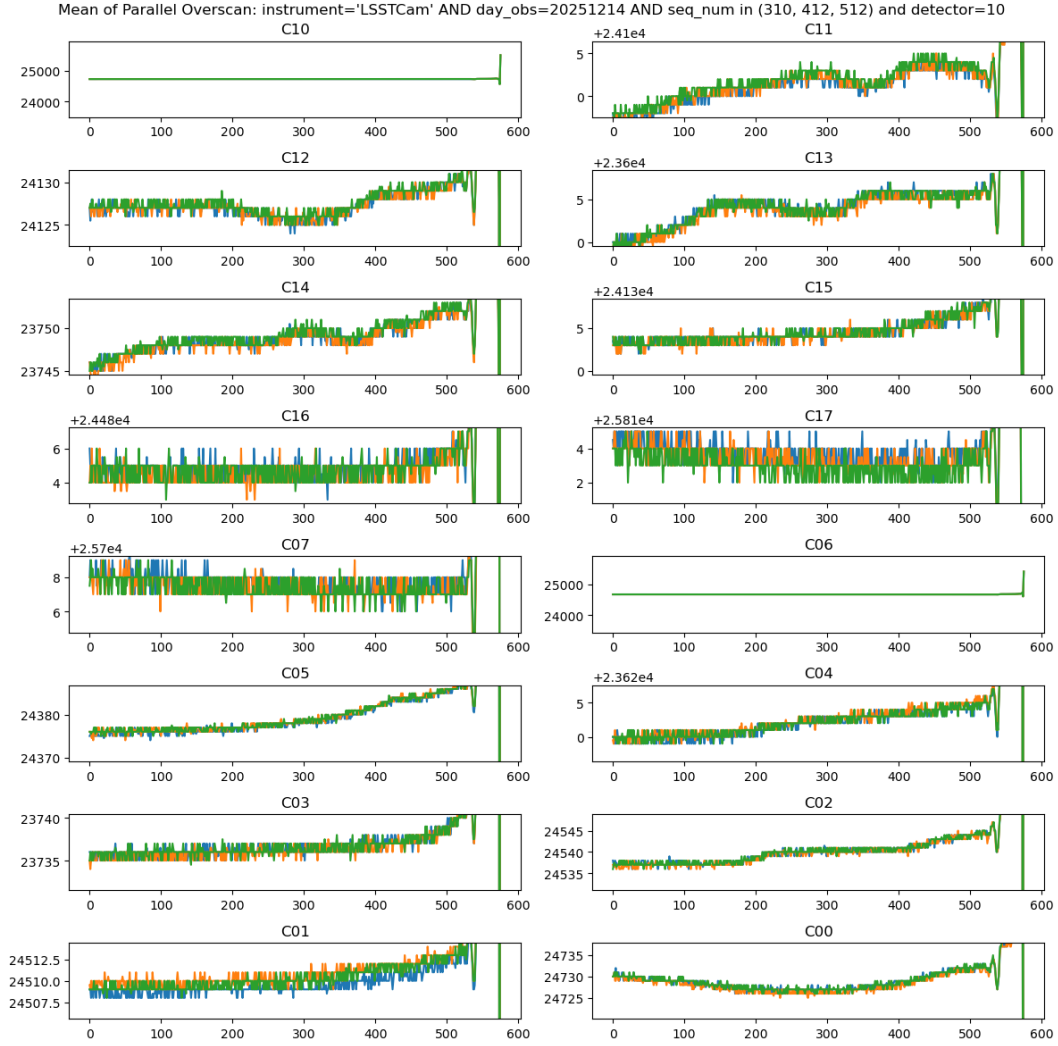
**3.1.3.5 Consistency across resets.** Since the phase shift introduced at REB synchronization persists until a link reset, the acquisitions of 14 December 2025 were split into three runs separated by an RCE reset. The mean parallel overscan profiles of the three runs agree amplifier by amplifier (Figure 67); no change was observed between before and after a reset. Together with the noise agreement above, this points at the 6.4 ns to 10 ns conversion rather than at the REB synchronization as the origin of the multimodality.

FIGURE 67: Mean of the parallel overscan for each amplifier of detector 10, for the three runs of 20251214 separated by an RCE reset (sequence numbers 310, 412 and 512). The three curves overlap in every channel.

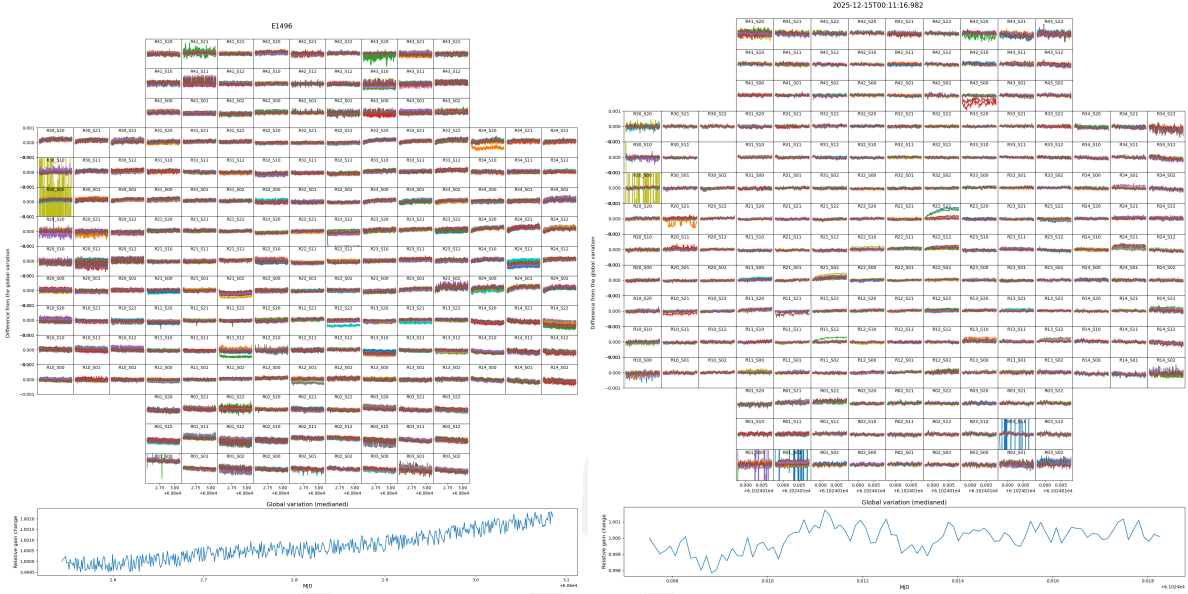
**3.1.3.6 Gain stability.** The relative gain change of every amplifier, measured against the focal-plane median, is shown in Figure 68 without and with the natural frequency firmware. Without it the median gain drifts by more than  $2 \times 10^{-3}$  over the run; with it the drift is removed and the residual per-amplifier scatter is at the level of the measurement noise. The amplifiers that remain noisy in the right-hand panel are noisy intrinsically.

FIGURE 68: Difference of the per-amplifier relative gain from the focal-plane median, and the median itself (bottom panel of each plot). Left: without the natural frequency firmware (run E1496). Right: with the natural frequency firmware (2025-12-15).

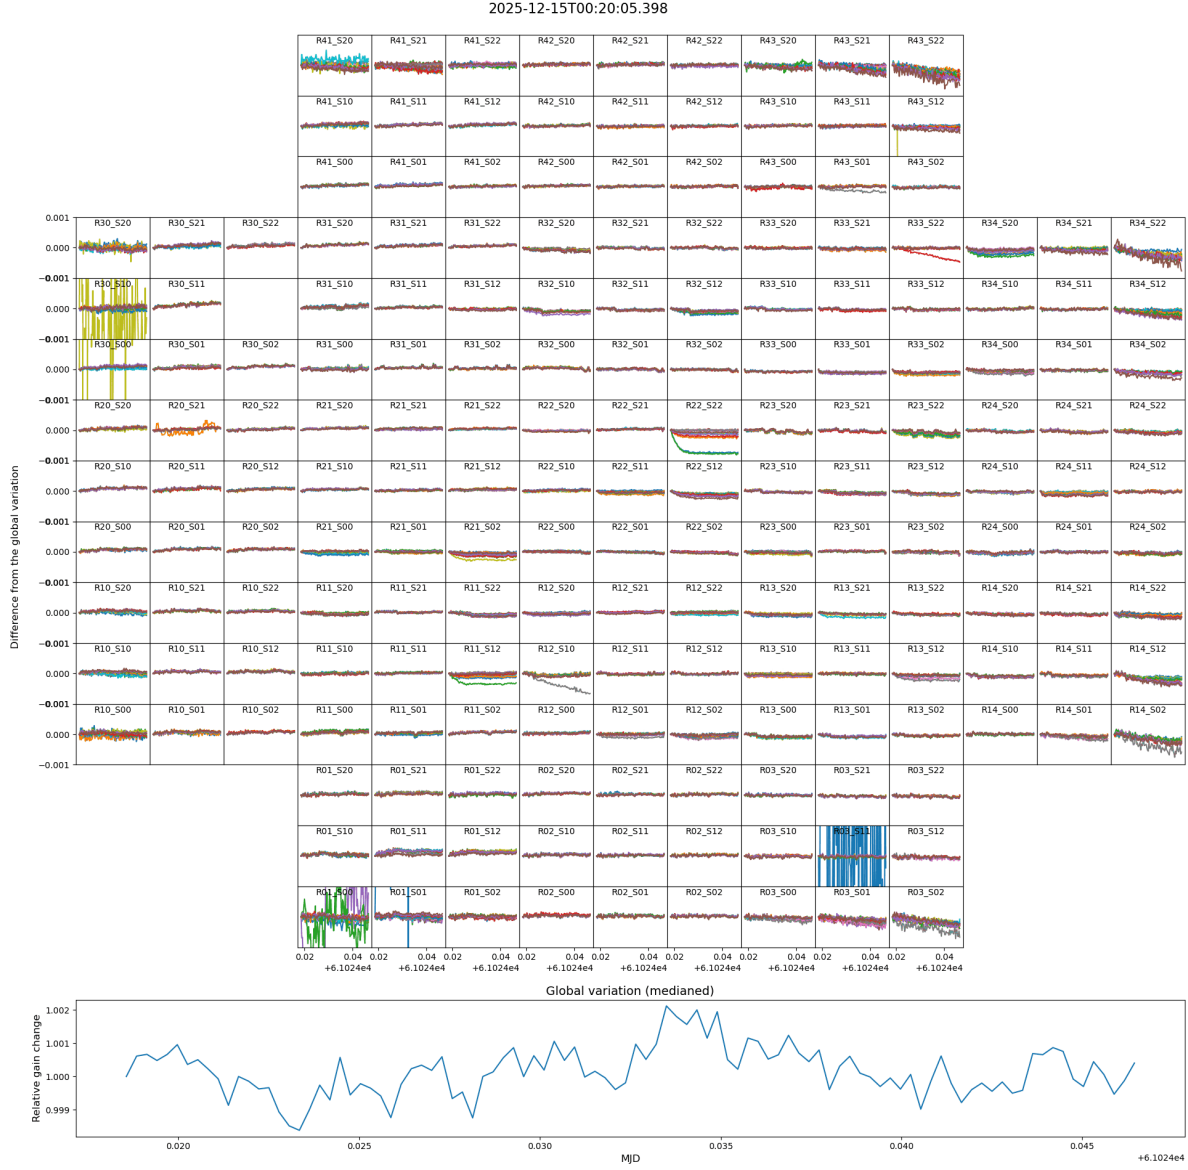
The same measurement performed on the high-flux flats (Figure 69) is to be compared with the specification of 0.1% RMS over 1 h and 1% RMS over 12 h. The majority of the amplifiers are better than  $\mathcal{O}(10^{-4})$ . Three classes of outlier remain: non-stable illumination at the edge of the focal plane, sensor-intrinsic behaviour, and a gain-temperature correlation that is not yet understood. The linearity analysis below finds residual patterns of exactly these two kinds — smooth variation over the night on the vignetted edge detectors, and a time and temperature correlation on isolated amplifiers — which suggests the two campaigns are seeing the same residual effects through different measurements.

FIGURE 69: Relative gain change per amplifier for the high-flux flats acquired with the natural frequency firmware (2025-12-15), in the same format as Figure 68.

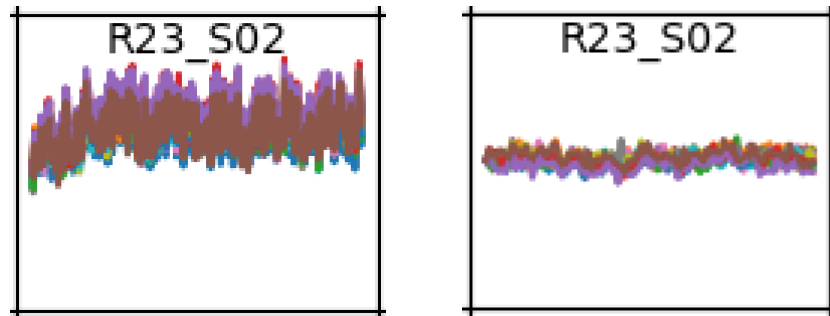
Figure 71 shows the covariances  $\langle \text{cov}_{ij} \rangle$  for all channel pairs of R23\_S02, excluding the self-correlations, before and after the change. The average over pairs, shown as an inset, carries a clear checkerboard in the original data and is flat with the natural frequency firmware. P. Astier interpreted the decaying signal at  $\Delta y = 0$  as a gain variation, which the natural frequency partially cures: the spread of the relative gain of R23\_S02 narrows from roughly  $\pm 10^{-3}$  to a considerably smaller range (Figure 72).

FIGURE 72: Relative gain of R23\_S02 over the course of a run, on a vertical scale of  $\pm 0.001$ . Left: original configuration. Right: with the natural frequency firmware.

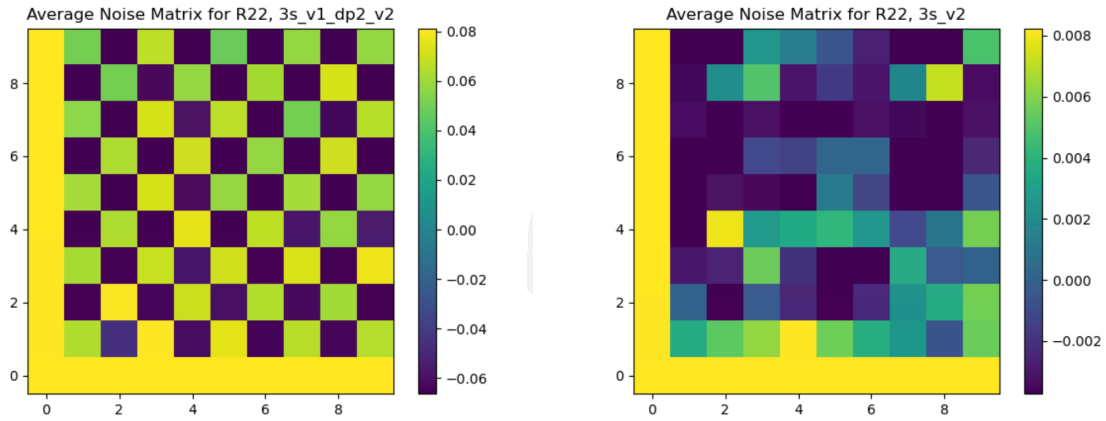
**3.1.3.8 Checkerboard in the PTC.** The PTC products confirm the same result on the flats, through a completely different measurement. Averaged over raft R22, the e2v noise matrix carries an unmistakable checkerboard in  $3s\_v1\_dp2\_v2$ ; with  $3s\_v2$  the pattern disappears and the colour scale shrinks by an order of magnitude, from  $\pm 0.08$  to  $\pm 0.008$  (Figure 73). The  $A$  matrix behaves the same way: the alternating structure that was superimposed on the smooth brighter-fatter falloff is absent in the new data (Figure 74), which means the  $a_{ij}$  measurement is no longer polluted. ITL, averaged over R02, shows the same improvement in the noise matrix at lower amplitude (Figure 75); the ITL  $A$  matrix was already free of the pattern and is essentially unchanged, consistent with the checkerboard having been an e2v effect from the start.

FIGURE 73: Average PTC noise matrix over raft R22 (e2v). Left:  $3s\_v1\_dp2\_v2$ . Right:  $3s\_v2$ . Note that the colour scale differs by a factor of ten between the two panels (E. Rykoff).

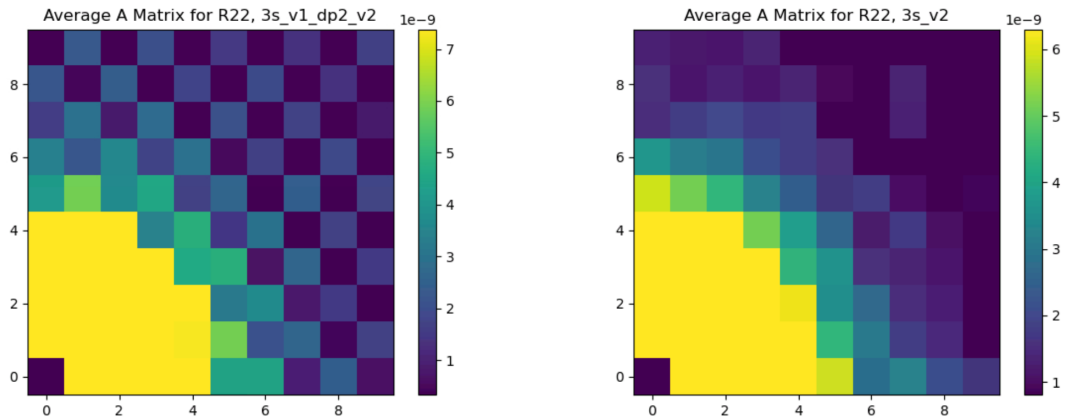
FIGURE 74: Average  $A$  matrix over raft R22 (e2v). Left:  $3s\_v1\_dp2\_v2$ . Right:  $3s\_v2$ . The checkerboard superimposed on the brighter-fatter falloff is gone (E. Rykoff).

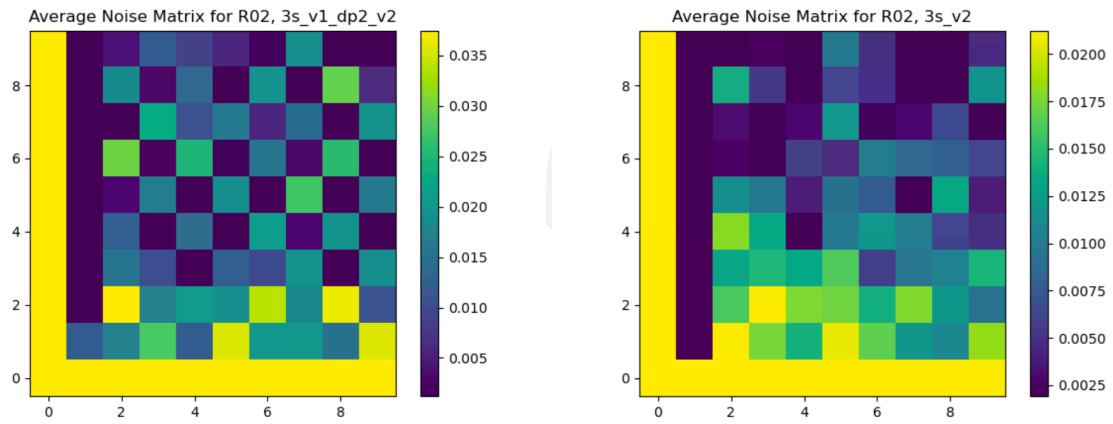
FIGURE 75: Average PTC noise matrix over raft R02 (ITL). Left: 3s\_v1\_dp2\_v2. Right: 3s\_v2 (E. Rykoff).

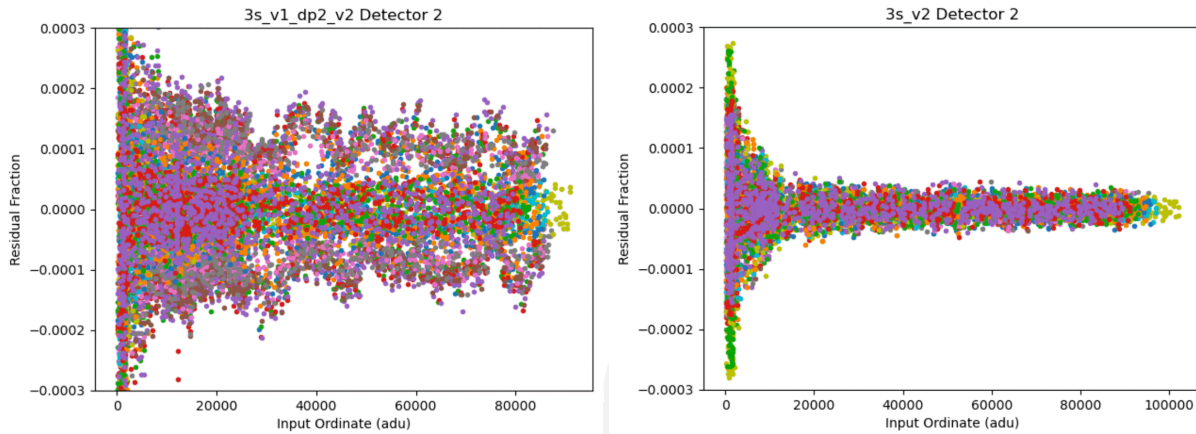
**3.1.3.9 Linearity.** The linearity solution improves as well, most visibly on the ITL detectors, where the structure that the old solution left in the residuals is largely gone (Figure 76). With  $3s\_v1\_dp2\_v2$  the residual fraction is spread over roughly  $\pm 1.5 \times 10^{-4}$  with visible wave-like structure across the full signal range; with  $3s\_v2$  it collapses to a narrow band that tightens with signal, and the usable range extends past  $10^5$  adu. Some ITL detectors improve only slightly (for example detector 15), and the e2v detectors, which started in better shape, improve more modestly but consistently (Figure 77).

FIGURE 76: Linearizer residual fraction against input ordinate for every amplifier of ITL detector 2. Left:  $3s\_v1\_dp2\_v2$ . Right:  $3s\_v2$ . The structure spread over  $\pm 1.5 \times 10^{-4}$  in the old solution collapses to a narrow band (E. Rykoff).

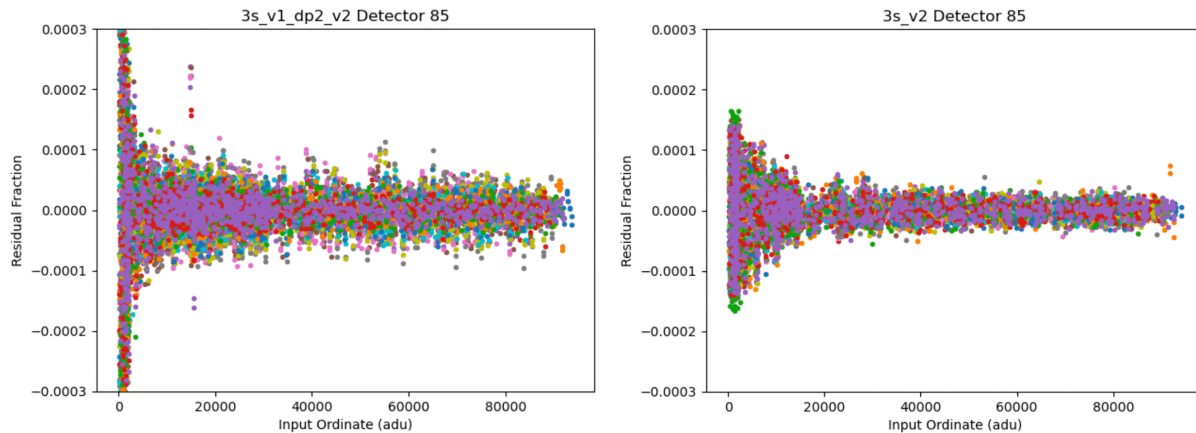
FIGURE 77: The same comparison for e2v detector 85, which was already in better shape. Left:  $3s\_v1\_dp2\_v2$ . Right:  $3s\_v2$ .

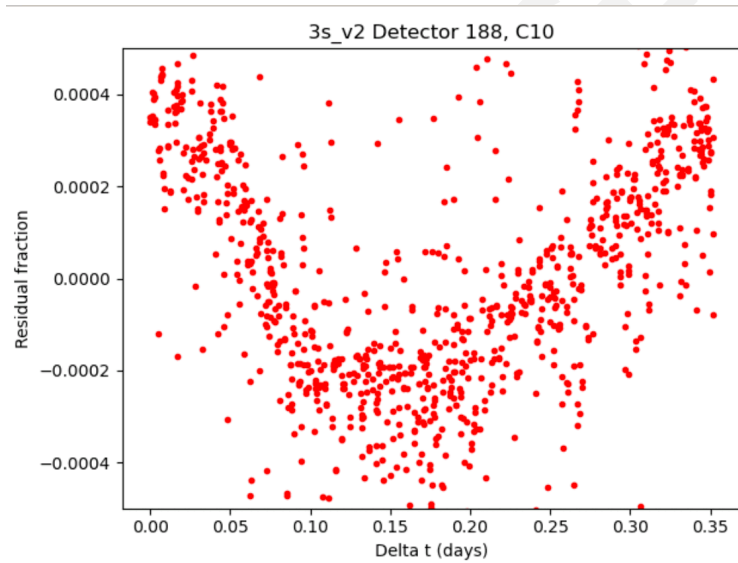
The amplifiers at the edge of the focal plane show a residual that varies smoothly over the night (Figure 78). The same or similar patterns appear on all partly vignettted and nearly-partly-vignettted detectors, for example detector 178 (R42\_S21), while the inner amplifiers and detectors show nothing of the kind. Variable illumination at the edges is the natural explanation, and it accounts for the edge outliers in the flat-field gain stability above.

FIGURE 78: Absolute linearizer residual fraction against elapsed time for detector 188 (R43\_S22), amplifier C10, with the 3s\_v2 data. The smooth variation over the night is seen on the partly vignettted detectors only (E. Rykoff).

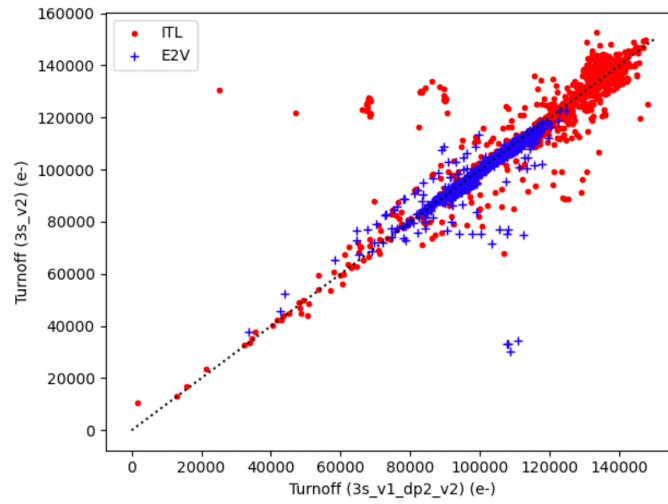
**3.1.3.10 PTC turnoff.** The PTC turnoffs, expressed in electrons, are broadly consistent between the two configurations, with a set of outliers and a locus of e2v turnoffs that moved up (Figure 79); both are still being followed up.

FIGURE 79: Per-amplifier PTC turnoff in electrons, 3s\_v1\_dp2\_v2 against 3s\_v2 (E. Rykoff).

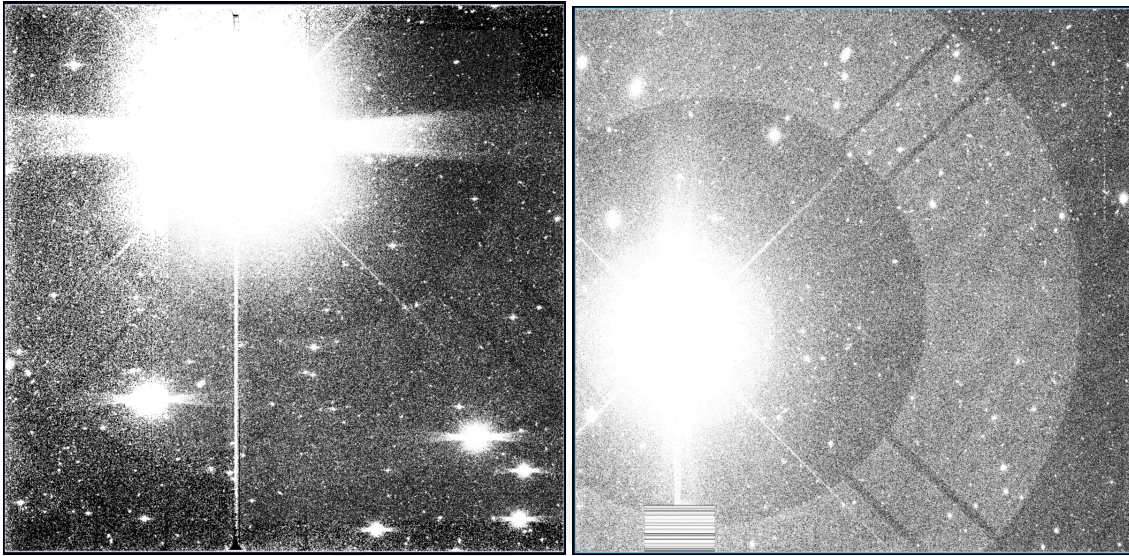
**3.1.3.11 Science images.** Science images were taken with the natural frequency firmware on 3 January 2026 (for example exposures 655 and 657); two examples are shown in Figure 80. The expected gap in illumination between ITL and e2v sensors, caused by the small gain change, is visible, as is a small crosstalk residue. Both are expected, since no calibration products were regenerated for these frames. No other issue was found.

FIGURE 80: Two science images acquired with the natural frequency firmware on 3 January 2026, around a saturated star. The residual crosstalk and the illumination step between vendors are visible at low level.

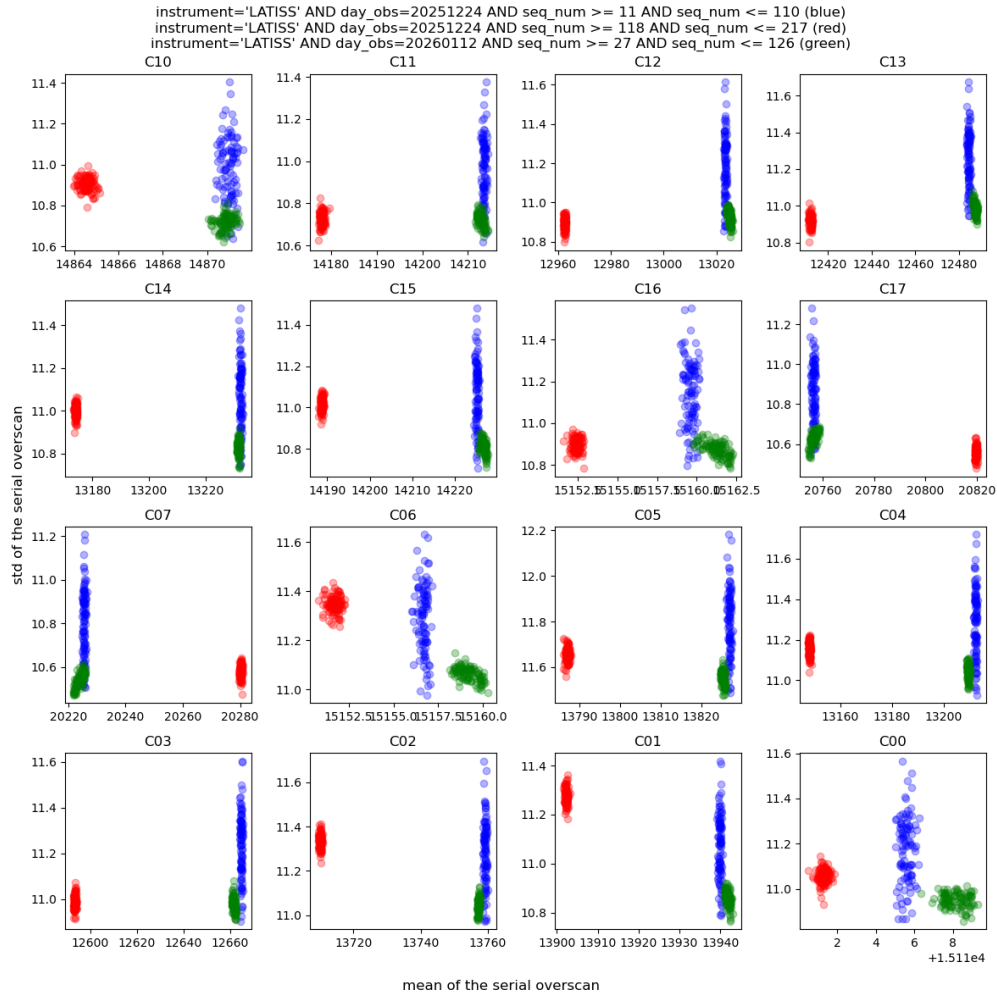
**3.1.3.12 LATISS testing (WREB).** The WREB behaves differently. The noise measurement in the noise–bias plane is noisier than for the science rafts (Figure 81), and print-through was identified as the cause: a section of the serial overscan shows the print-through structure directly (Figure 82). Disabling the ASPIC temperature read made the print-through go away. The pattern in the covariance, however, still exists in a different form, and is present whether or not the science rafts are running the natural frequency firmware (Figure 83).

FIGURE 81: Standard deviation versus mean of the serial overscan for each amplifier of LATISS, for three acquisitions: 20251224 sequence numbers 11–110 (blue), 20251224 sequence numbers 118–217 (red) and 20260112 sequence numbers 27–126 (green).

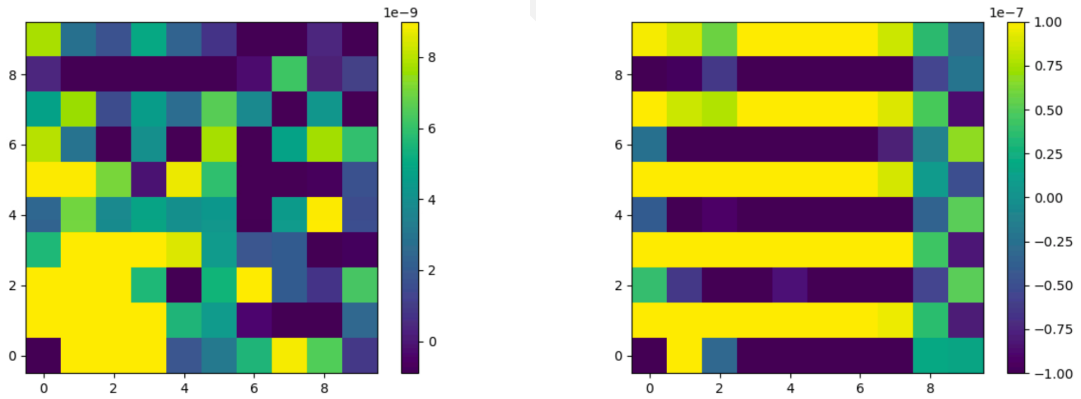
The PTC products flag a wavefront problem of their own: one amplifier, R40\_SW1\_C13, produces an  $A$  matrix in the new run that is clearly wrong, showing alternating rows that saturate both ends of a colour scale two orders of magnitude larger than expected, where the old run gave the smooth brighter-fatter structure (Figure 84). Whether this is the same underlying

FIGURE 84: A matrix for R40\_SW1\_C13. Left: old run, as expected. Right: new run, with alternating rows and a colour scale two orders of magnitude larger (E. Rykoff).

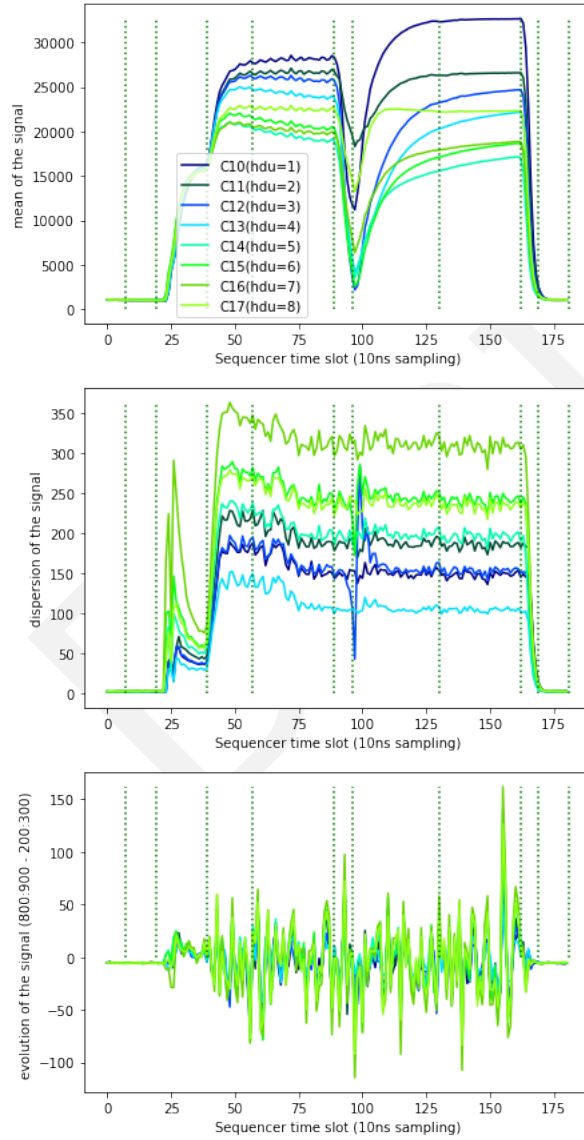
**3.1.3.13 Understanding the wavefront sensors.** Scan mode is the natural tool for understanding the underlying issue, since it resolves the signal within the sequencer time slots. The scan-mode data taken on R00\_SW0 in run 13108 (Figure 85) show a wild signal after the RST/CL toggling, wiggles in the first ramp, and an increase of the noise for a longer ramp time. These acquisitions have not been repeated since November 2023. Progress requires getting TS8 running and testing there, and then stepping to LATISS and LSSTCam.

FIGURE 85: Scan-mode data for R00\_SW0, run 13108, sampled every 10 ns of the sequencer. Top: mean of the signal for the eight channels. Middle: dispersion of the signal. Bottom: evolution of the signal between scans 800–900 and 200–300. Dotted lines mark the sequencer transitions.
