Vera C. Rubin Observatory  
Rubin Observatory Operations

## The LSST Camera commissioning

CTN-007

This technote describes what we found during the LSST Camera commissioning.

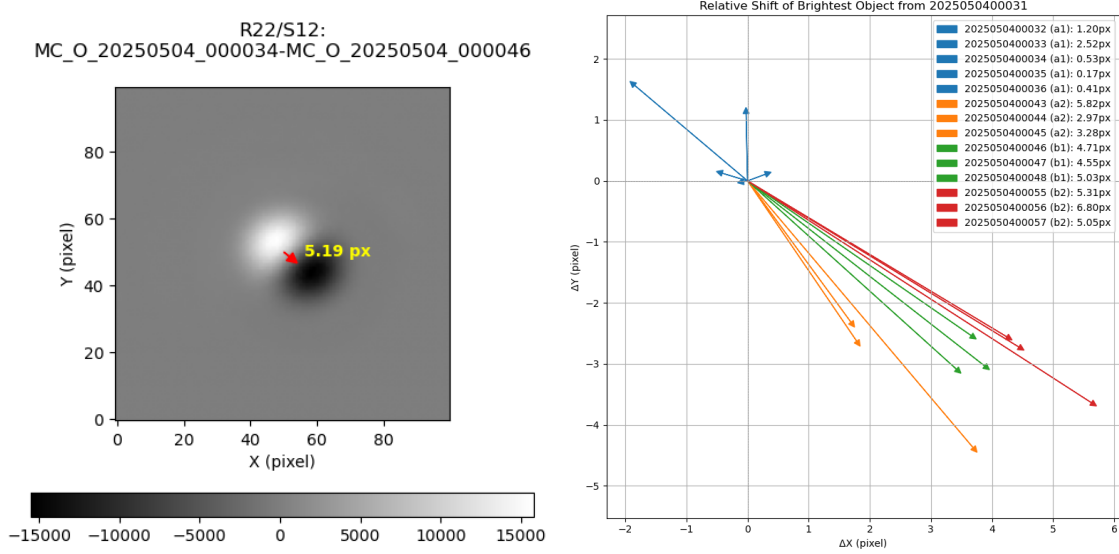
FIGURE 87: Caption

The left-hand panel of Figure 87 shows a difference image between the first exposure before the filter change and the fourth exposure after the filter change, revealing small but systematic shifts in the pinhole positions. The right-hand panel displays the measured positional offsets relative to the first exposure for images that are taken when the rotator angle was  $0^\circ$ . Scatter within a single condition (e.g., all points from a1) is on the order of a few pixels, indicating that the CBP itself is stable but non-negligible motion could be present.

Systematic offsets are evident when comparing conditions: the average shift between a1 and b1 is  $\approx 2$  px in X and  $\approx 3$ –4 px in Y. The four distinct groups (a1, a2, b1, b2) are distributed rea-

sonably consistent but distinguishable distributions. Because the total displacements are well below the 10-pixel (100  $\mu\text{m}$ ) repeatability requirement, we conclude that the filter placement is within specification. Nevertheless, the observed systematic trends suggest that both filter positioning and rotator repeatability contribute to the measured offsets, making it difficult to isolate the dominant source without further controlled experiments.

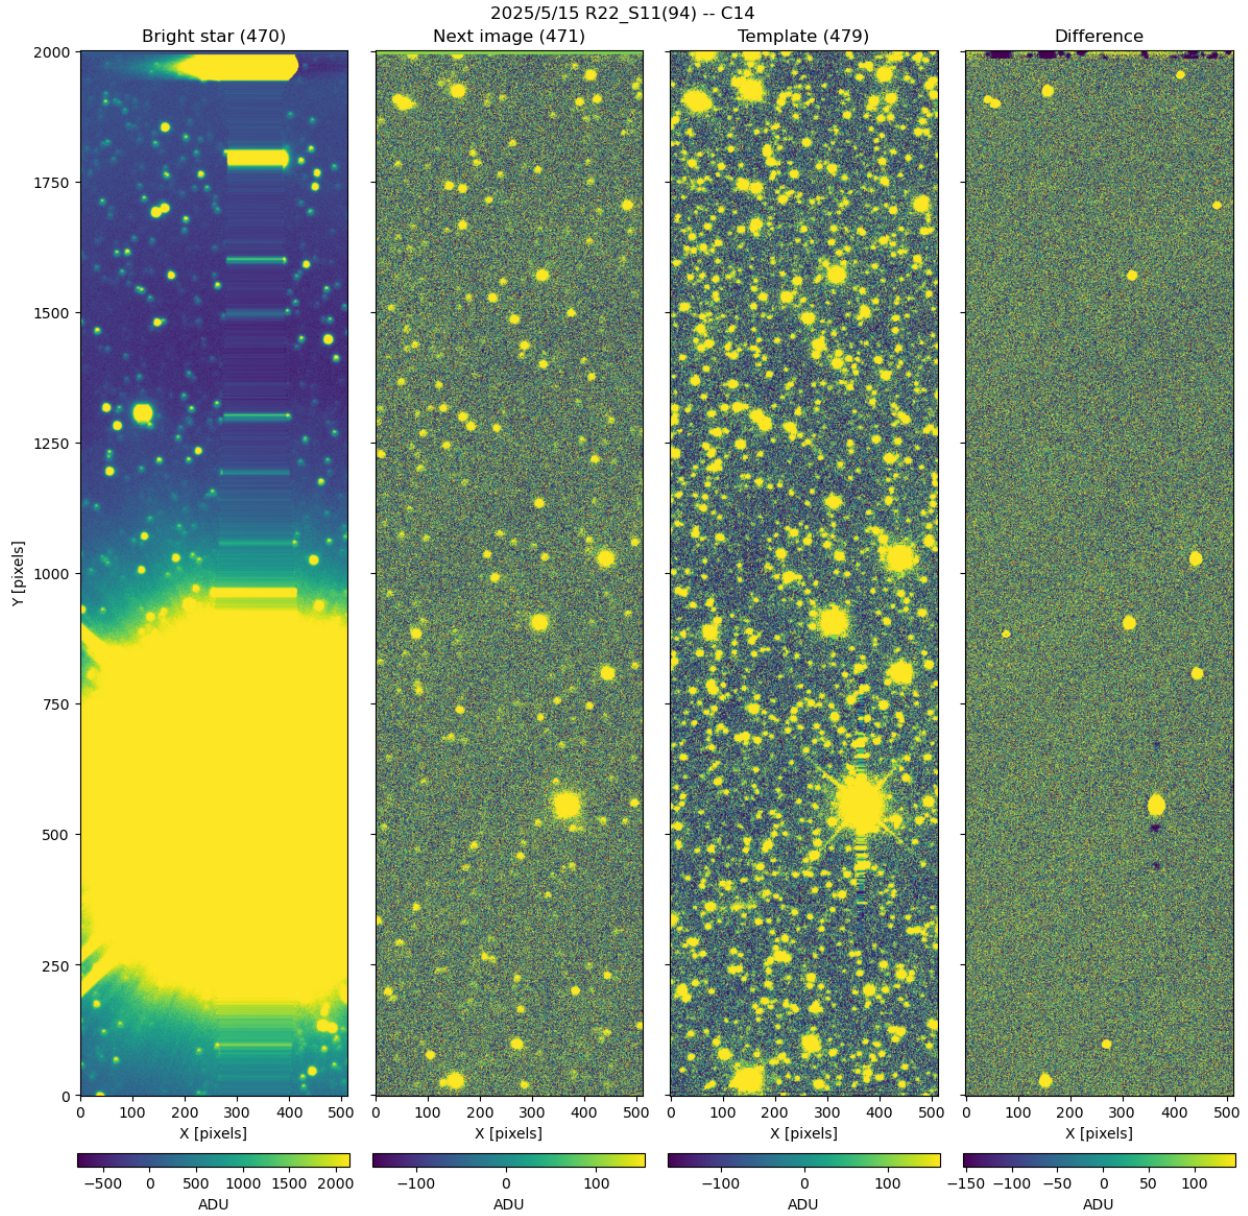
On the night of May 15, 2025, LSSTCam observed a bright star on R22/S11, which is an e2v sensor, during BLOCK-T417 (CLT-001 Incremental Closed Loop w/ coma bending modes). The first panel of Figure 88 shows the bright star image (Image sequence 470) after applying the standard `isrTask` (correcting bias, dark, flat, linearity, defects, etc.) and `calibrateImageTask` (calibrating WCS, photometry, and removing sky background). The bright star saturated its footprint to the full well and bled charges across entire columns. This star could leave the persistence signal in the subsequent image (471), but there was no obvious persistence remaining (the second panel of Figure 88; the same image process has been applied).

The result is shown in the right-most panel of Figure 88. No persistence residue is obvious in the region where the bright star was located. There are residual bright stars and dark spots. The bright stars are the stars that are above the saturation, and the dark spots are associated with the saturation bleed in the template image.

FIGURE 88: Demonstration of the absence of the persistence effect on an e2v sensor (R22/S11). The strip for channel 14 is cut out from an assembled CCD image. "Bright star" shows how the star appeared in the observation, "Next image" shows the next image after the bright star image, "Template" is a template image, and the Difference image is also shown.
