# The LSST Camera commissioning

CTN-007

This technote describes what we found during the LSST Camera commissioning.

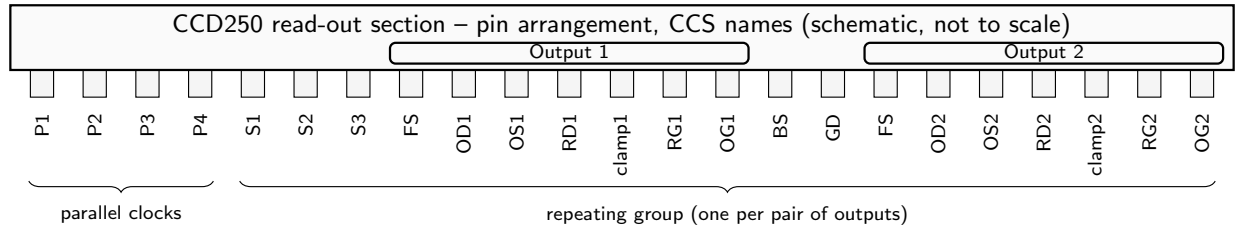
**2.1.1.1 Location and pin arrangement.** R30 is an e2v raft; Reb1 reads S10, S11 and S12 (Fig. 2). The read-out section of the CCD250 is organised in a repeating group; in CCS names the pin order is S1 S2 S3 FS OD1 OS1 RD1 clamp1 RG1 OG1 BS GD FS OD2 OS2 RD2 clamp2 RG2 OG2, preceded by the parallel clocks P1–P4 (Fig. 3). Here P1–P4 are the parallel (image) clocks and S1–S3 the serial clocks; OD is the output drain, OS the output amplifier source, RD the reset transistor drain and RG the reset transistor gate; OG is a DC bias at the end of the serial register, ahead of the sense node and the reset transistor; FS and BS are the front and back substrate and GD the guard diode. The clamp gate (*Reset 2* in Fig. 5) is connected to P4.

FIGURE 3: Pin arrangement of the CCD250 read-out section in CCS names, drawn after the pin order given in the CCD250 Design Report (e2v technologies, 2009). The names are explained in the text.

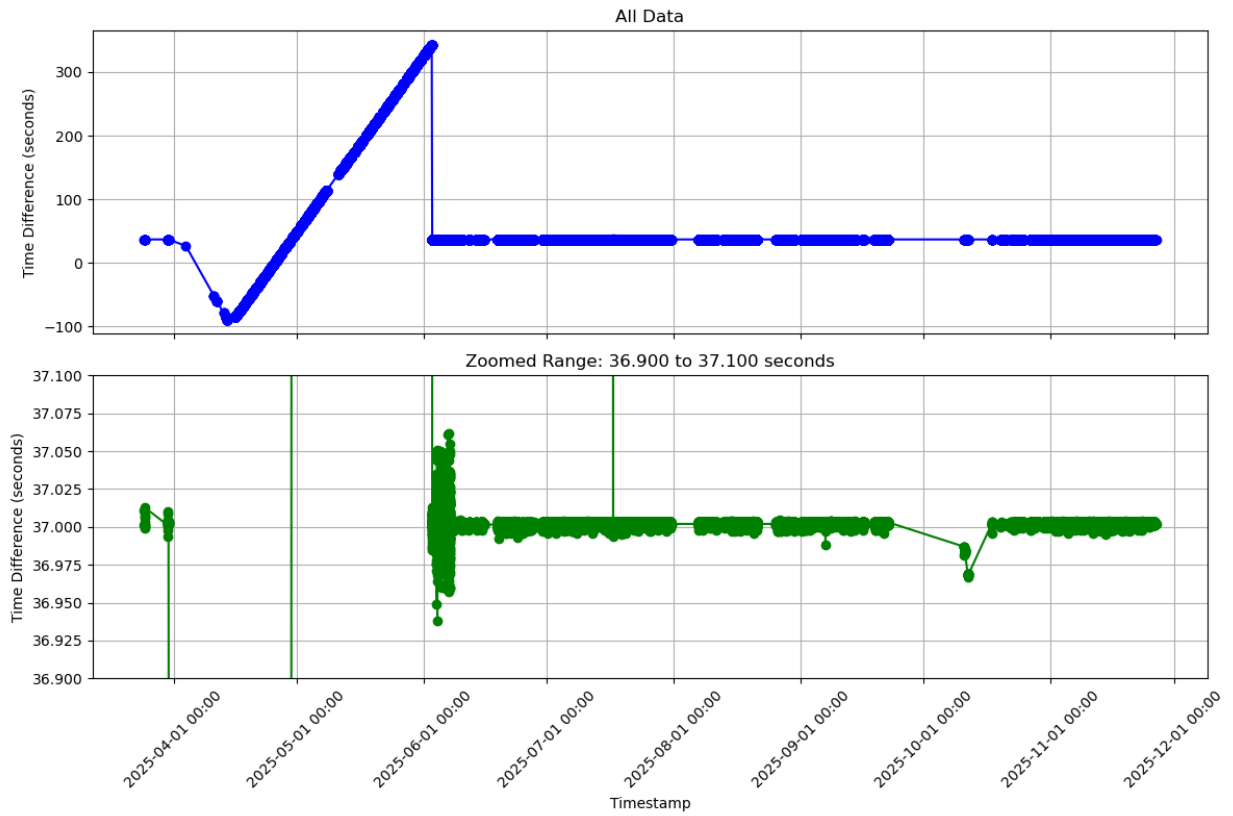
FIGURE 22: Timing between the CCS time when takeExposure was recorded and the time when the motion profile records the startTime. This does not reflect the actual shutter motion timing.

in the MCM log (“sent takeExposure to shutter1”) were paired with TAI timestamps from motion profiles (“startTime.tai.isot”). Because TAI leads UTC by 37 seconds, the expected difference is approximately: *37 seconds + system/network jitter*. Plotting these deltas reveals three operational periods during 2025 in Figure 22:

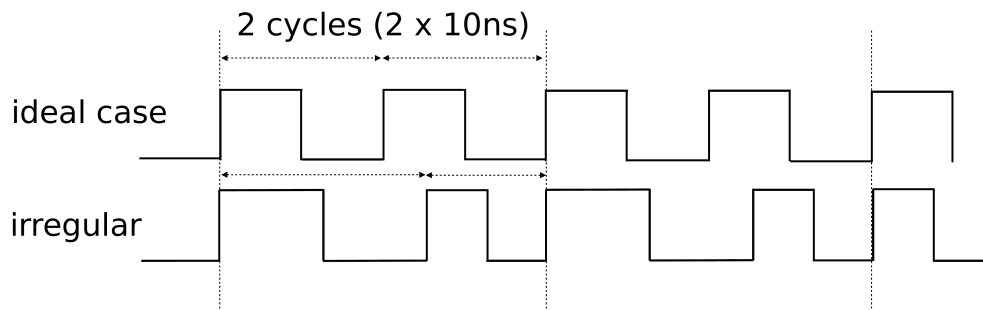
The checkerboard pattern admits a separate and complementary interpretation, proposed by the French team: the regular pattern can be produced by a pair of clocks that carry a slight time difference between them while their overall timing remains the same. If the ramp time takes an odd number of clock cycles and the number of columns is odd, the alternation between the two clocks maps onto the pixel grid and generates a checkerboard (Figure 27). P. Antilogus produced the even2 sequencer file, in which all the relevant time periods take an even number of cycles. This sequencer, carrying both the even-odd change and the natural frequency timing, was subsequently adopted as the production sequencer under the name 3s-v2 (calibration tag 3s\_v2), superseding 3s-v1.

FIGURE 27: Schematic of the even-odd effect. In the ideal case (top) each period of the read-out covers two full clock cycles ( $2 \times 10$  ns). When the number of cycles is odd (bottom), successive periods start on alternating clock phases, so consecutive columns are read with a slightly different timing.

The natural frequency operation is provided by Science REB firmware 0x313B5019, released in December 2025 and listed in Table 10. That release completes the code refactor which allows the system clock to be chosen on a per-target basis using a common set of functional blocks, so that the same VHDL code serves both the 6.4 ns and the 10 ns cases with only a parameter change. The same libraries can now be used in the WREB and GREB firmware, and the remaining work is to apply them to the devices unique to those boards.

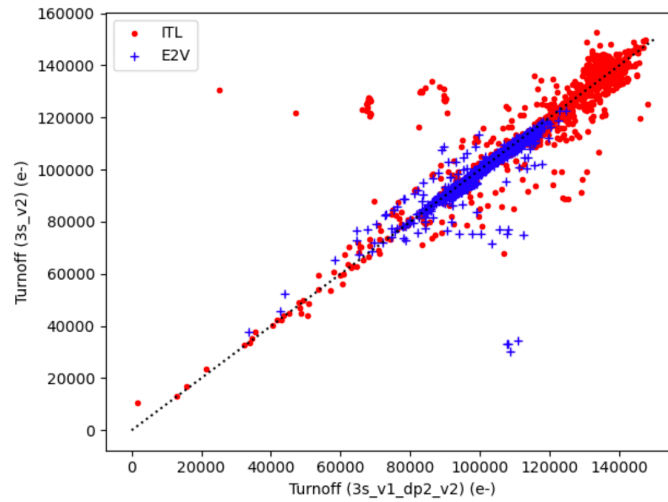
**3.1.3.10 PTC turnoff.** The PTC turnoffs, expressed in electrons, are broadly consistent between the two configurations, with a set of outliers and a locus of e2v turnoffs that moved up (Figure 44); both are still being followed up.

FIGURE 44: Per-amplifier PTC turnoff in electrons, 3s\_v1\_dp2\_v2 against 3s\_v2 (E. Rykoff).
