Vera C. Rubin Observatory  
Rubin Observatory Operations

# The LSST Camera commissioning

CTN-007

This technote describes what we found during the LSST Camera commissioning.

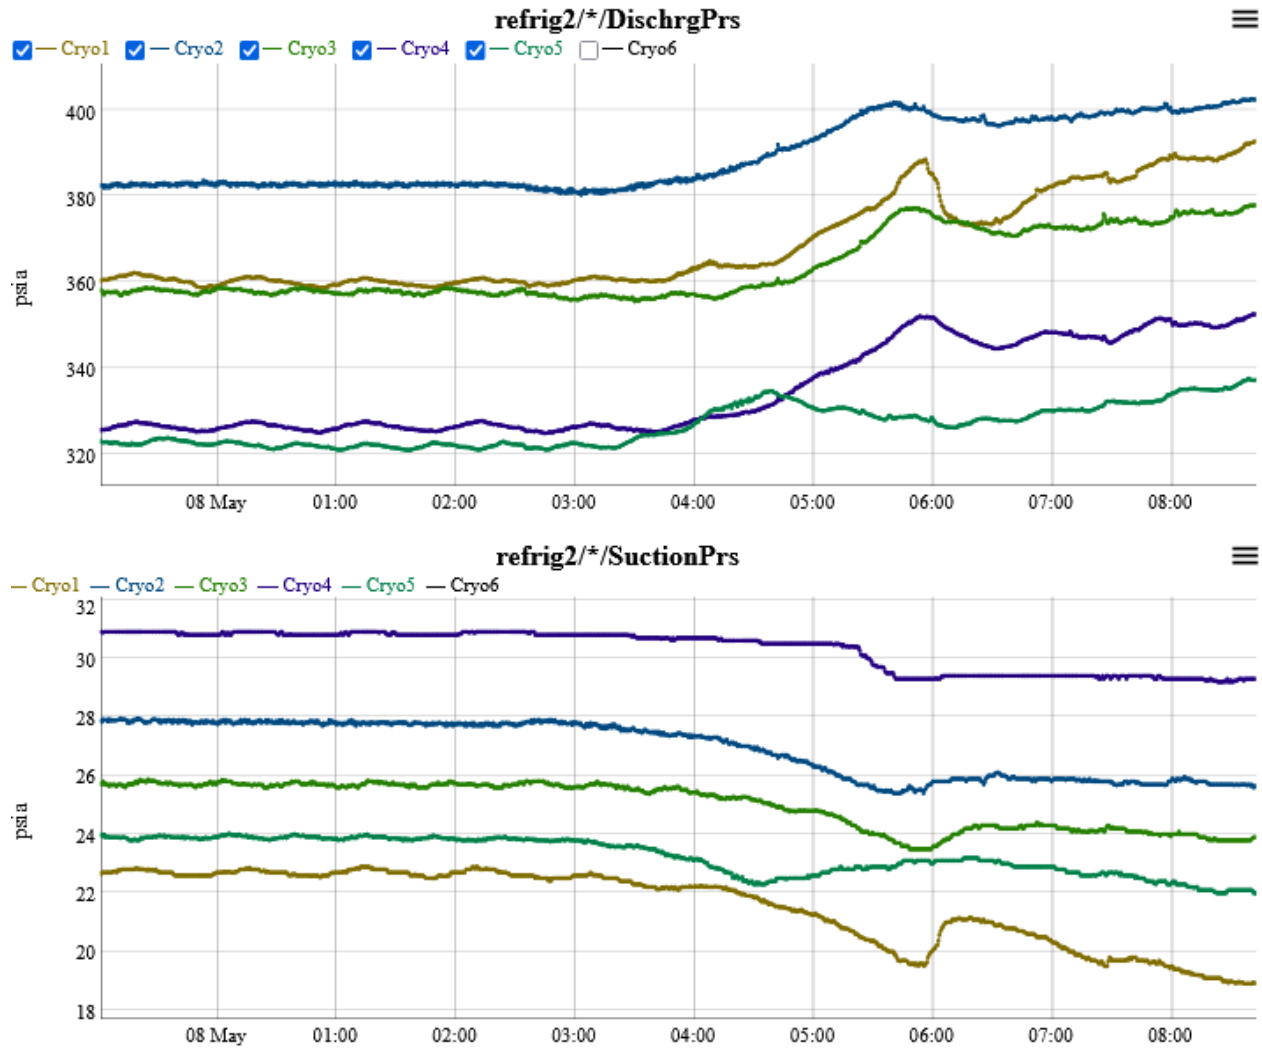
All five running circuits showed increase in discharge pressure and reduction in suction pressure, indicating that there was an increase in flow impedance. This is shown in Figure 14

FIGURE 14: Discharge and suction pressure of each Cryo circuit at around 6 am on May 8, 2025

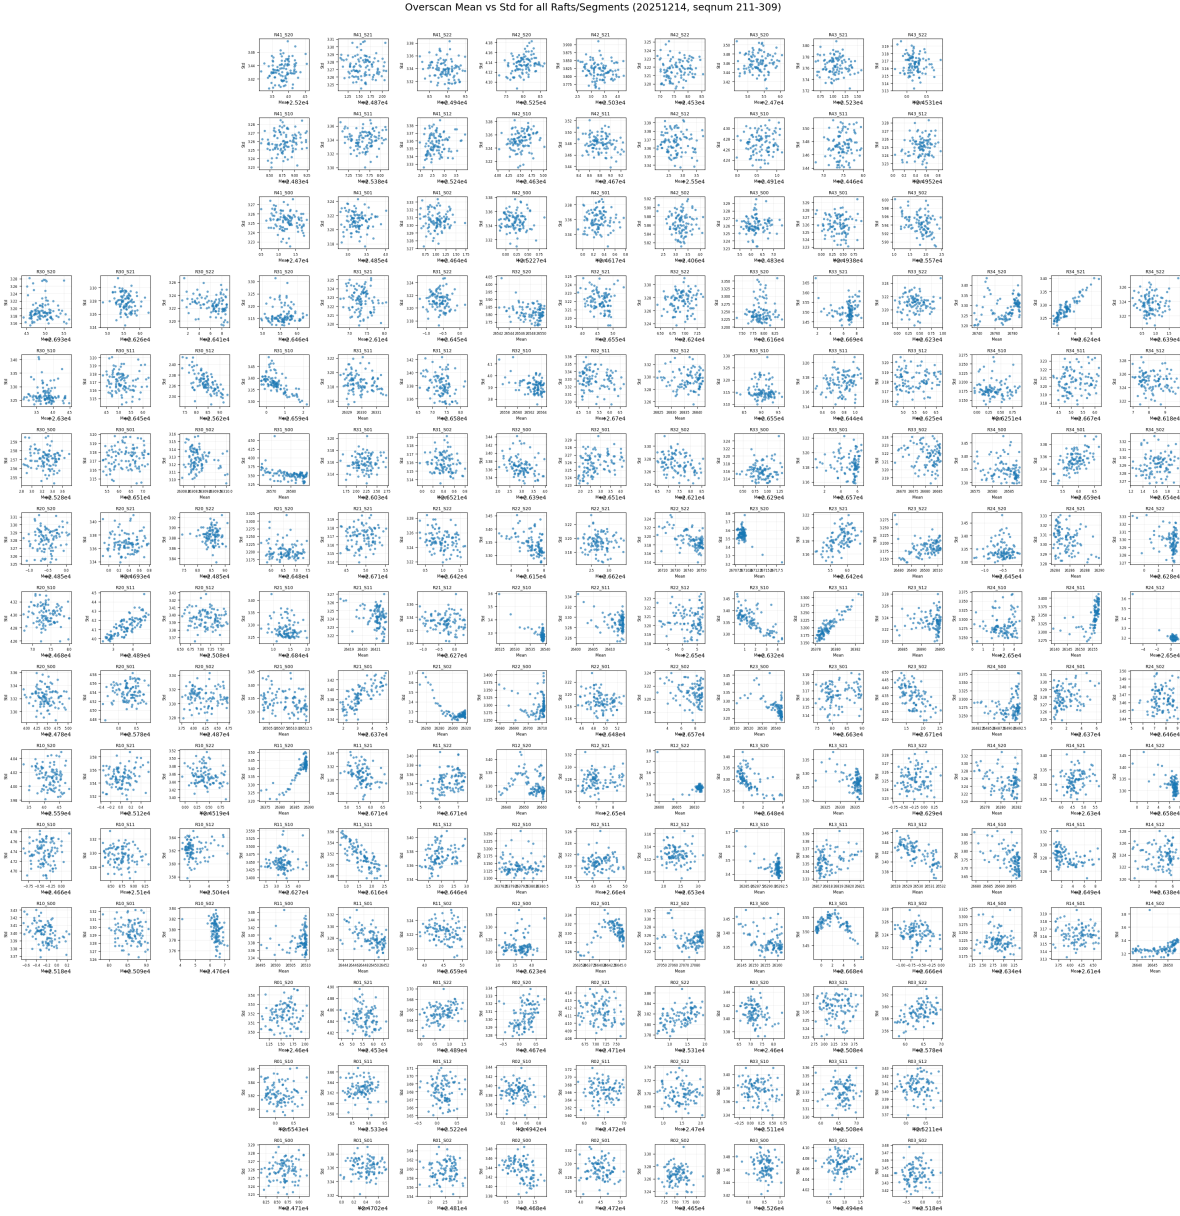
**3.1.3.3 Bias level versus noise.** Plotting the overscan noise against the overscan mean for one amplifier per sensor over the whole focal plane (Figure 30) no longer shows multiple distinct populations. The residual systematic drift within each sensor is consistent with gain and temperature changes over the duration of the acquisition rather than with discrete state changes.

FIGURE 30: Overscan mean versus overscan standard deviation for all rafts and sensors (20251214, sequence numbers 211–309), one amplifier per sensor. The distinct populations seen before the firmware change (Figure 26) are absent.

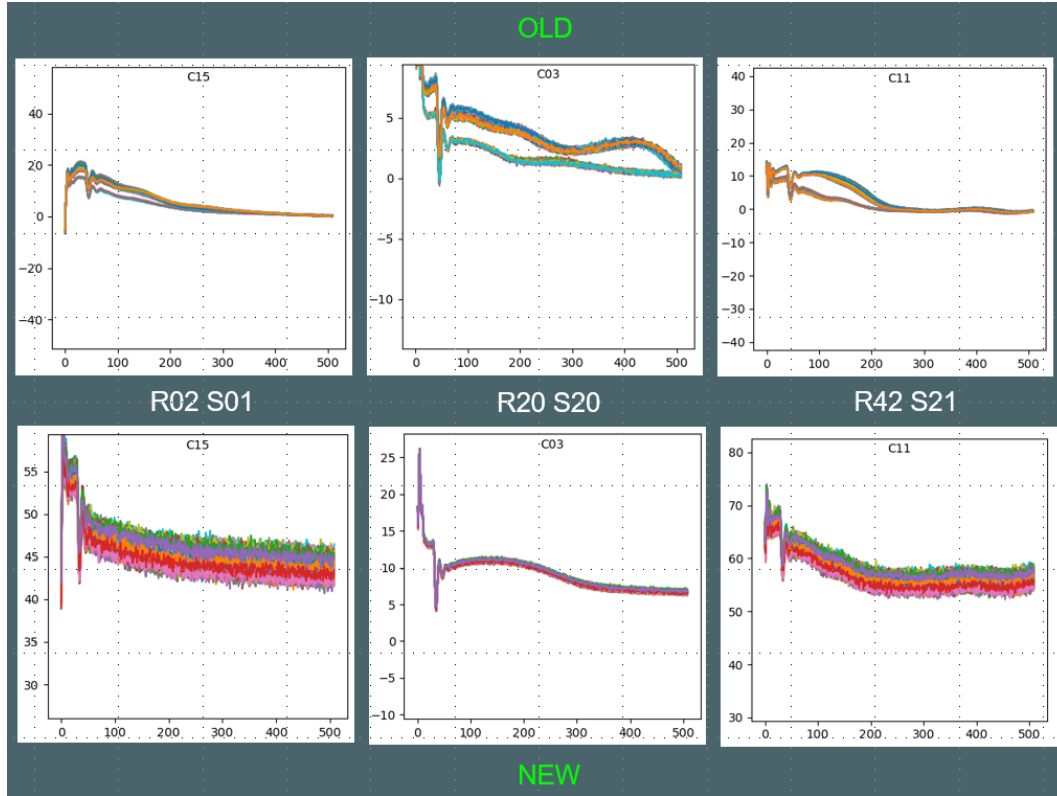
**3.1.3.4 Bias row profiles.** The row profiles measured before and after the change are compared in Figure 31. With the original firmware the profile of a given amplifier differed between exposures; with the natural frequency firmware the profiles from repeated exposures fall on top of each other.

FIGURE 31: Bias row profiles for three amplifiers (R02\_S01 C15, R20\_S20 C03, R42\_S21 C11) with the original firmware (top) and with the natural frequency firmware (bottom, run E1110, 9 December 2025). The profiles become consistent from exposure to exposure (T. Guillemin).

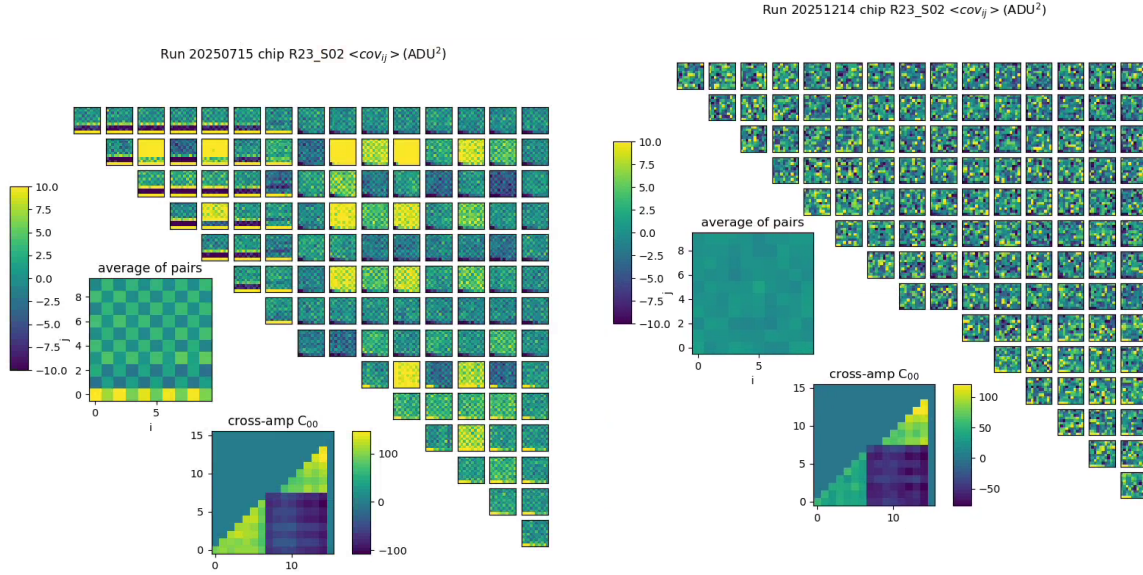
Figure 36 shows the covariances  $\langle \text{cov}_{ij} \rangle$  for all channel pairs of R23\_S02, excluding the self-correlations, before and after the change. The average over pairs, shown as an inset, carries a clear checkerboard in the original data and is flat with the natural frequency firmware. P. Astier interpreted the decaying signal at  $\Delta y = 0$  as a gain variation, which the natural frequency partially cures: the spread of the relative gain of R23\_S02 narrows from roughly  $\pm 10^{-3}$  to a considerably smaller range (Figure 37).

FIGURE 36: Covariances for all channel pairs of R23\_S02, excluding self-correlations, with the average over pairs and the cross-amplifier  $C_{00}$  shown as insets. Left: run 20250715 (original). Right: run 20251214 (natural frequency). The checkerboard in the average of pairs disappears (P. Astier).

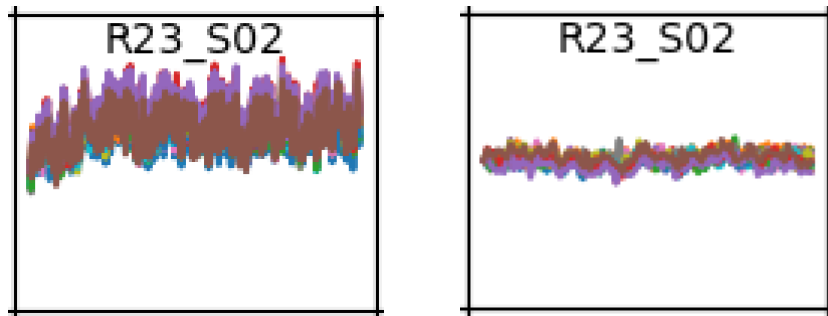
FIGURE 37: Relative gain of R23\_S02 over the course of a run, on a vertical scale of  $\pm 0.001$ . Left: original configuration. Right: with the natural frequency firmware.

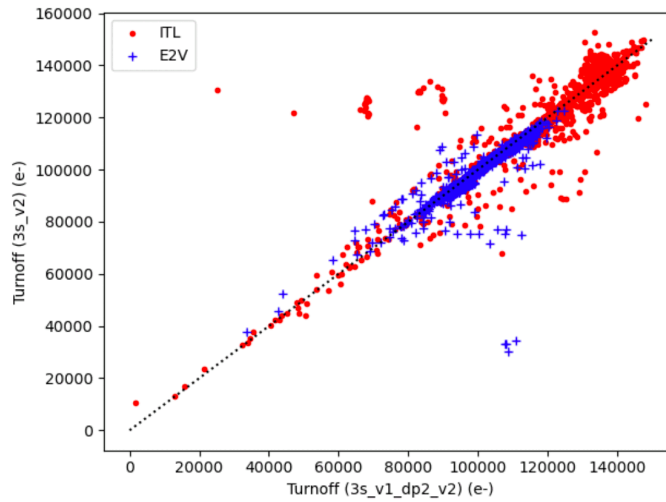
**3.1.3.10 PTC turnoff.** The PTC turnoffs, expressed in electrons, are broadly consistent between the two configurations, with a set of outliers and a locus of e2v turnoffs that moved up (Figure 44); both are still being followed up.

FIGURE 44: Per-amplifier PTC turnoff in electrons, 3s\_v1\_dp2\_v2 against 3s\_v2 (E. Rykoff).
