# The LSST Camera commissioning

CTN-007

This technote describes what we found during the LSST Camera commissioning.

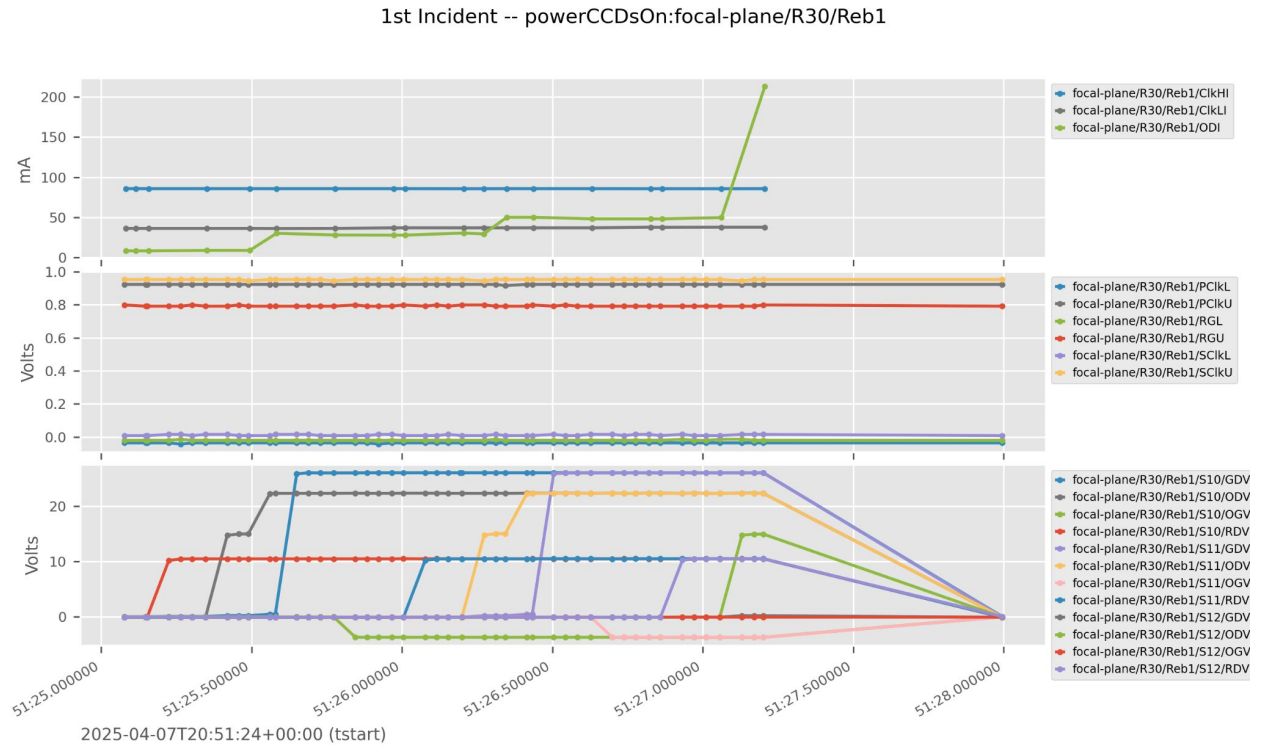
FIGURE 3: Trending of the first power-on attempt (Marshall, 2025b). Top: the REB parent currents, with ODI (green) leaving its baseline as the bias sequence proceeds and reaching 213 mA. Middle: the clock rails. Bottom: the CCD bias voltages; the last trace to rise, to  $\approx 15$  V, is the OD of S12, and all biases return to zero at 51:28 when the protection has fired and powerCCDsOff runs.

**2.1.1.2 Three over-current trips.** Three attempts to power on R30/Reb1 failed with an OD over-current condition (Fig. 3, Table 1). The log of the first reads

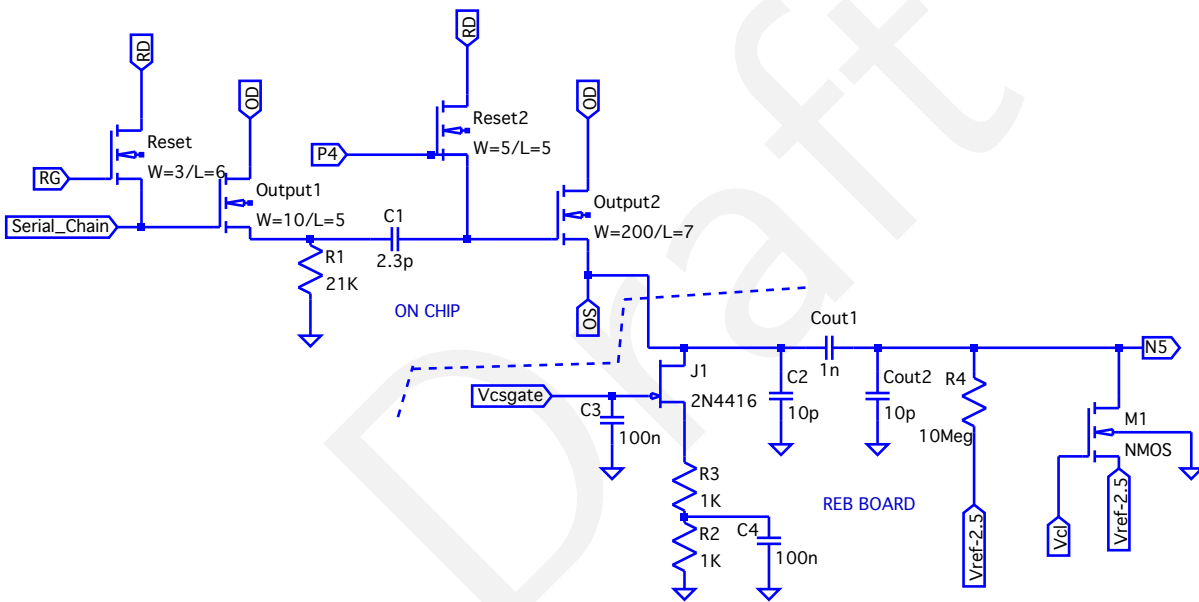
FIGURE 4: The e2v output stage and the first stage of the REB circuit, drawn by C. Lage (Lage, 2025). The two on-chip source followers (*Output1*, *Output2*) are coupled through  $C1$ , with the clamp *Reset 2* on that node driven by  $P4$ ; *Output2* drives the OS pin into the current source  $J1$  on the REB, whose return to ground through  $R3$  and  $R2$  carries the per-segment current monitor. The suspected short is from the OS node to ground.

**2.1.1.3 Interpretation.** A shorted segment reading zero current follows from where the currents are measured (Fig. 4). Each segment current is monitored on the low side of that

Bias2/OD2 in the log message is the OD supply of S12, and its current is measured for that supply as a whole, so a short anywhere in the CCD raises it: the over-current localises the fault to S12 but does not identify the segment. It is the zero reading on Seg17 that points to that segment. It was also noted in the discussion that the shorted node need not be at ground potential but could sit a couple of diode drops above it; the current source still needs some positive compliance voltage, so the effect would be the same, through a diode rather than through a resistance.

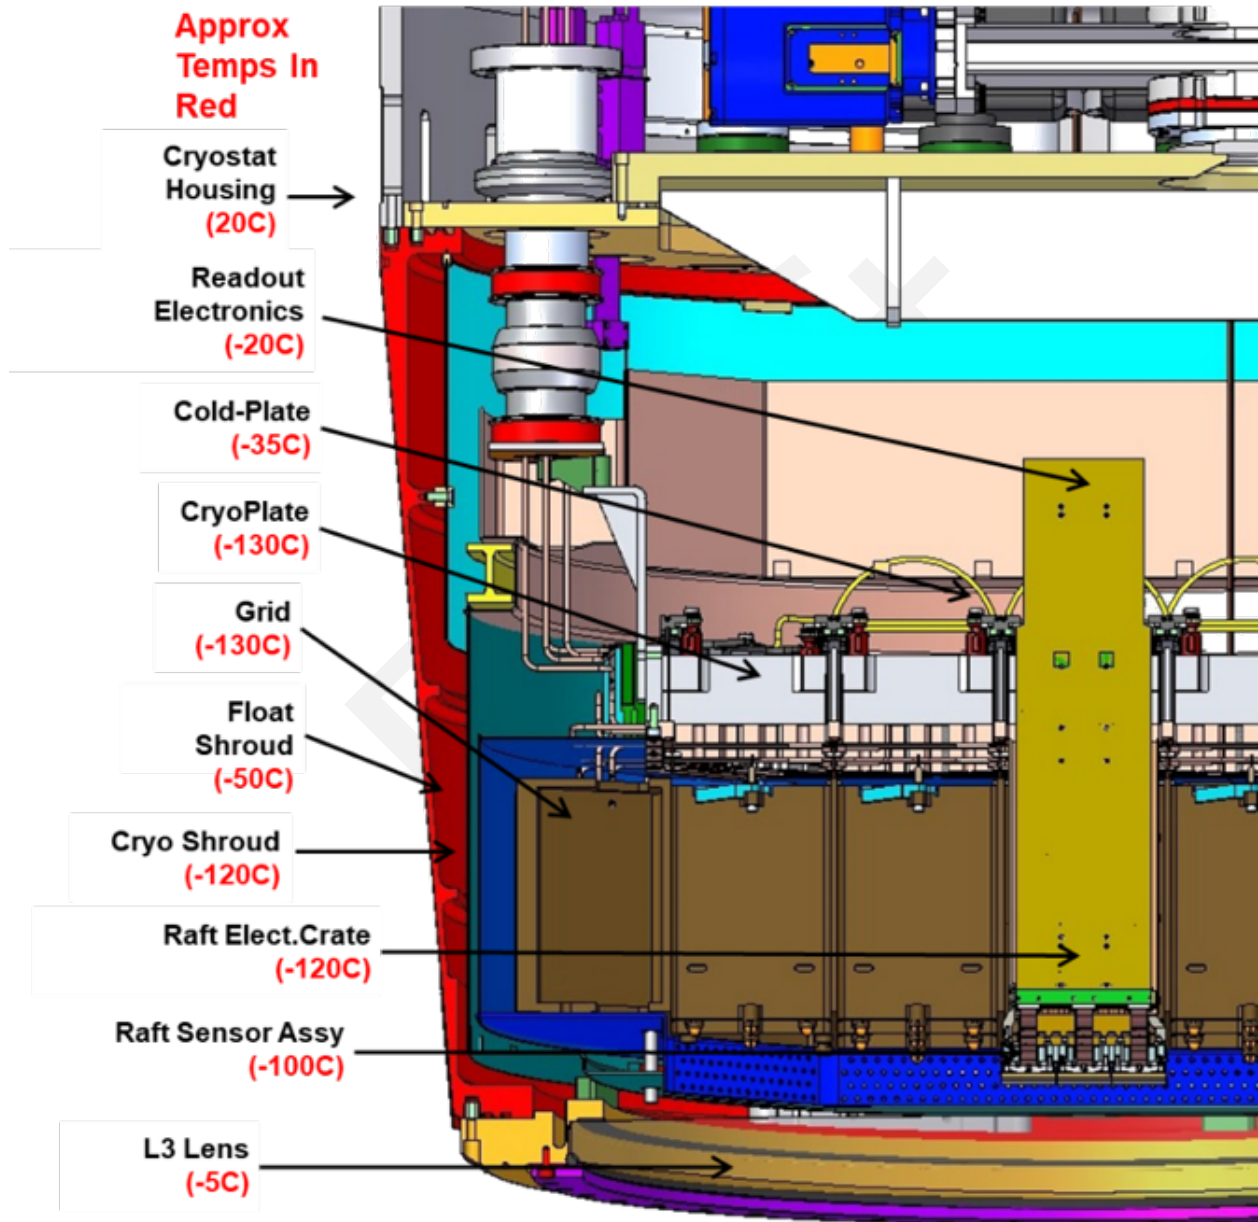
FIGURE 5: Cross section of the cryostat with its principal thermal regions and typical design temperatures during operation (in red).

The cryostat is designed to be a vacuum insulating vessel ( $<10^{-7}$  Torr) containing the Cold and Cryo systems’ evaporators, the “coldplate” and the “cryoplate”. Figure 5 shows a cross section of the cryostat with the principal thermal regions and typical operating temperatures. Refrigerants enter the cryostat, pass through the evaporators and return through 4.5” vacuum conflat flanges on the rear annular feedthrough plate. The refrigerant tubing itself is continuous and joint-free within the cryostat vacuum to eliminate any potential for a leaking. The refrigeration system components outside the cryostat (in the Utility Trunk) have an in-

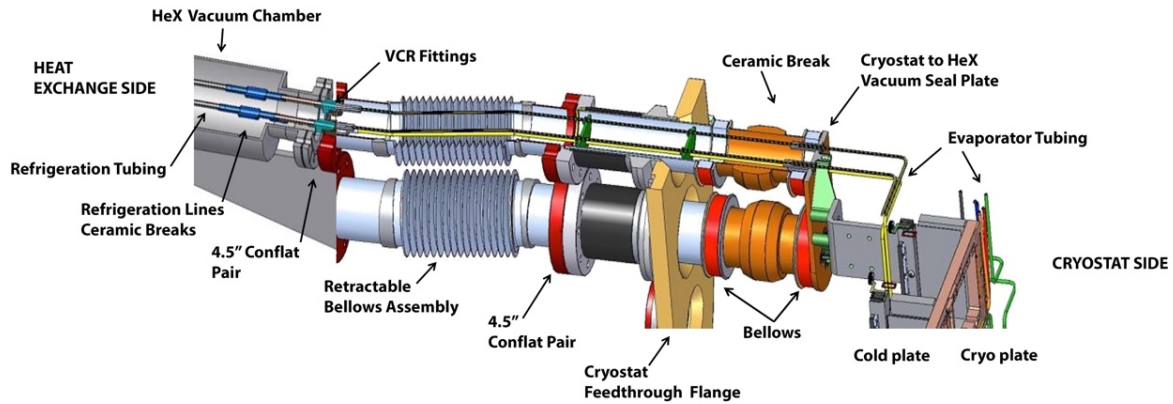
FIGURE 6: Detailed routing of the refrigeration system at the interface between the cryostat and the heat exchanger vacuum system.

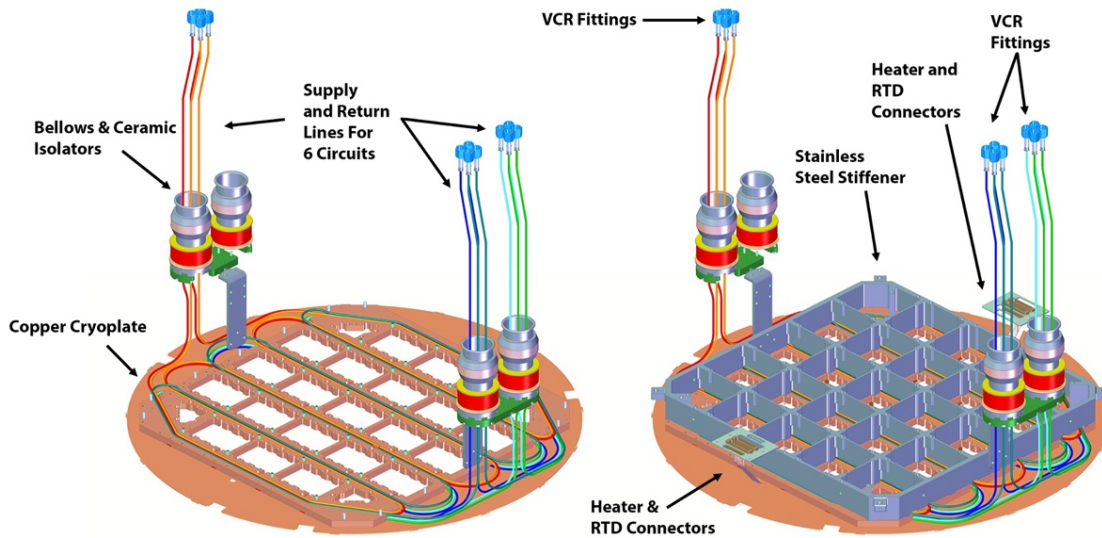
FIGURE 7: Cryoplate (a) Routing of the six refrigerant circuits in the copper cryoplate (b) with stainless steel stiffening frame attached.

The cryoplate layout is shown in Figure 7. It comprises a single machined and polished copper plate which is brazed to a stainless-steel plate to rigidize it, with cutouts for each of the Raft Tower Modules (RTMs). There are 21 “bays” where the science RTMs are attached, and 4 corner bays for the corner RTMs containing guider CCDs and wavefront sensors. The six stainless steel refrigerant lines – one for each Cryo circuit - run continuously through the top and bottoms of the six copper ribs, having been brazed in place. Three lines are on the top, and three on the bottom, and the refrigerant flow direction is organized to be counterflow. The rafts are bolted down to the copper on the front side of the orthogonal ribs.

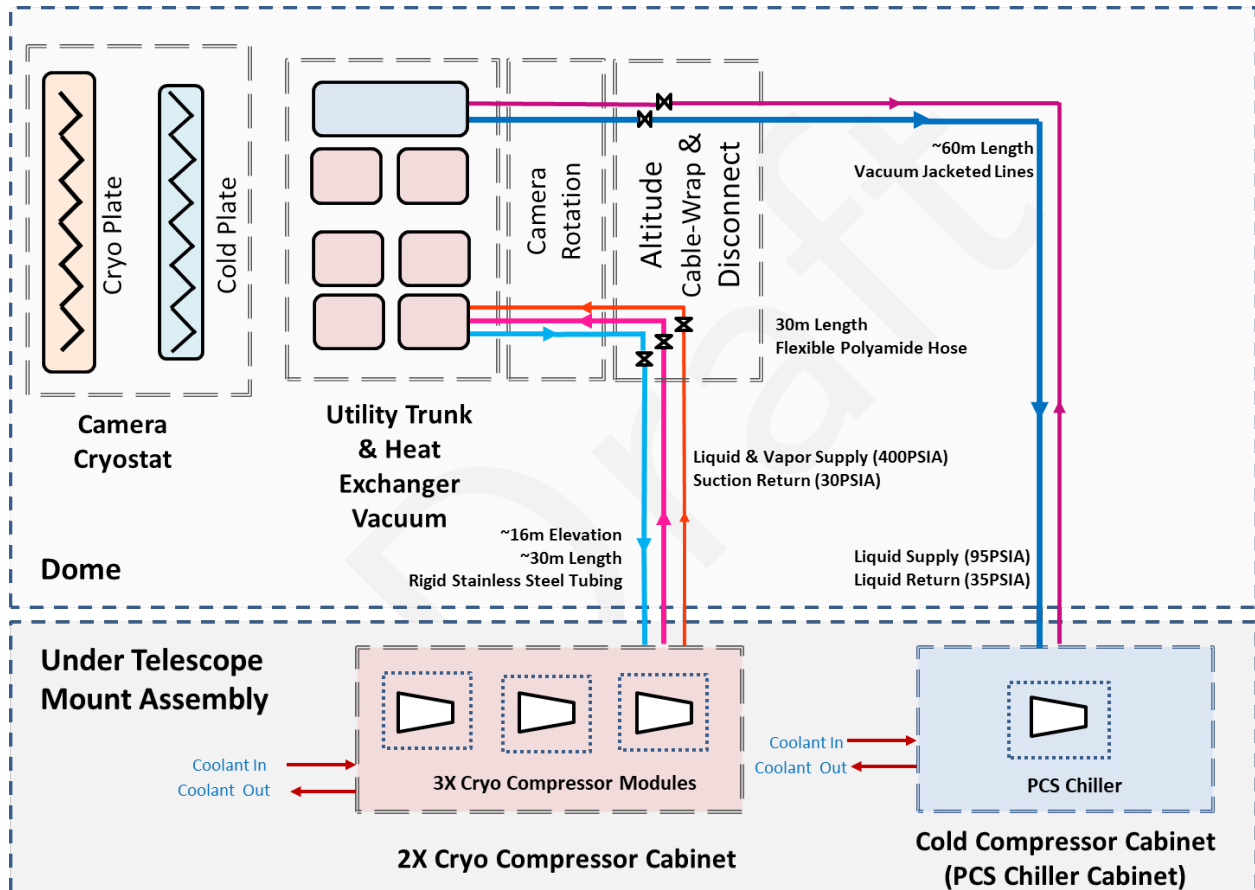
FIGURE 8: The physical layout of each Cryo system is shown schematically in Figure 8. With the exception of the transfer line lengths, a largely identical system supports LSSTCam operation in the Clean Room Maintenance Facility at the Vera C. Rubin Observatory.

module contains a commercial hermetically sealed compressor that has been modified to add a water cooling jacket and an oil-reservoir with both visual and electronic oil level gauges.[1] The compressor is followed by an oil separator, a refrigerant condenser (or "after-cooler"), and a refrigerant phase separator. A small sight glass in the liquid supply line indicating both flow and moisture content is incorporated after the phase separator. Three diaphragm valves on the low- and high-pressure sides isolate the module from the rest of the circuit. A small heated "surge tank" on the low pressure side of each compressor module is used during charging and cooldown to increase the volume of the system. Each Cryo circuit is completed with a set of replaceable filter-driers (and isolation valves) on the suction return line as well as the liquid and vapor phase supply lines.

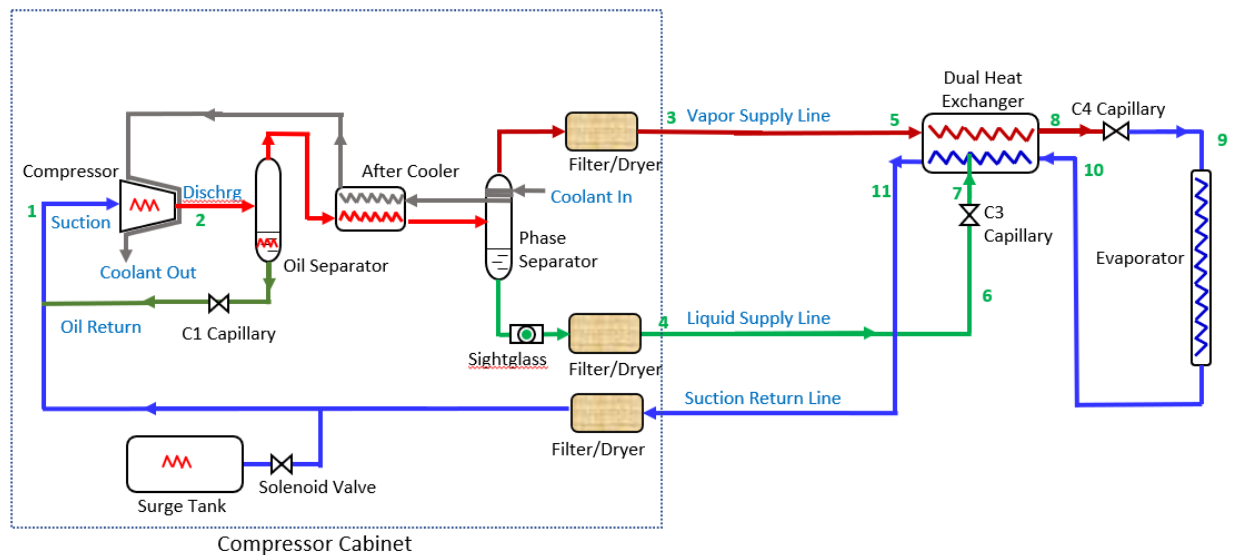
FIGURE 9: Layout of Cryo system.

The cryogenic refrigeration cycle (see Figure 9) begins with the ambient temperature low pressure ( $\sim 30$  psia), superheated vapor refrigerant mixture entering the compressor at the suction port (located at position "1" in the figure). It is then compressed to a higher pressure ( $\sim 400$  psia) and higher temperature ( $\sim 100$  degree C) refrigerant, while remaining in vapor form.

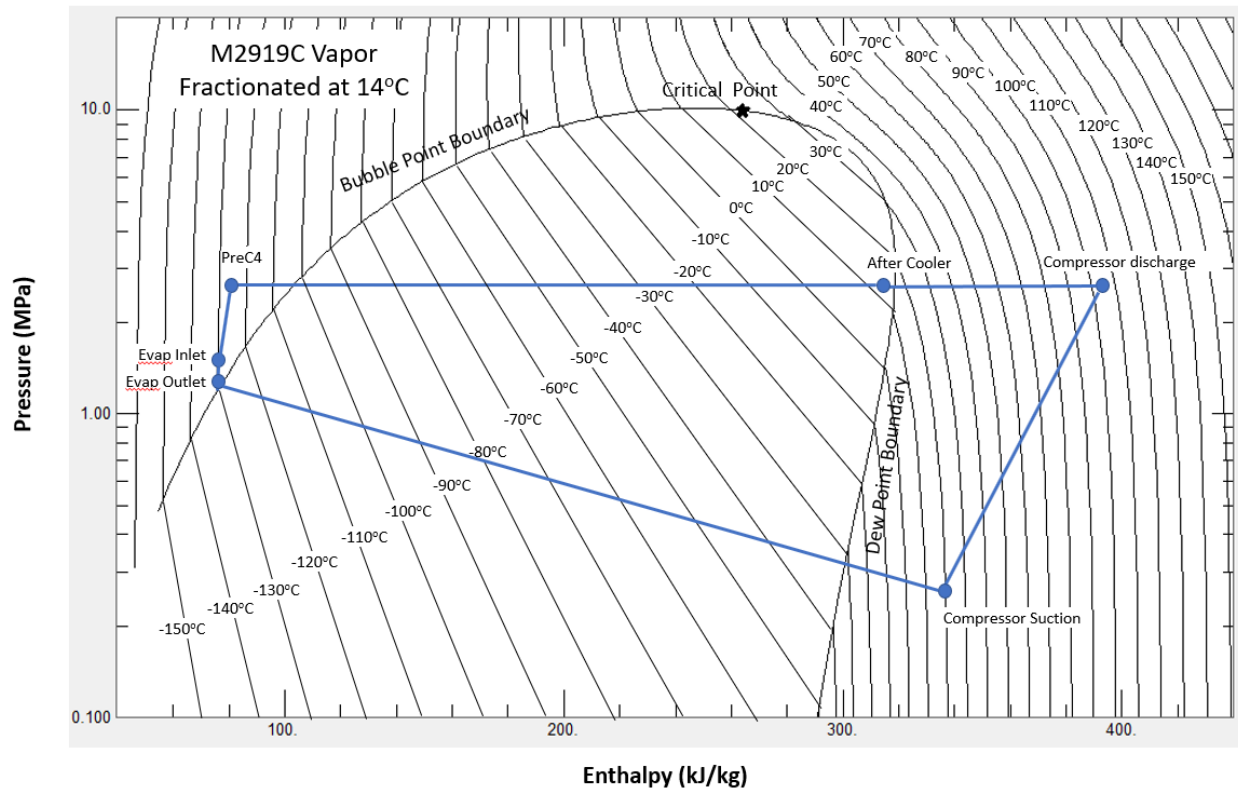
FIGURE 10: Pressure-Enthalpy Diagram of the M2919C vapor components, fractionated at 14 degree C and 350 psig.

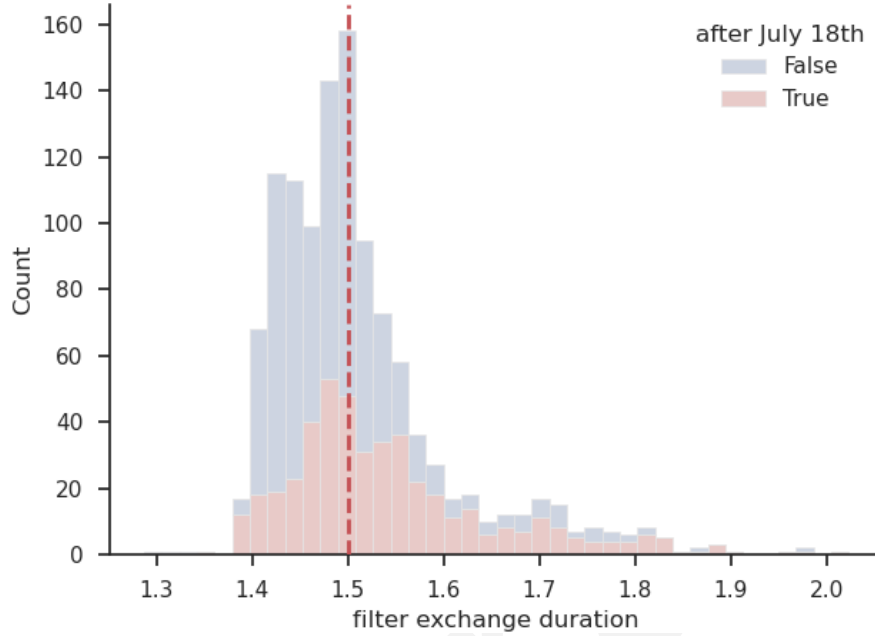
FIGURE 19: Histogram of filter exchange duration between April 15th and July 18th (blue) and after July 18th (red)

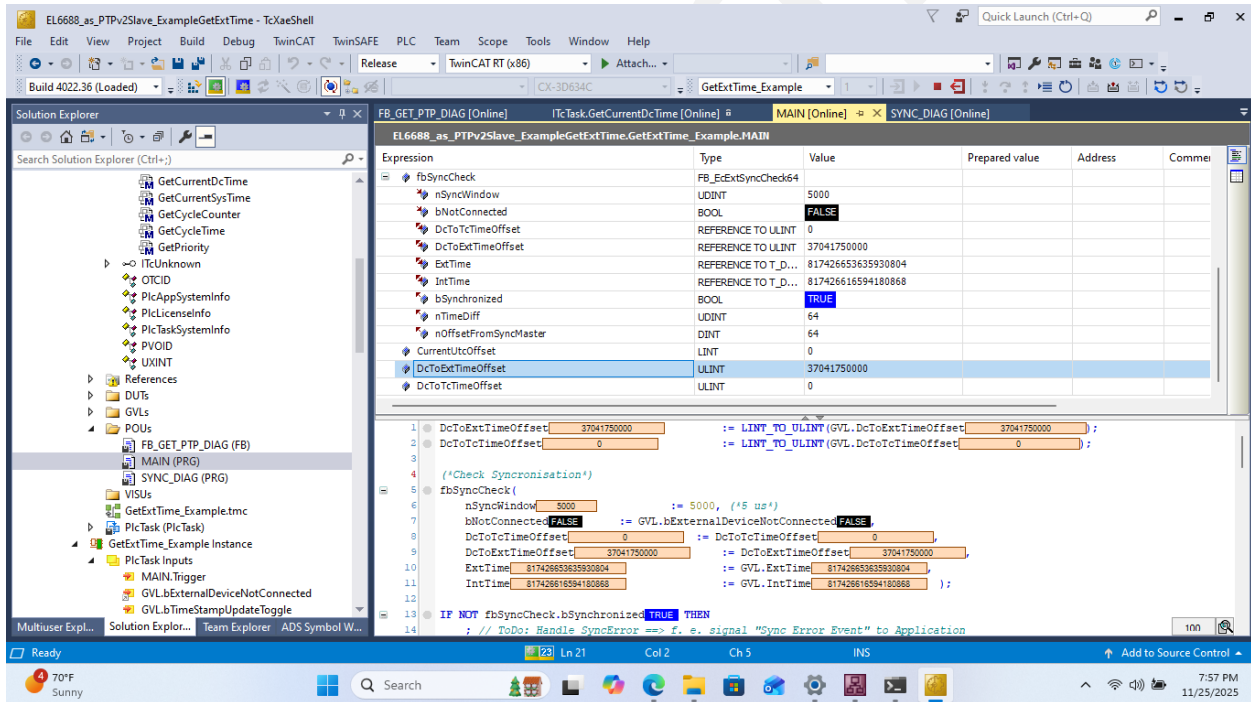
FIGURE 22: A screenshot of the vendor-provided sample program. DcToTcTimeOffset, DcToExtTimeOffset and bSynchronized as well as nTimeDiff are displayed in this screenshot.

bSynchronized and nTimeDiff are also important parameters. These are unique in the vendor-provided project. These tell us whether EL6688 is synchronized with PTP or not and how much delay is observed. The meaning of synchronization in the vendor implementation is broad. The synchronization is established regardless of whether the DC is synchronized to the Beckhoff Windows or EL6688, since EL6688 gives a reference clock and the actual clock synchronization is done in the Beckhoff Windows system using the built-in functions. nTimeDiff seems to be different from Offset from master.

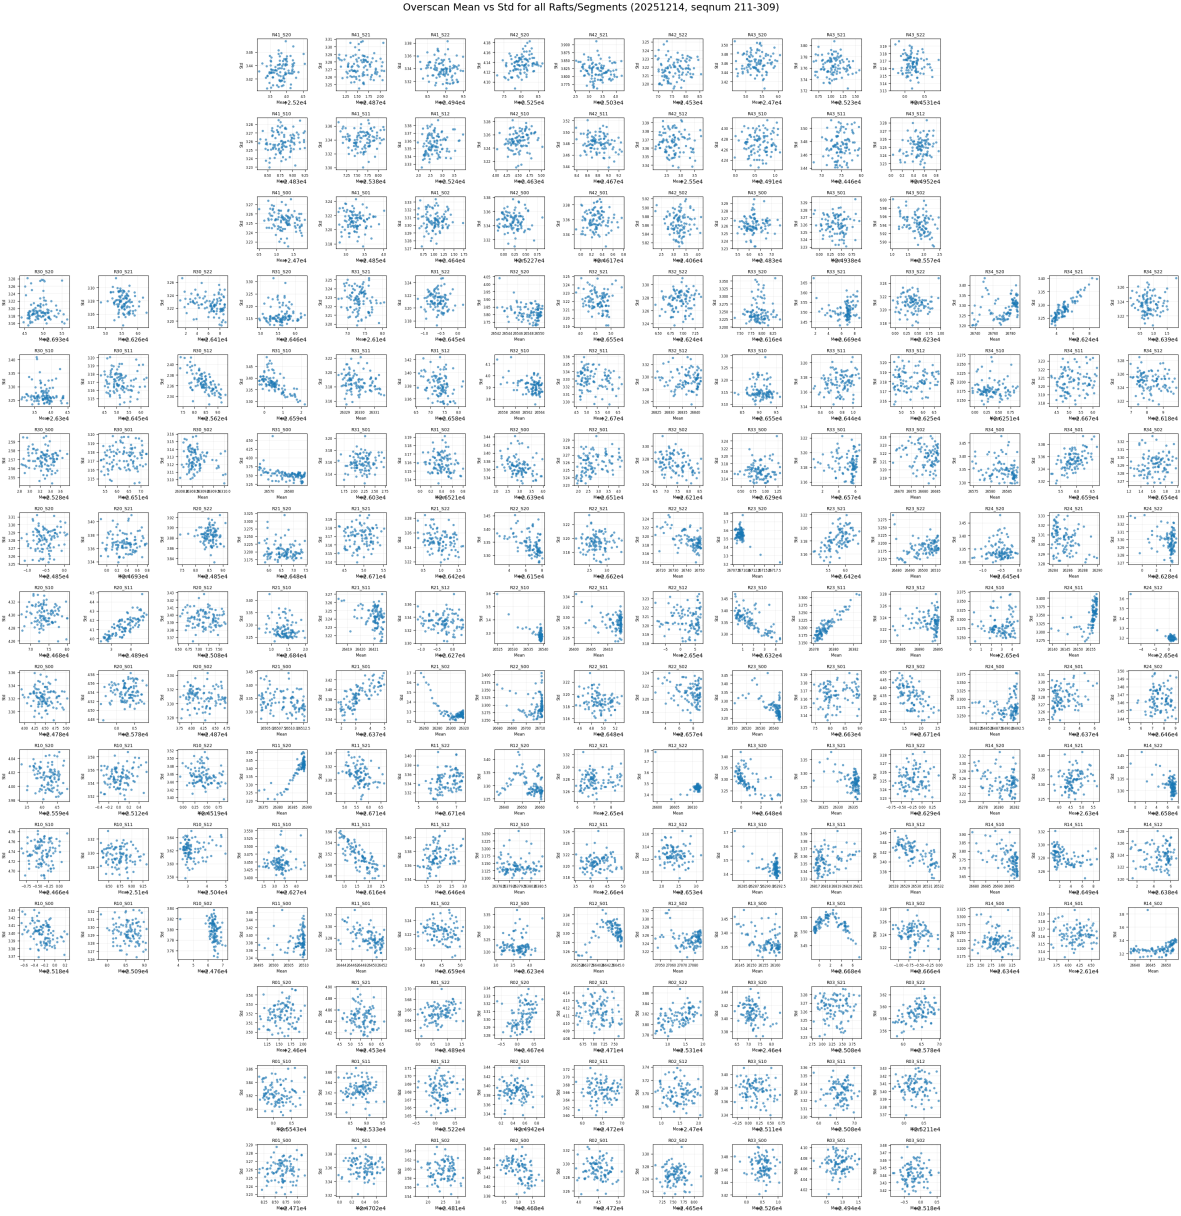
FIGURE 29: Overscan mean versus overscan standard deviation for all rafts and sensors (20251214, sequence numbers 211–309), one amplifier per sensor. The distinct populations seen before the firmware change (Figure 25) are absent.

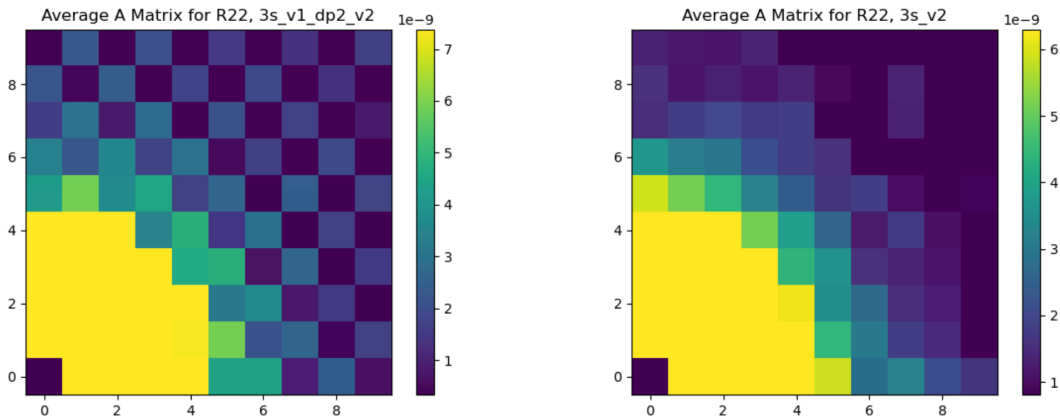
FIGURE 38: Average  $A$  matrix over raft R22 (e2v). Left: 3s\_v1\_dp2\_v2. Right: 3s\_v2. The checkerboard superimposed on the brighter-fatter falloff is gone (E. Rykoff).

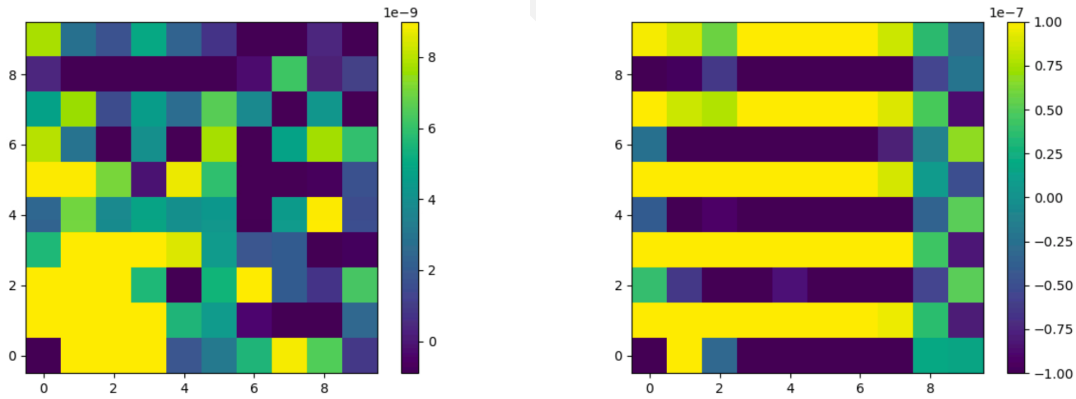
FIGURE 48: A matrix for R40\_SW1\_C13. Left: old run, as expected. Right: new run, with alternating rows and a colour scale two orders of magnitude larger (E. Rykoff).
